1. Task Number 090810CBB1947		2. Investigator's ID 2248		EPIDEMIOLOGIC INVESTIGATION REPORT
3. Office Code 810	4. Date of Accident YR MO DAY 2009 04 01	5. Date Initiated YR MO DAY 2009 08 10

6. Synopsis of Accident or Complaint UPC The consumer, his wife and 2 children moved into a new home in December 2006. It was reported that Chinese drywall in the home has caused several health issues. Appliances have ceased to function. Blackening and discoloration of copper pipes and metal fixtures throughout the home have been observed. Corrosion within the 2 AC units is evident. Product identification on the drywall is unknown. <div style="text-align: right;"> <p>CPSC (6/01/1) CLEARED for PUBLIC</p> <p>✓ NO MFRS/PRVT LBRS OR PRODUCTS IDENTIFIED</p> <p>EXCEPTED BY: PETITION RULEMAKING ADMIN. PRCDG</p> <p>✓ WITH PORTIONS REMOVED: <u>4, 262</u></p> <p style="font-size: 1.2em; margin-left: 20px;">WJC 5/19/10</p> </div>

090810CBB1947

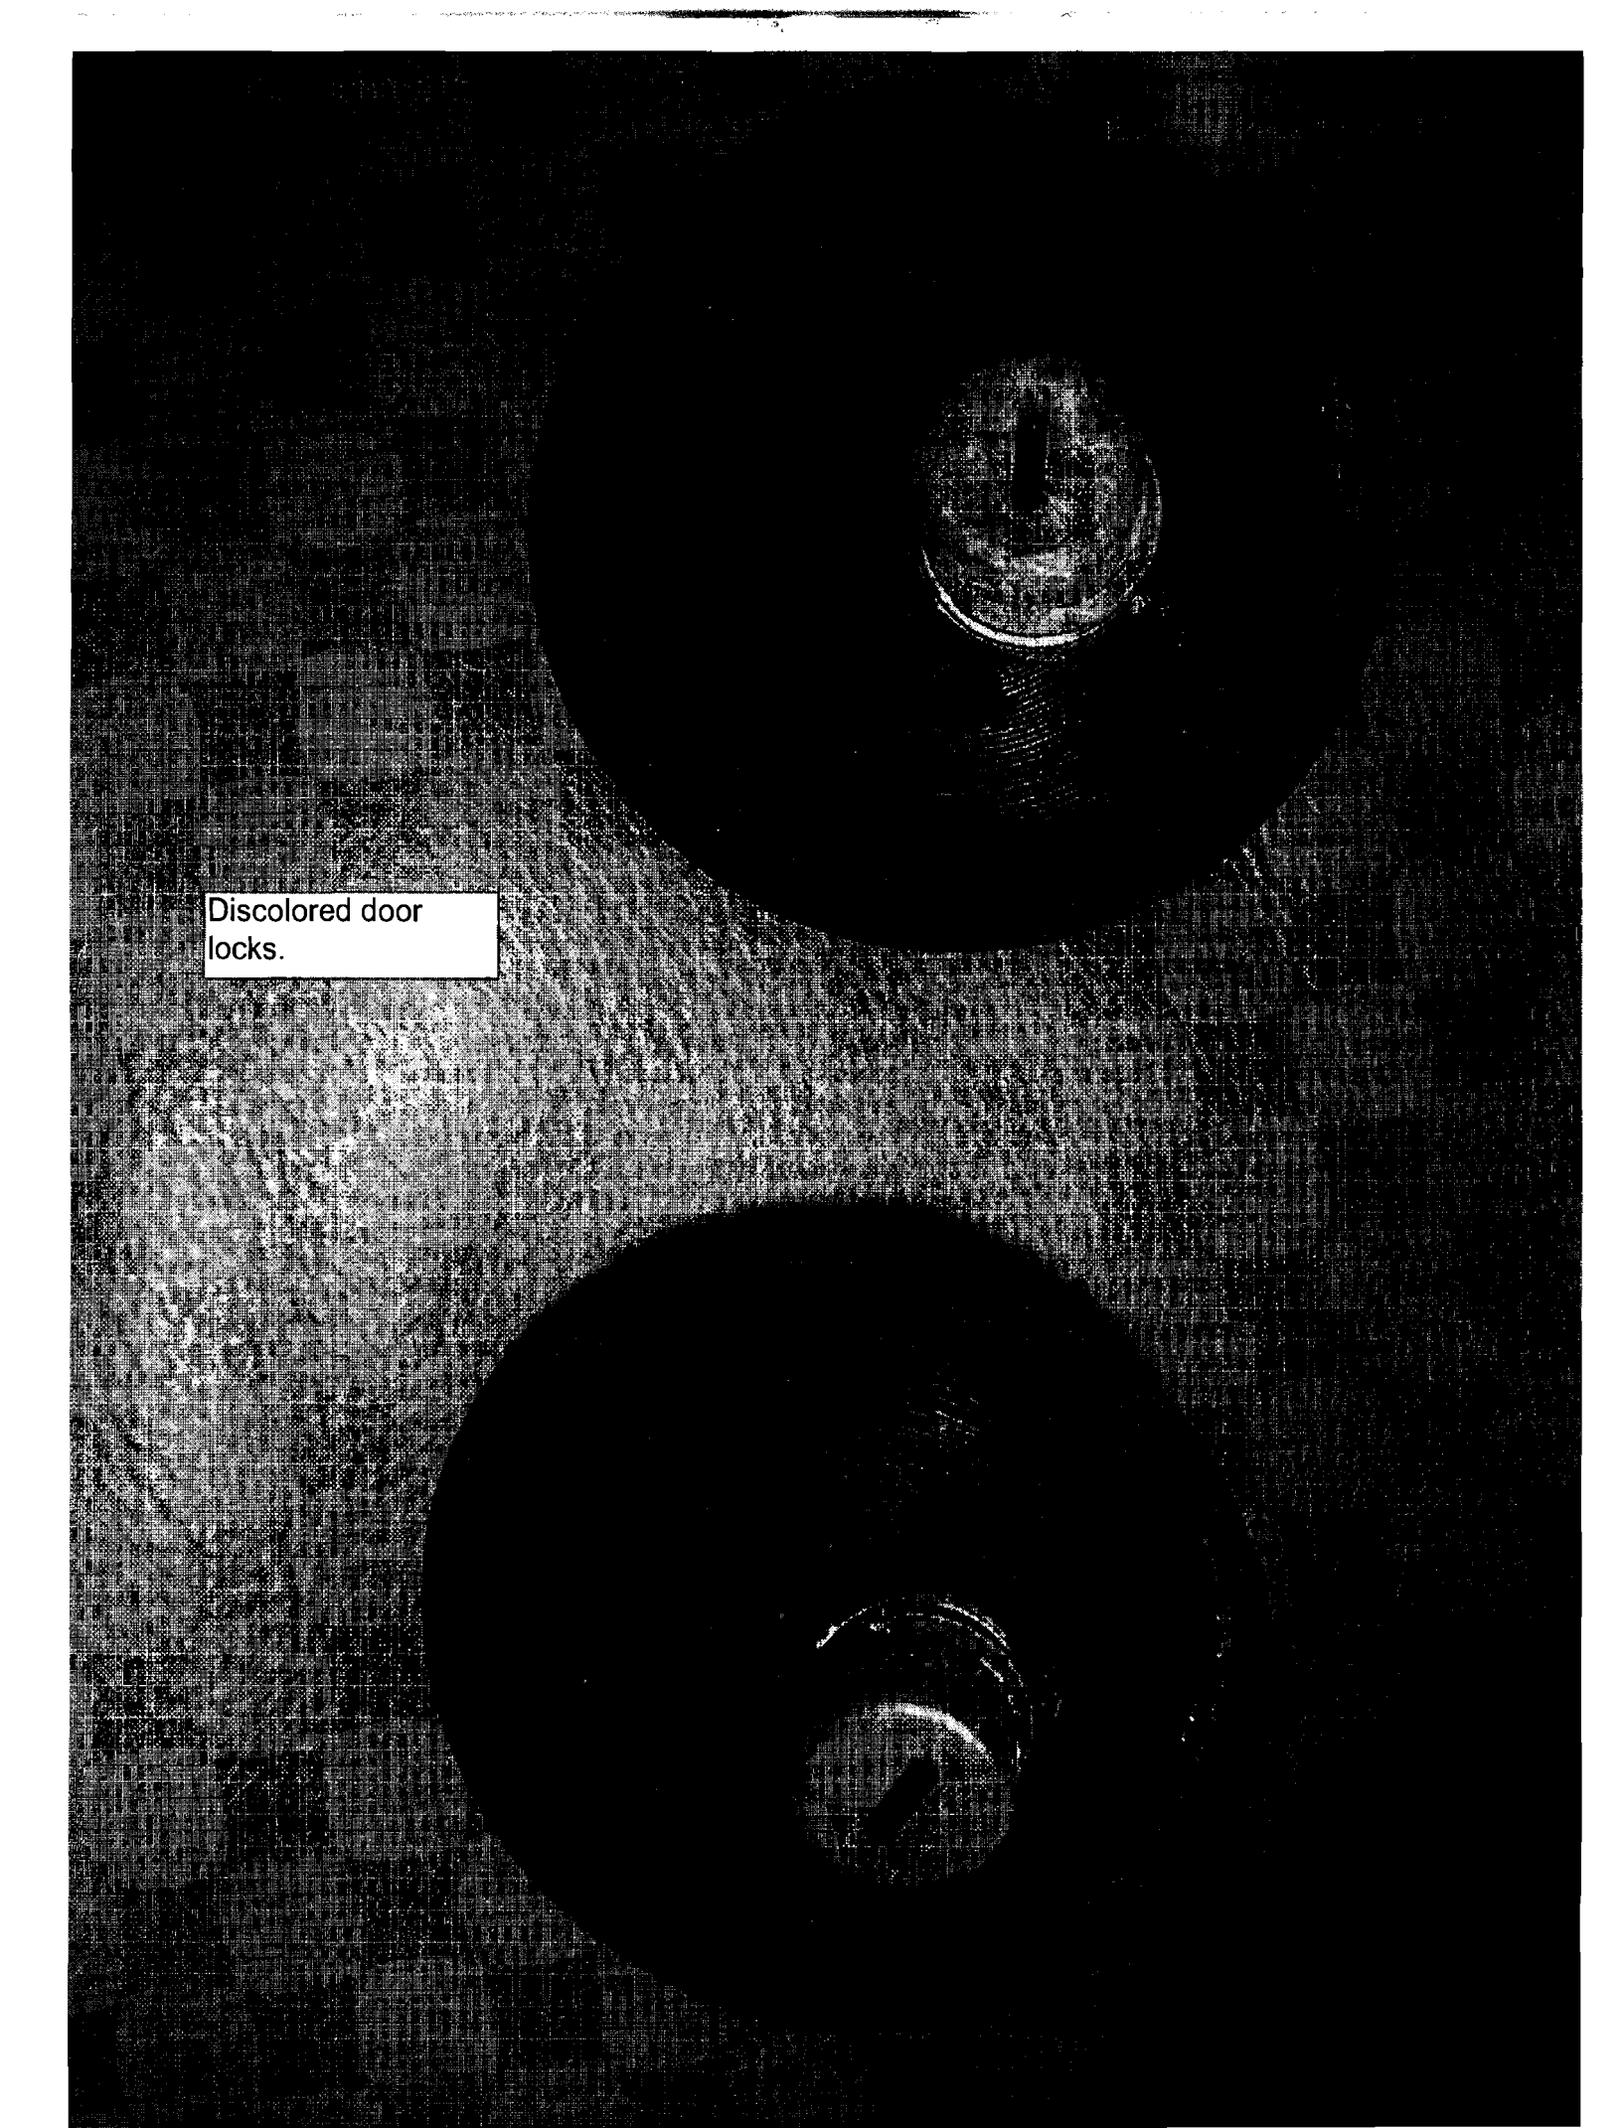
Discolored door
locks.

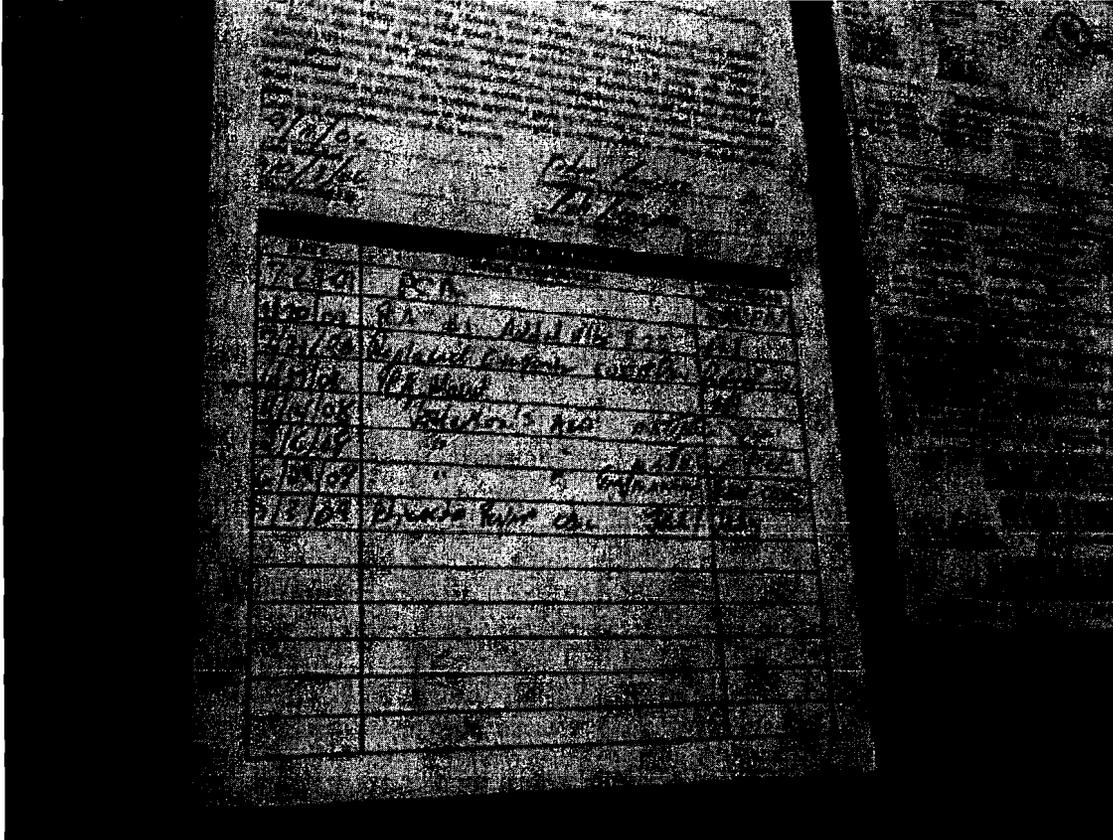
This house has two air conditioning systems. One is a three ton Carrier unit that is for the upstairs part of the house and the other one is a two ton Carrier unit that is for the downstairs part of the house. In February 2008, the three-ton air conditioner stopped working. The air conditioning technician who came to determine the problem with the air conditioner said the evaporator coils had to be replaced because they had corroded. The homeowners had the evaporator coils replaced. In June 2009, the homeowners began to have problems with this same air conditioning unit. The technician came out again and said the coils had to be replaced again because they were corroded. The coils were replaced in July 2009 (Attachment 1, Photos 2-5).

PHOTO 5 – Close up view of the maintenance record attached to the larger air conditioning unit showing the air conditioning coils have been replaced on February 27, 2008 and again on July 3, 2009

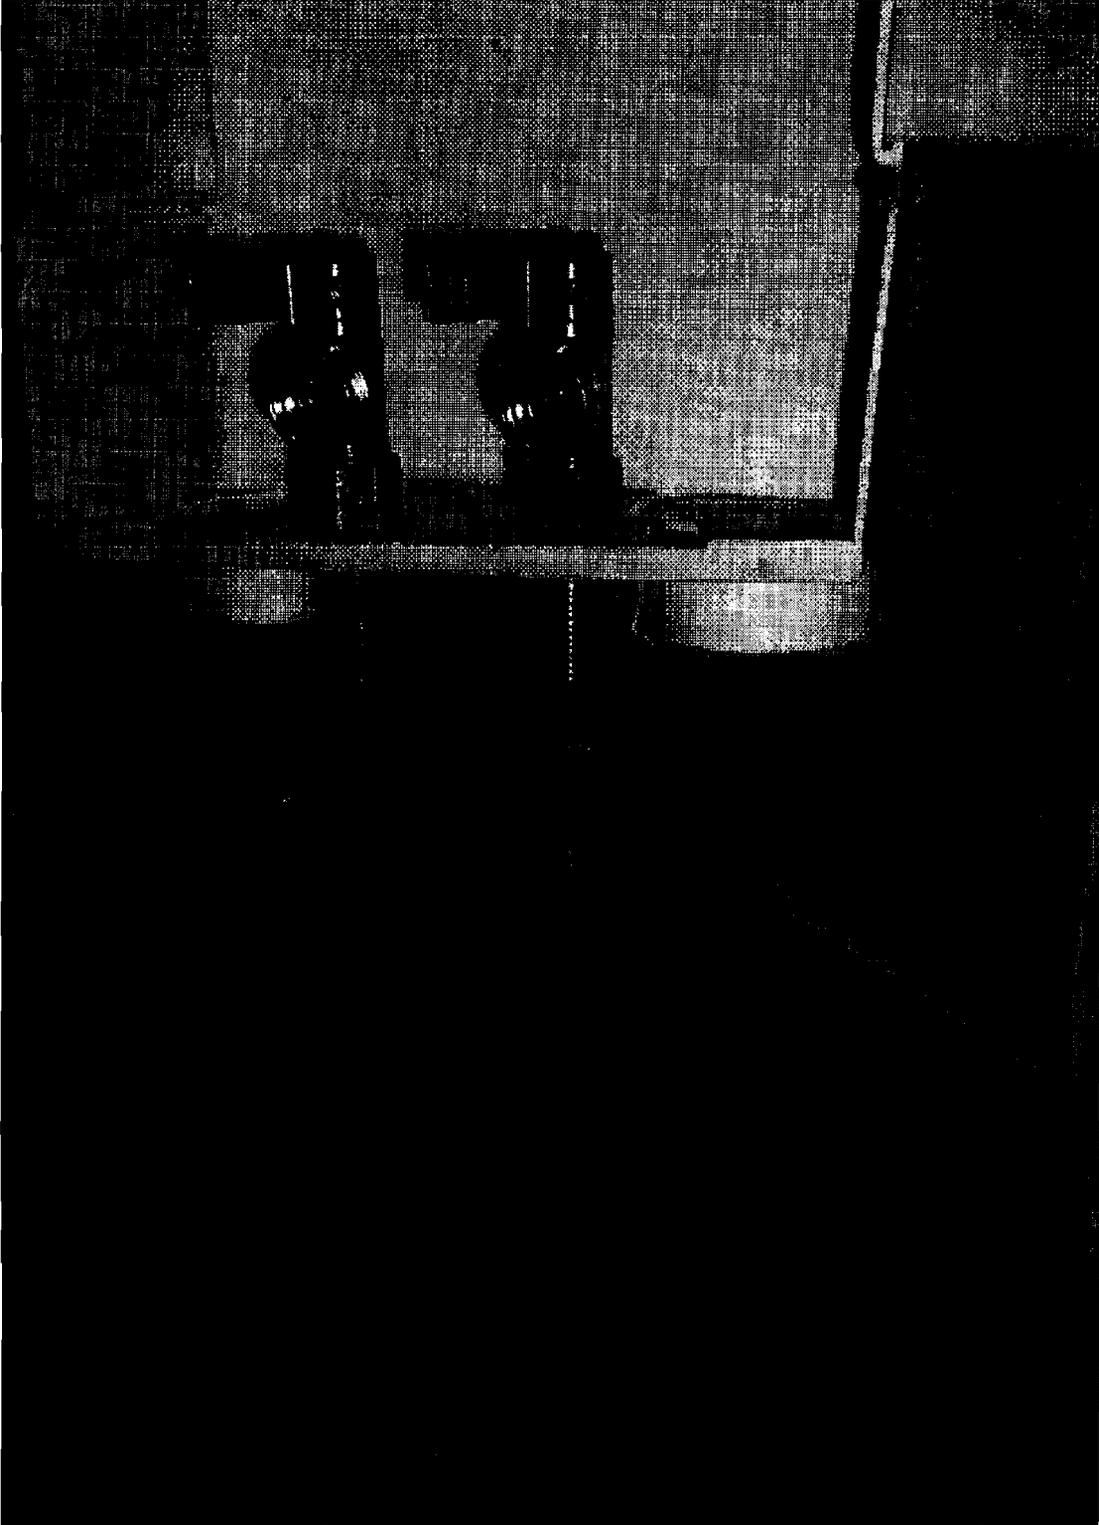
Photograph 1: Corrosion and blackening of copper pipes in kitchen of incident location

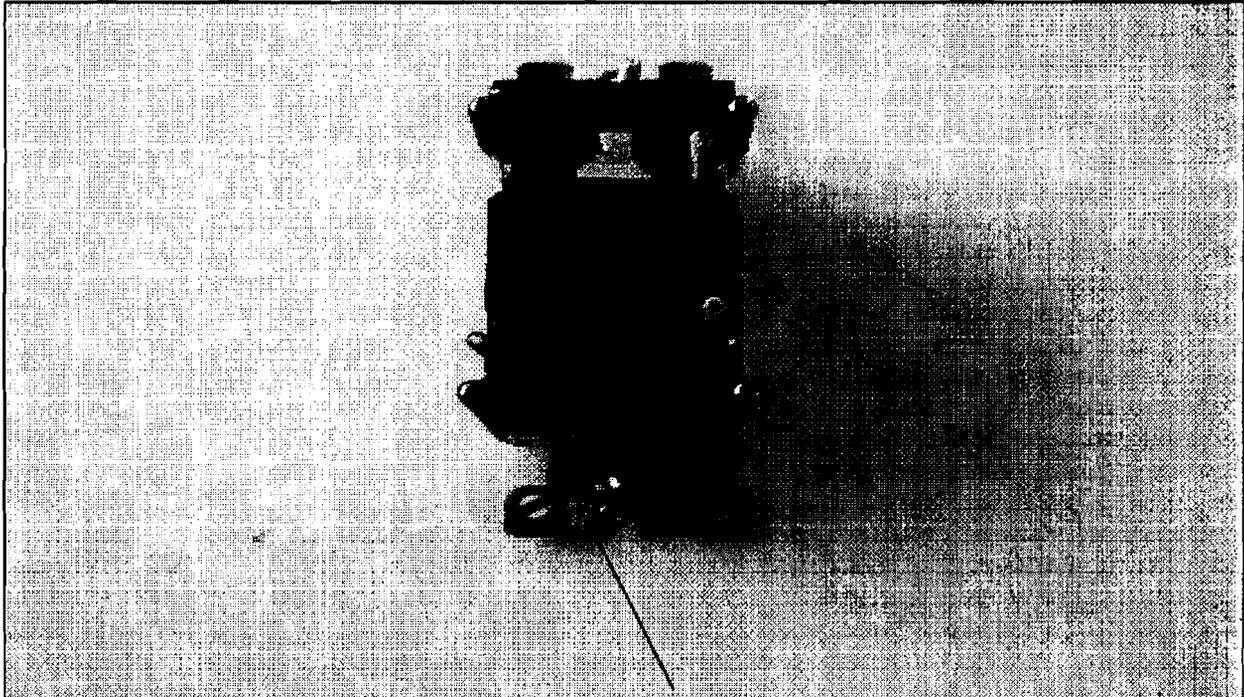
Figure #9: A view of the back of the GCFI.

The arrow is pointing to signs of corrosion on the copper wire.

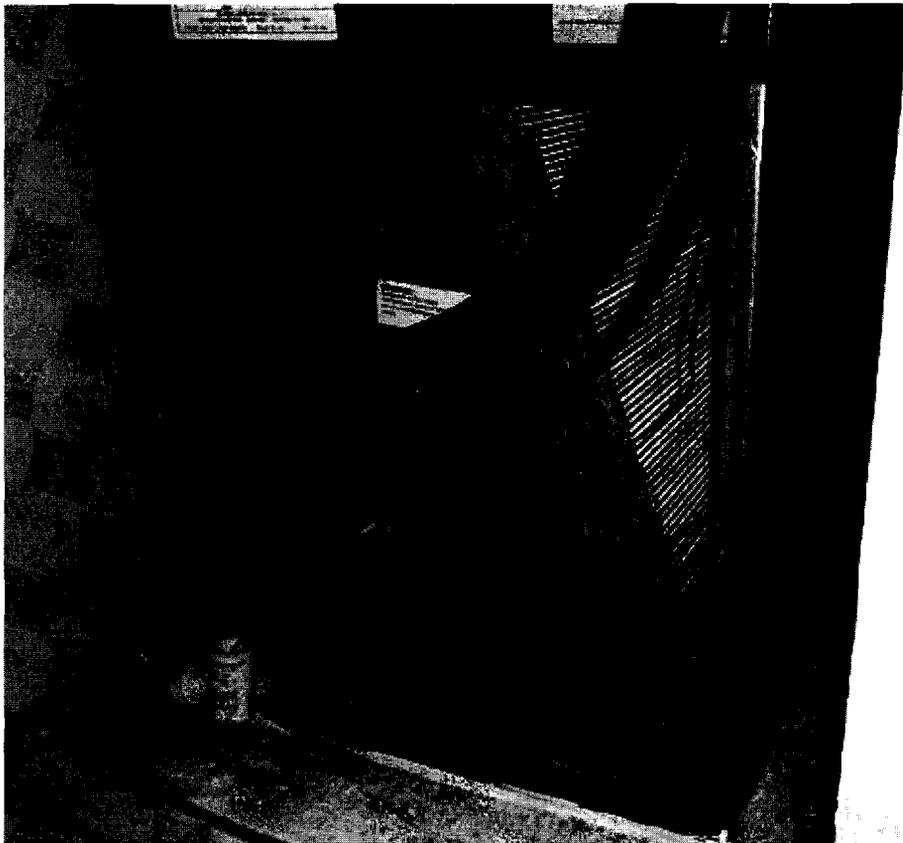
Photo 2 – View of the air conditioner coils that have corroded and turned black

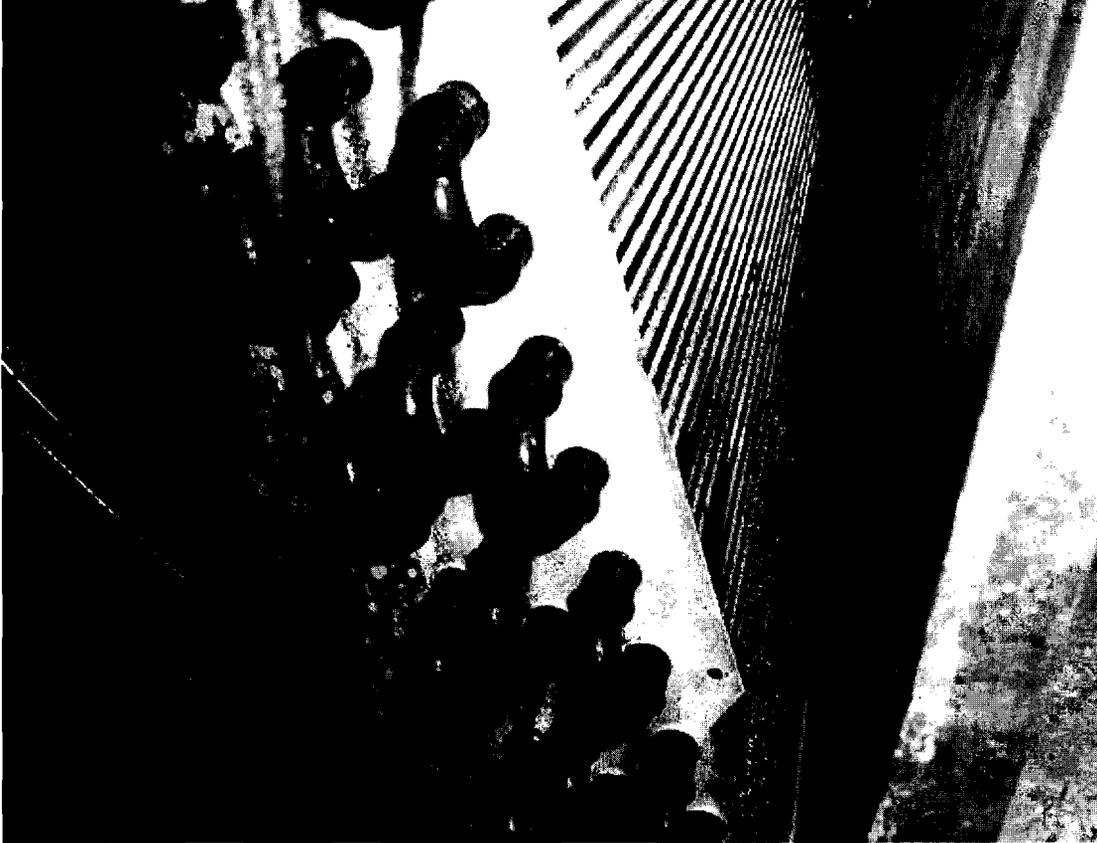
Photo 3 – Close up view of the coils in the air conditioner unit

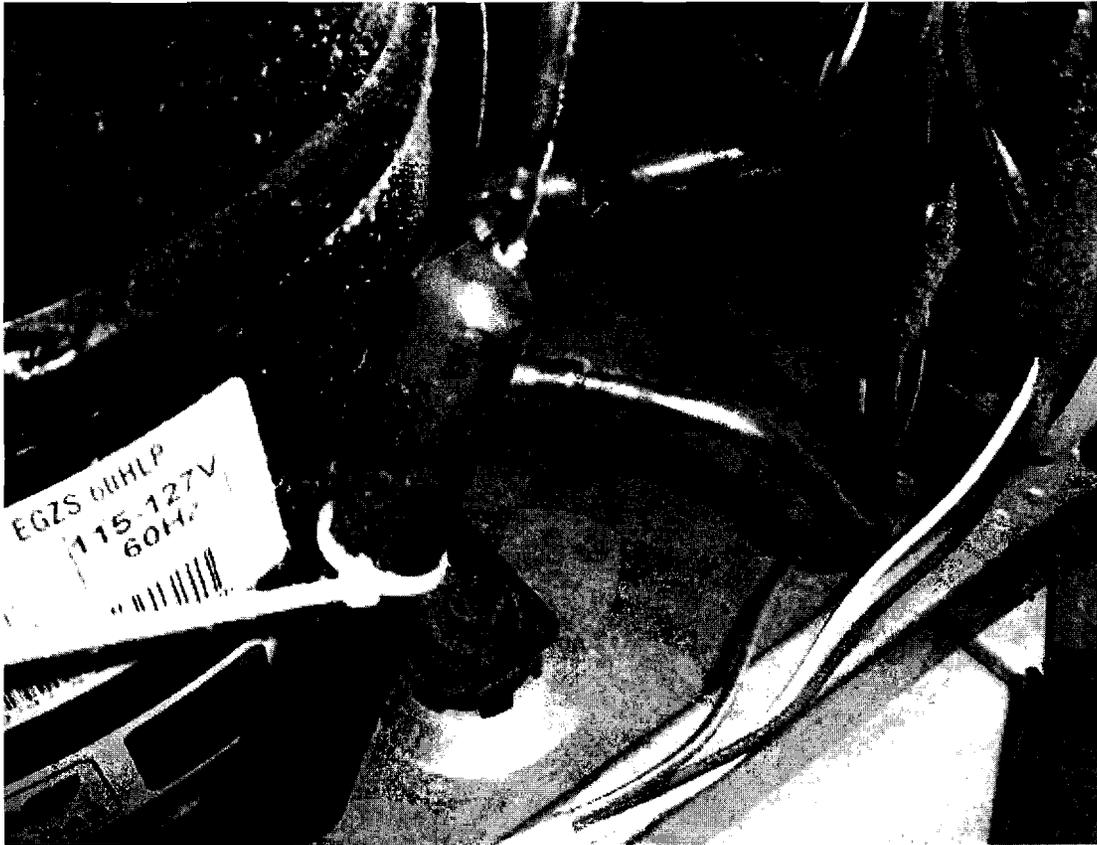
Photo 5 - Close up view of the copper wires on the back on the homeowner's refrigerator where they have corroded and started to turn black

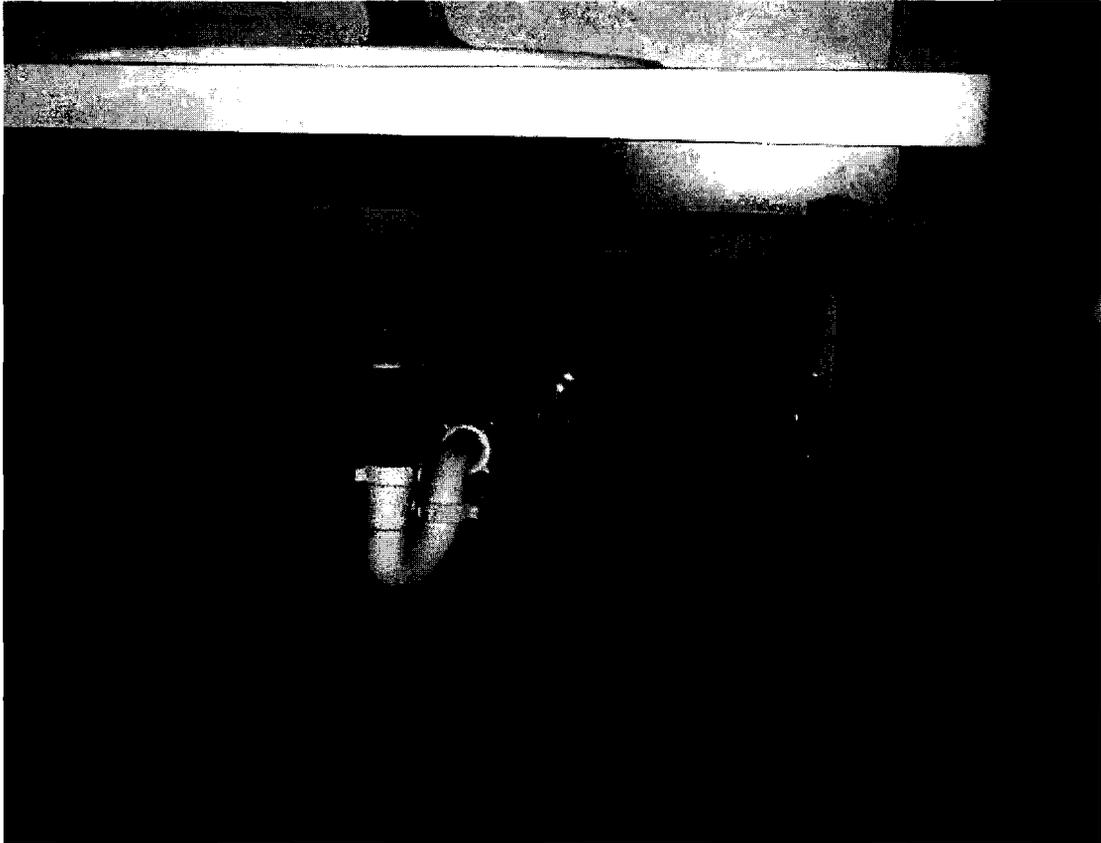
Photo 10 – View of the black corrosion on the copper pipes under the bathroom sink

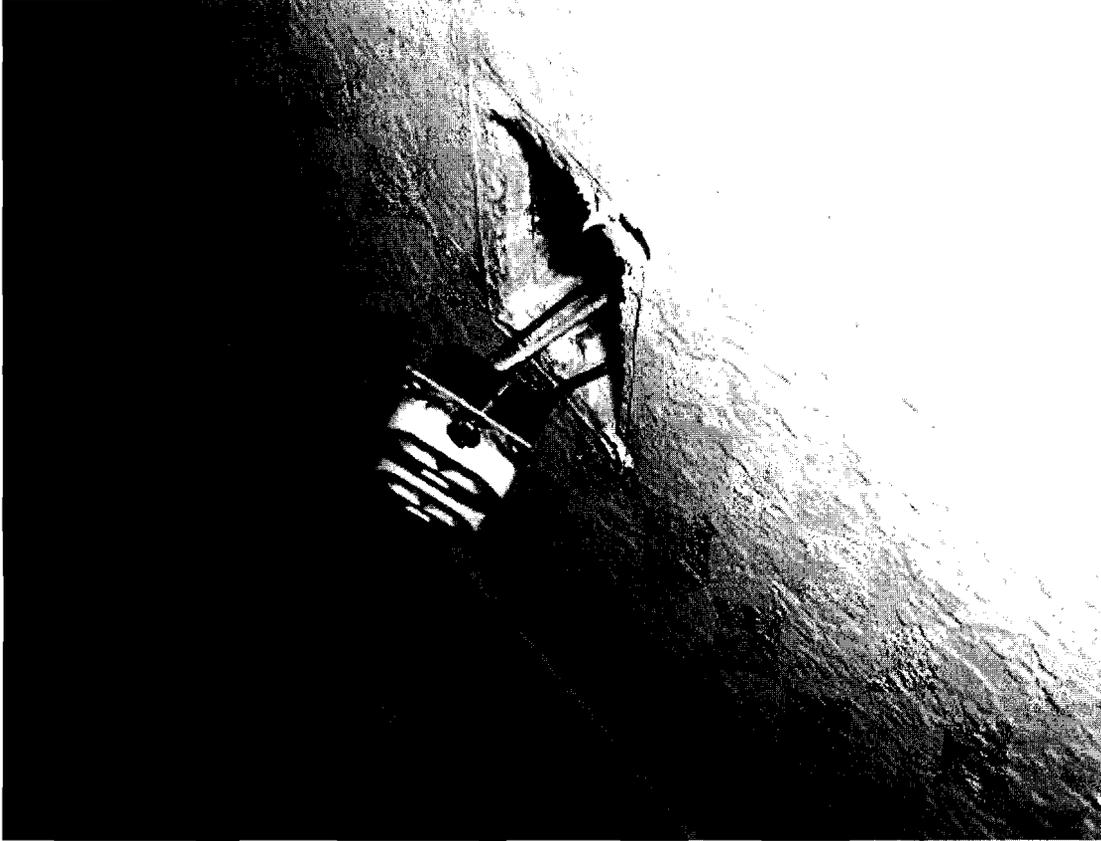
Photo 12 – View of the corrosion on the wires in an outlet

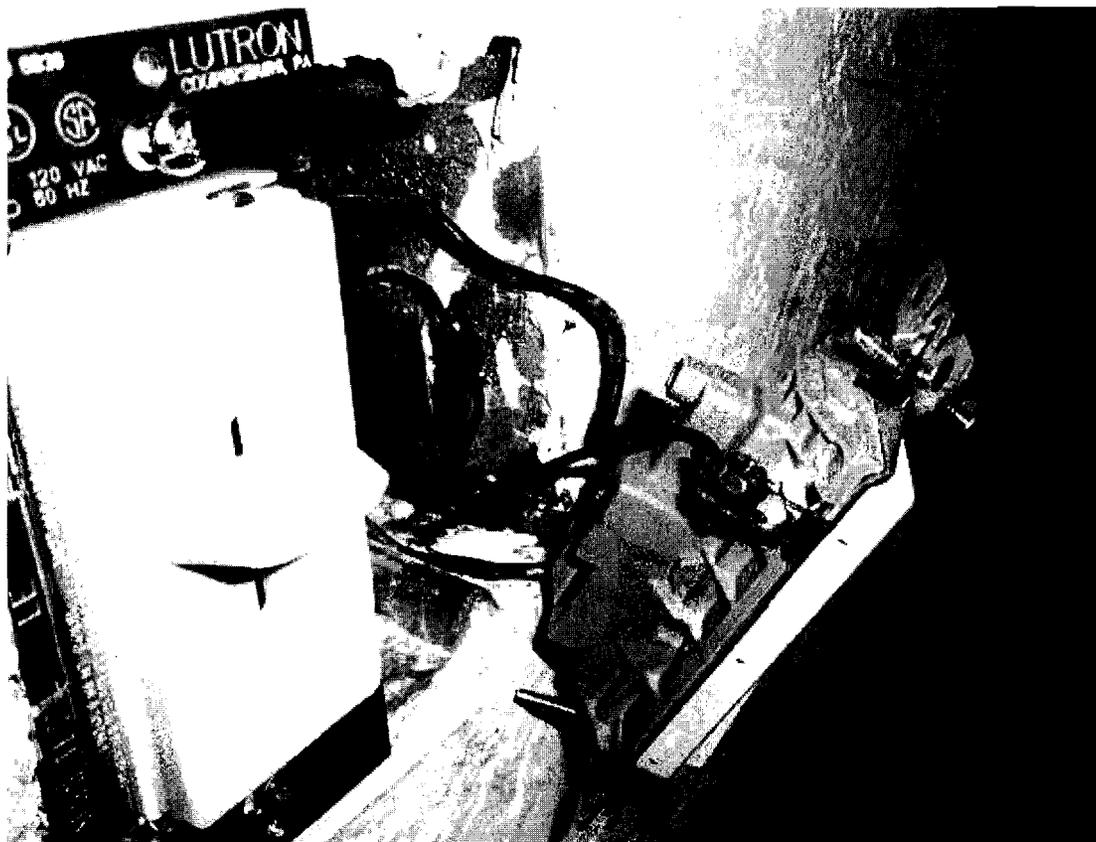
Photo 14 – View of black corroded wires behind light switch

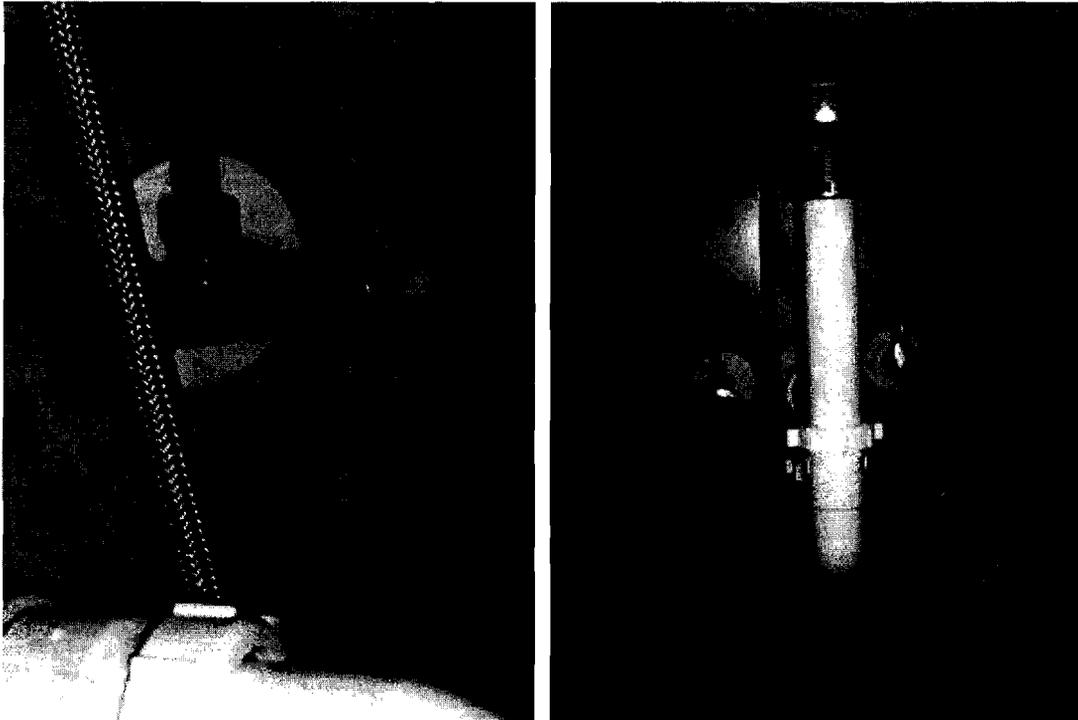
Photographs show visible signs of blackened copper pipes under sinks.
