| 1. Task Number 090529CBB1741 | | 2. Investigator's ID 9102 | | EPIDEMIOLOGIC INVESTIGATION REPORT |
| 6. Synopsis of Accident or Complaint UPC 0-81999-10522-8 The family moved into their home in October 2006 and had to move out in April 2009 due to the ill health affects from the tainted drywall. The owner of the home cut holes in his walls to discover that the drywall was imported from Canada by an American Company and was a medium gray color. The homes two air conditioners coils had both been replaced twice. Chrome fixtures were pitted and electrical wiring was turning black. <div style="text-align: right;"> <p><u>MFR/PRV/LBR NOTIFIED</u> 10/13/09</p> <p>COMMENTS: <u>YES</u> <u>NO</u></p> <p><input checked="" type="checkbox"/> <u>OVERRULED</u>; <u>ATTACHED</u></p> <p><input checked="" type="checkbox"/> <u>EXCISIONS/FOIA Hqs.</u> <i>oche mpr.</i></p> <p><u>DO NOT RE-NOTIFY</u> <input checked="" type="checkbox"/> <u>RE-NOTIFY</u></p> </div> | | | | |

This incident involves health issues and copper and metal corrosion at the non seasonal home of the victims over an extended period of time as will be detailed later in this report which the owners believe were caused by contaminate

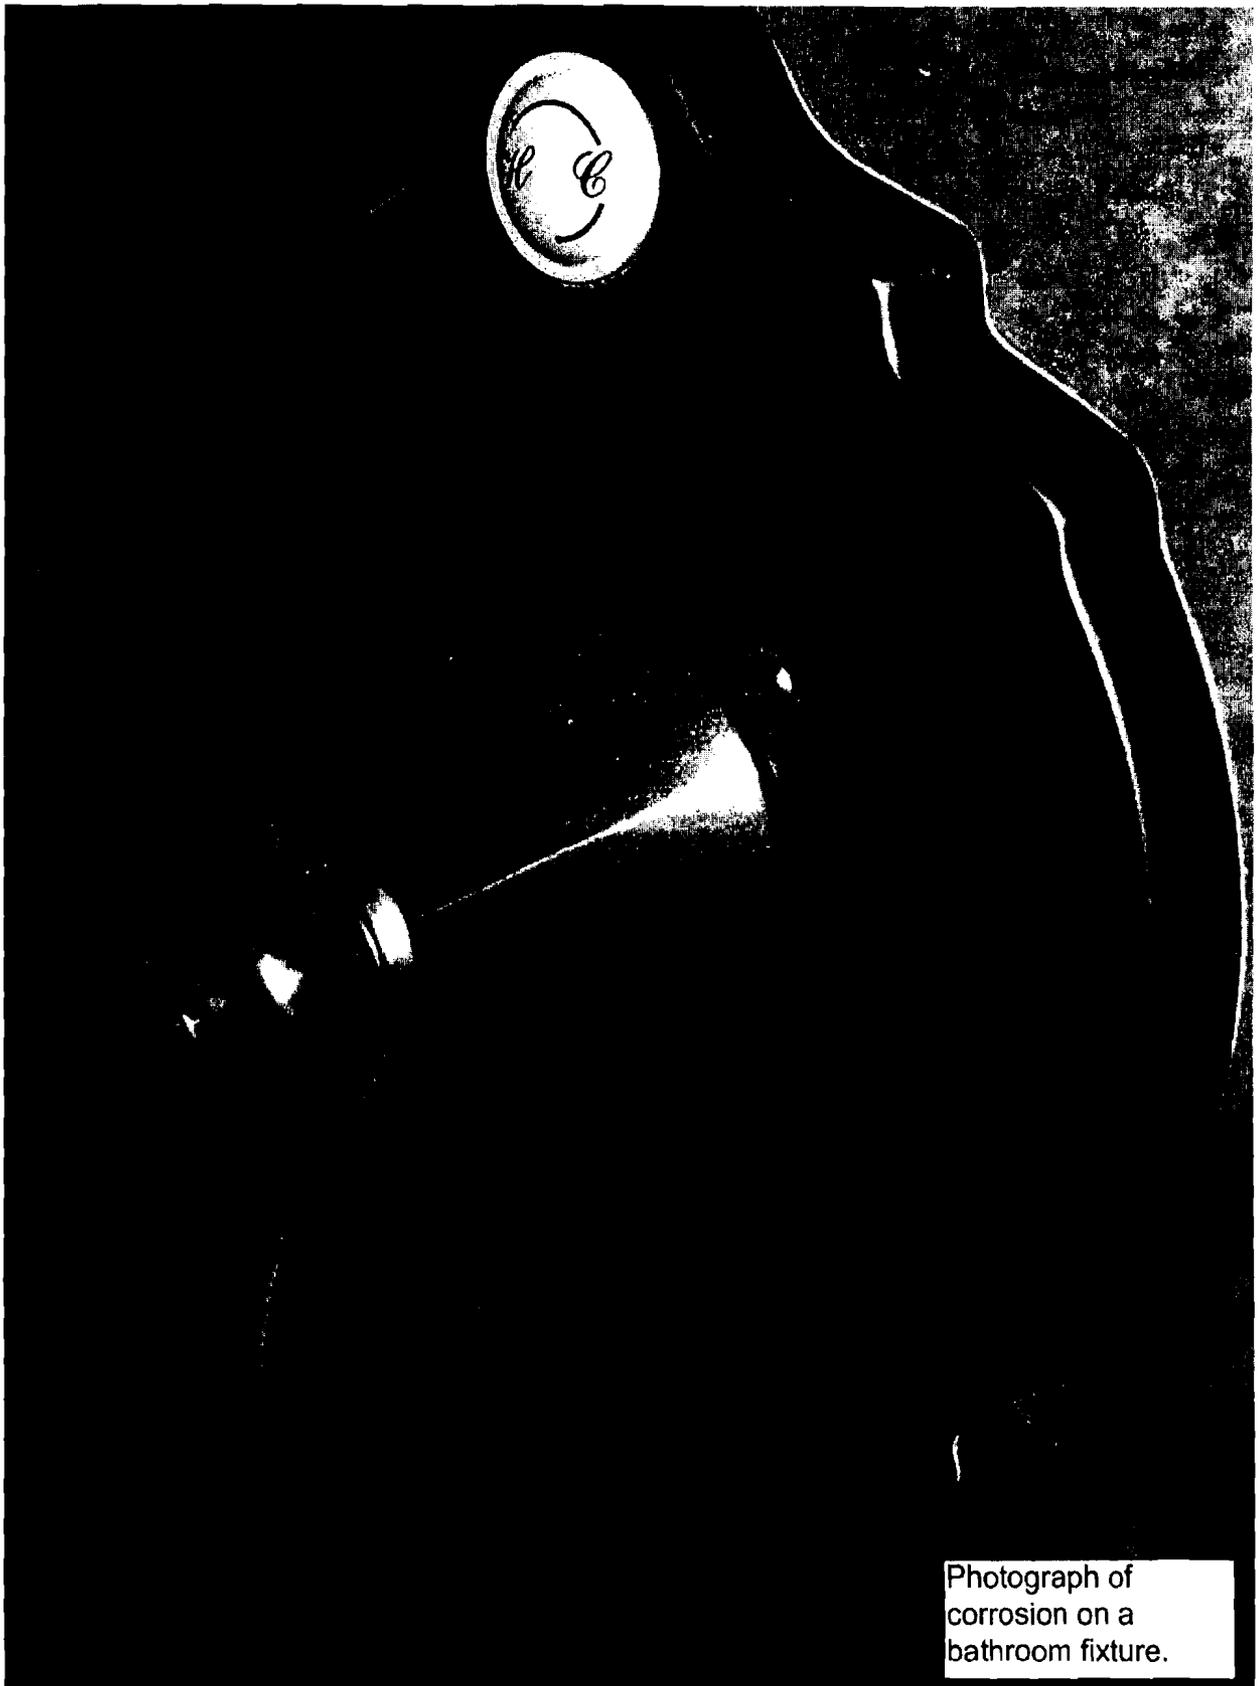
Photograph of corrosion on a bathroom fixture.

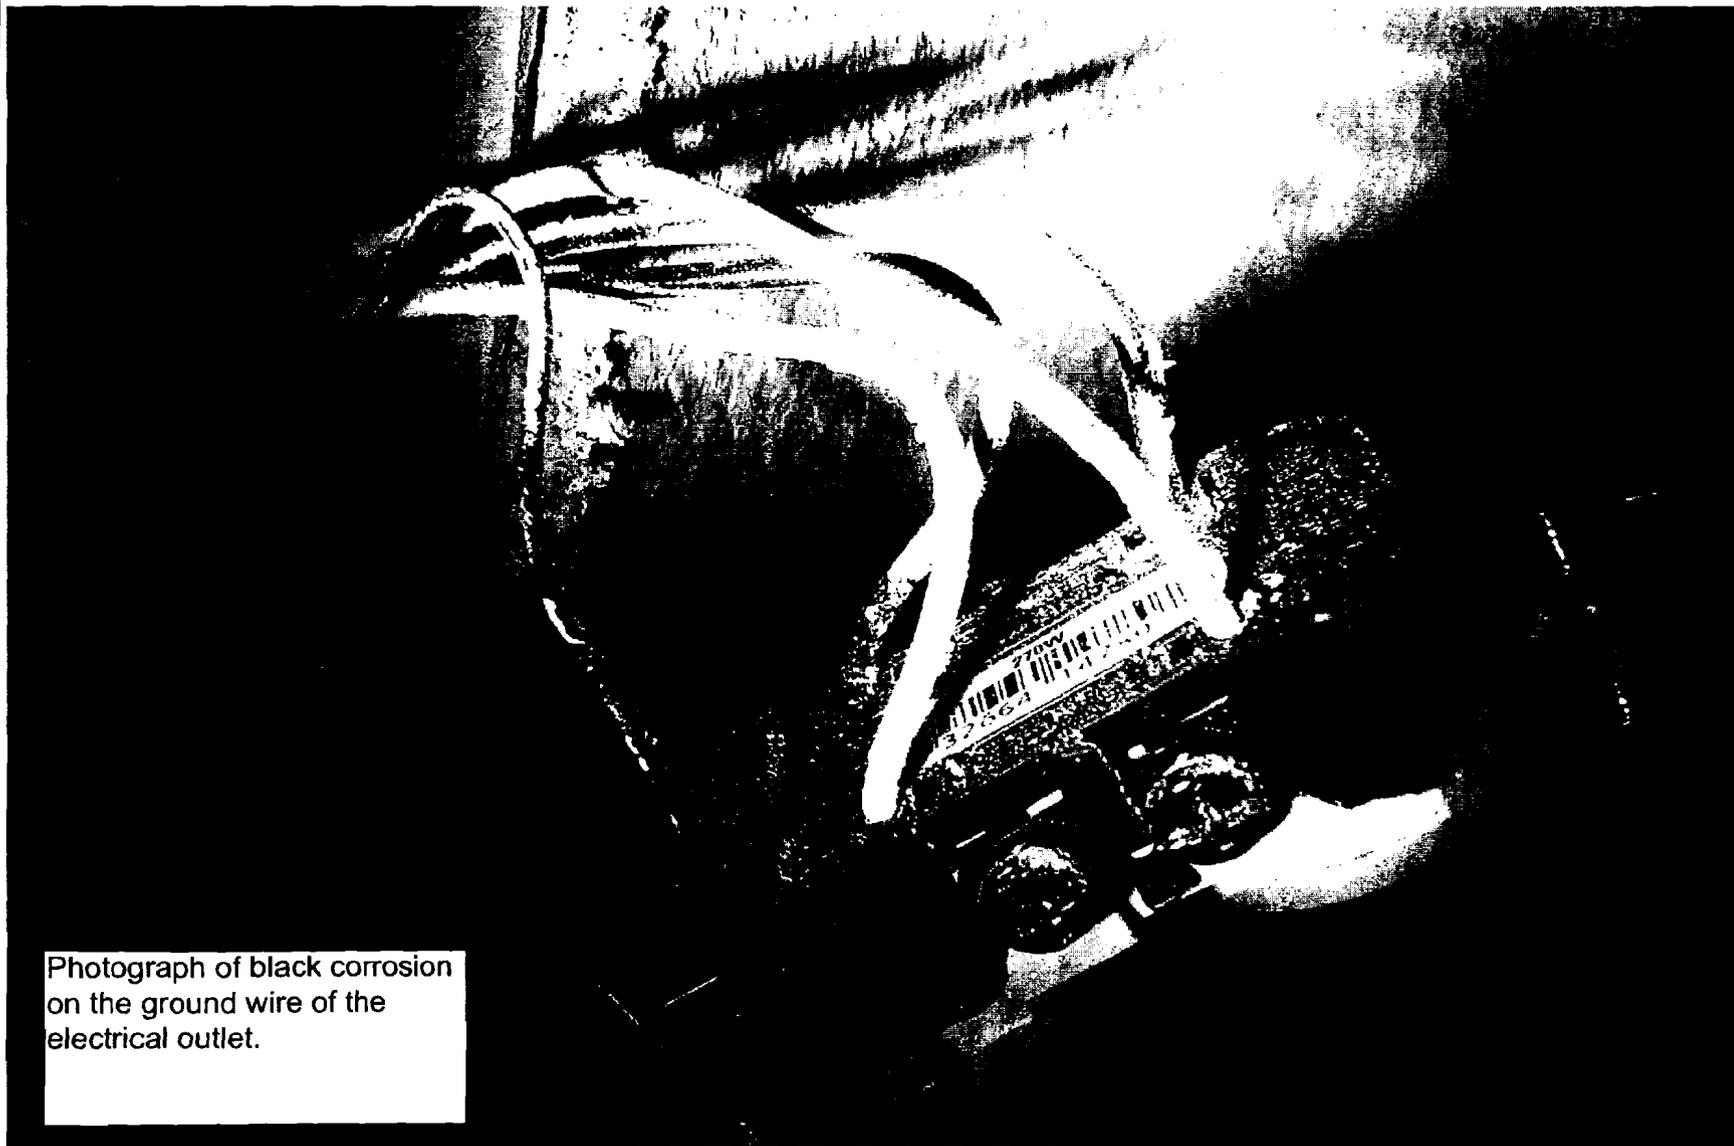
Photograph of black corrosion on the ground wire of the electrical outlet.

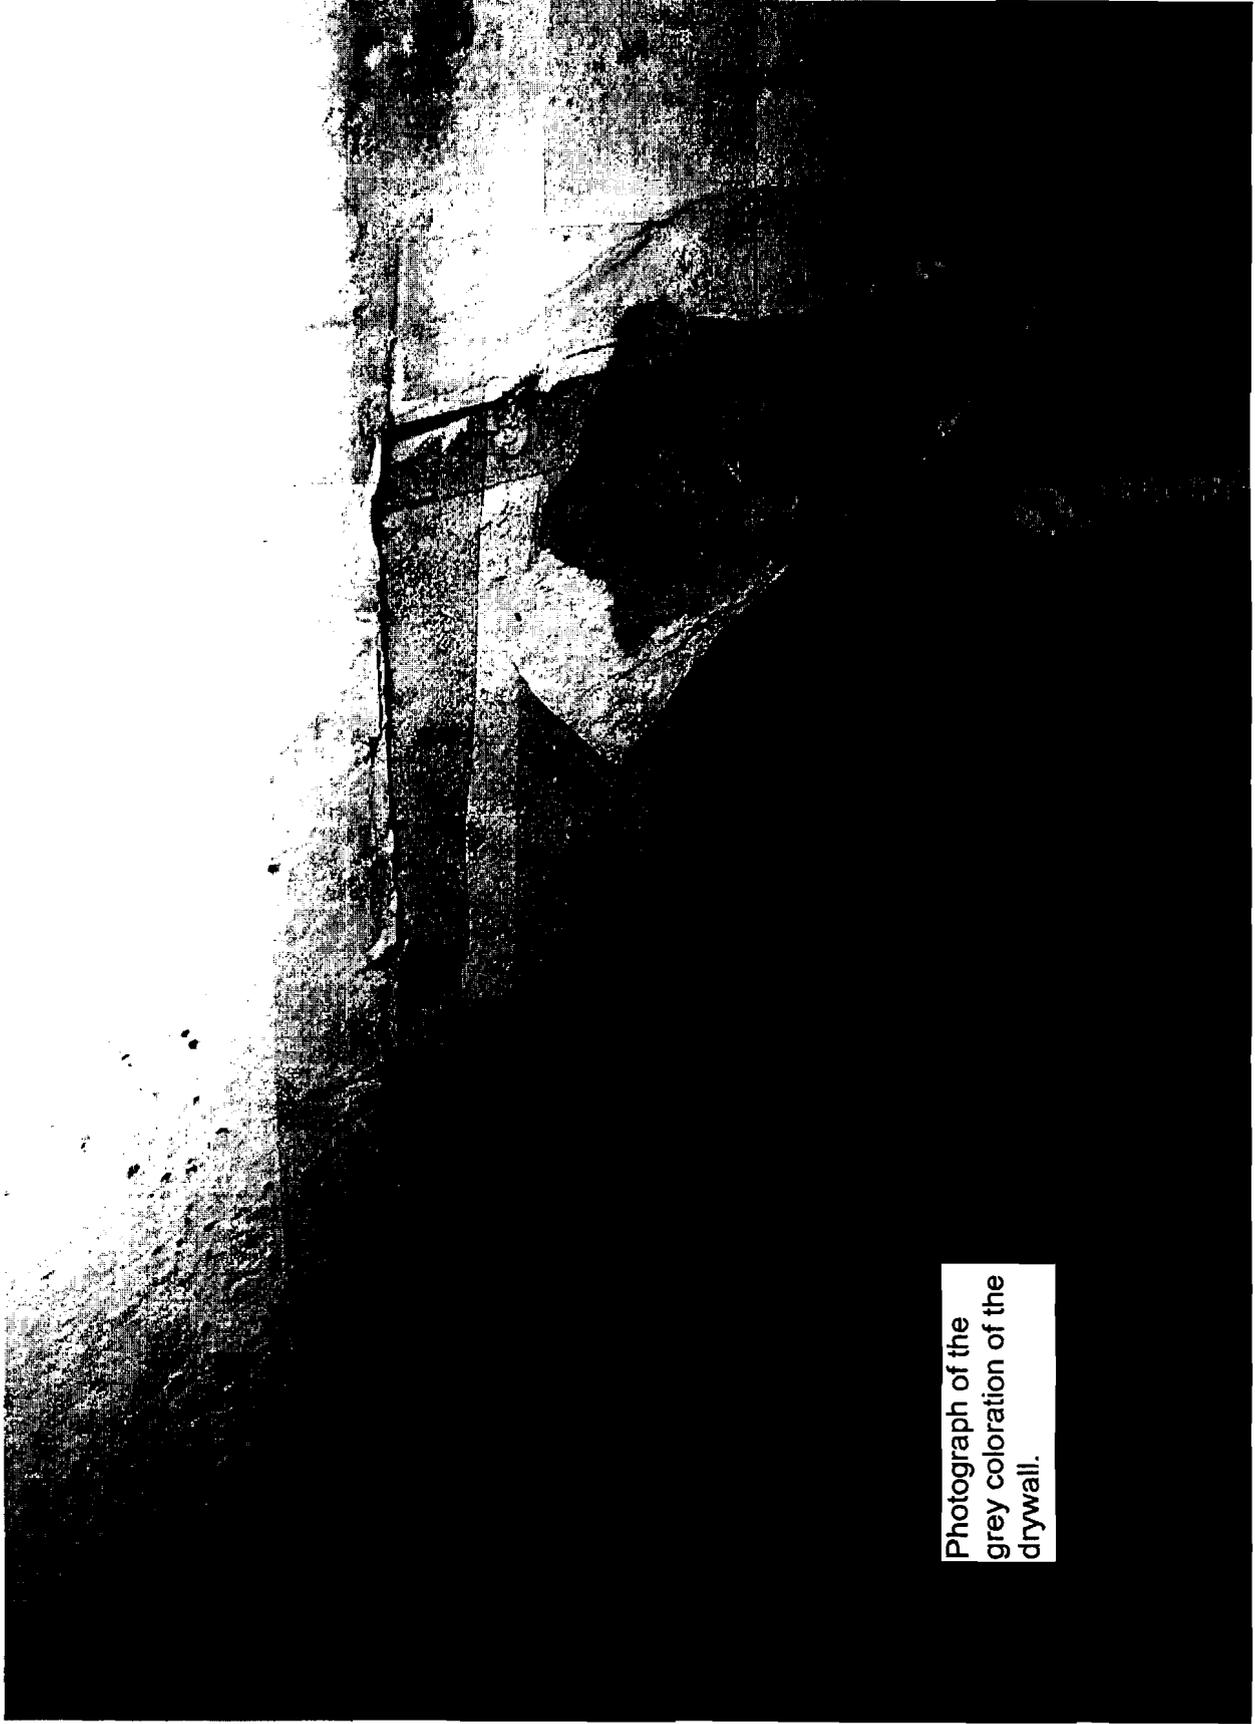
Photograph of the
grey coloration of the
drywall.

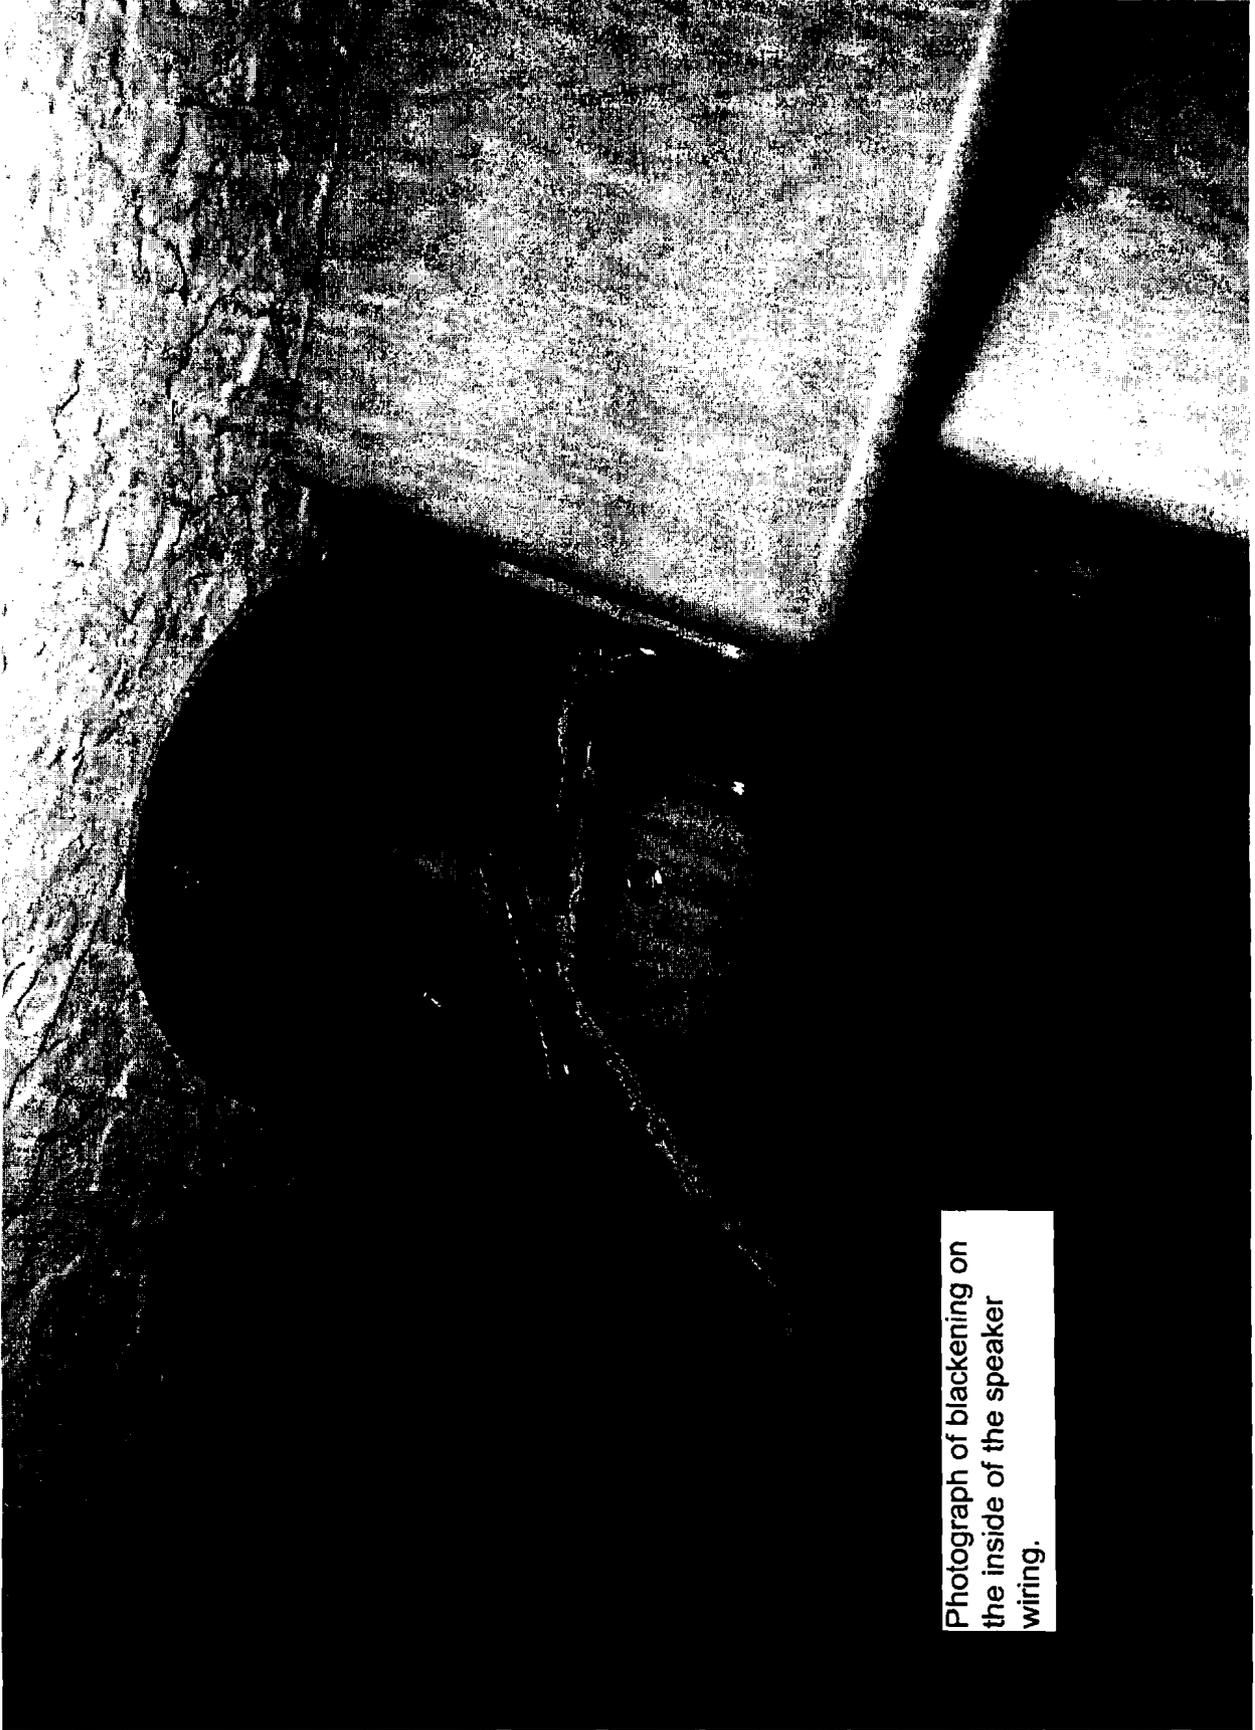
Photograph of blackening on the inside of the speaker wiring.

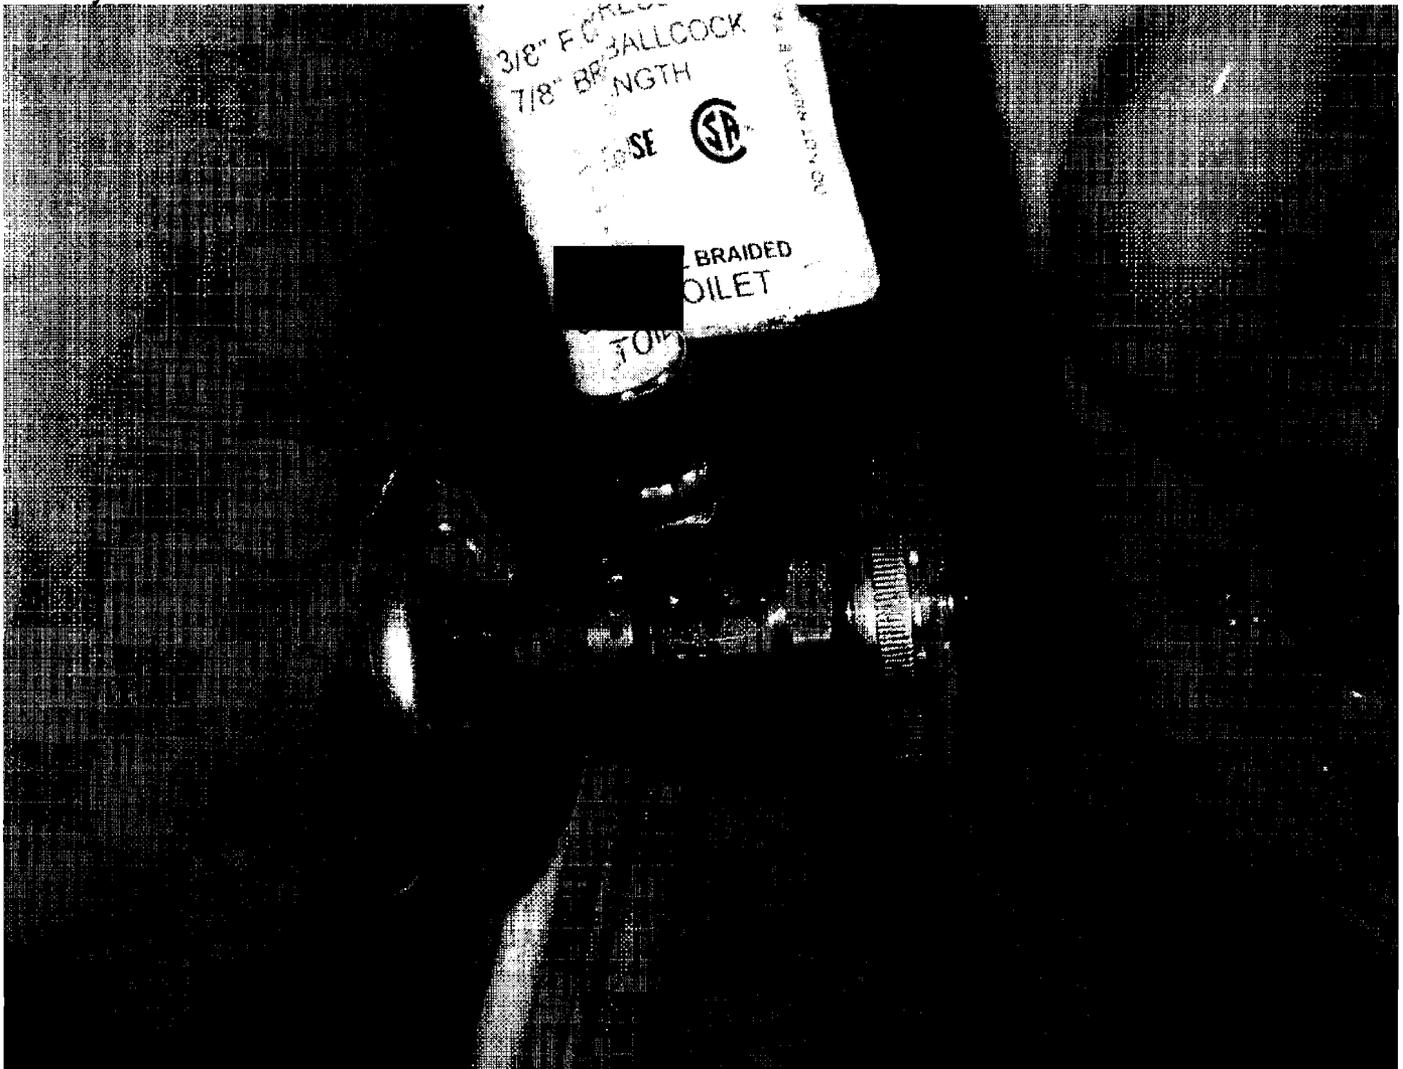
Photo 7: View of a mostly uncorroded toilet water supply valve located in a bathroom off of the hallway.

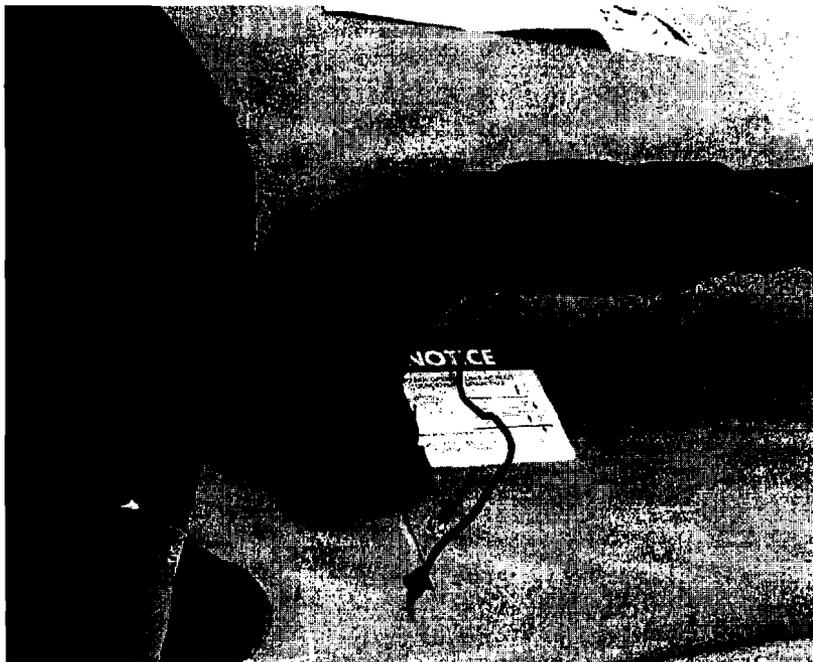
Exhibit 9 - Photo of blackened copper pipe outside of air handler.

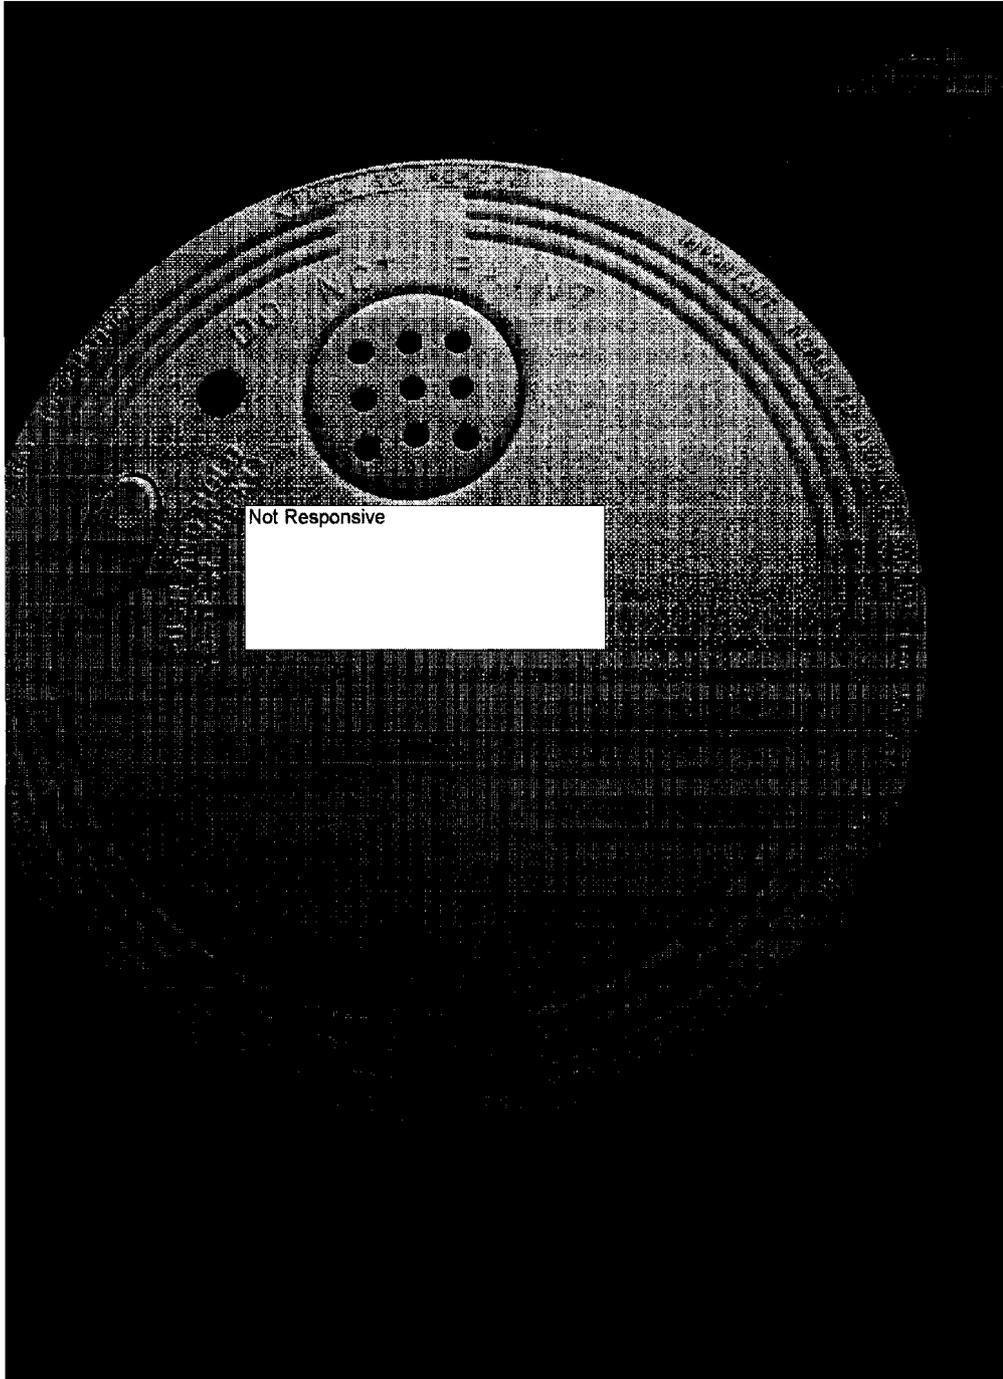
Exhibit A-13 is a view of the smoke alarm that malfunctioned.
