1. Task Number 061127HNE1688		2. Investigator's ID 8925		EPIDEMIOLOGIC INVESTIGATION REPORT
3. Office Code 810	4. Date of Accident YR MO DAY 2006 11 22	5. Date Initiated YR MO DAY 2006 11 27

6. Synopsis of Accident or Complaint UPC none Victim #1, a 10-year-old female passenger was riding in a four-wheeled utility vehicle. Victim #2, the driver, a 11-year-old male was operating the utility vehicle on private property/a field/wooded area. Victim #3, another 10-year-old female passenger was riding in the utility vehicle. They were not wearing helmets or seatbelts. They were traveling downhill, attempted to make a turn and the utility vehicle overturned. Victim #1 fell out and the utility vehicle landed atop of her. Victim #1 died at the scene. Victim #2 and #3 were not injured. VIN # is [REDACTED]

7. Location (Home, School, etc) 2- FARM		8. City HOPE TOWNSHIP		9. State MI
10A. First Product 5044- Utility Vehicles		10B. Trade/Brand Name YAMAHA/RHINO		10C. Model Number 660
10D. Manufacturer Name and Address YAMAHA MOTOR CORP/ VIN [REDACTED] 6555 Katella Ave Cypress, CA 90630				
11A. Second Product 0		11B. Trade/Brand Name NONE		11C. Model Number NONE
11D. Manufacturer Name and Addre

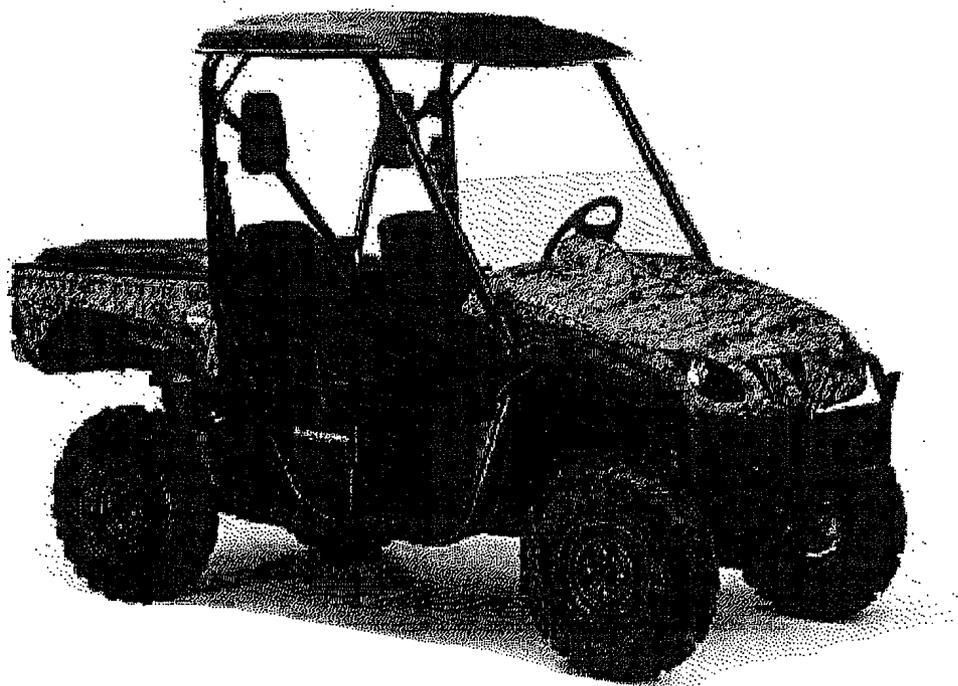
061130HCC2121 Exhibit A-1 below shows a 2006 Yamaha Rhino 660

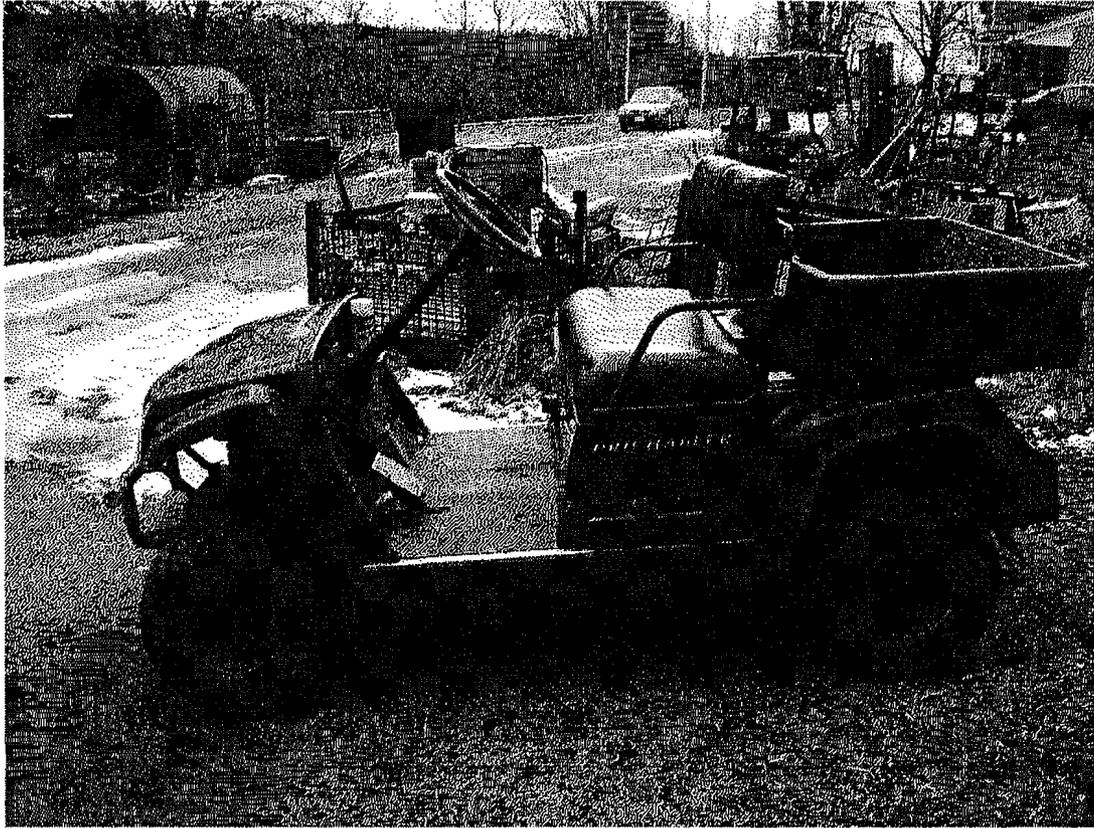
**Exhibit 1.1: Left Side View of Incident Utility Vehicle
IDI # 070122CCC1264**

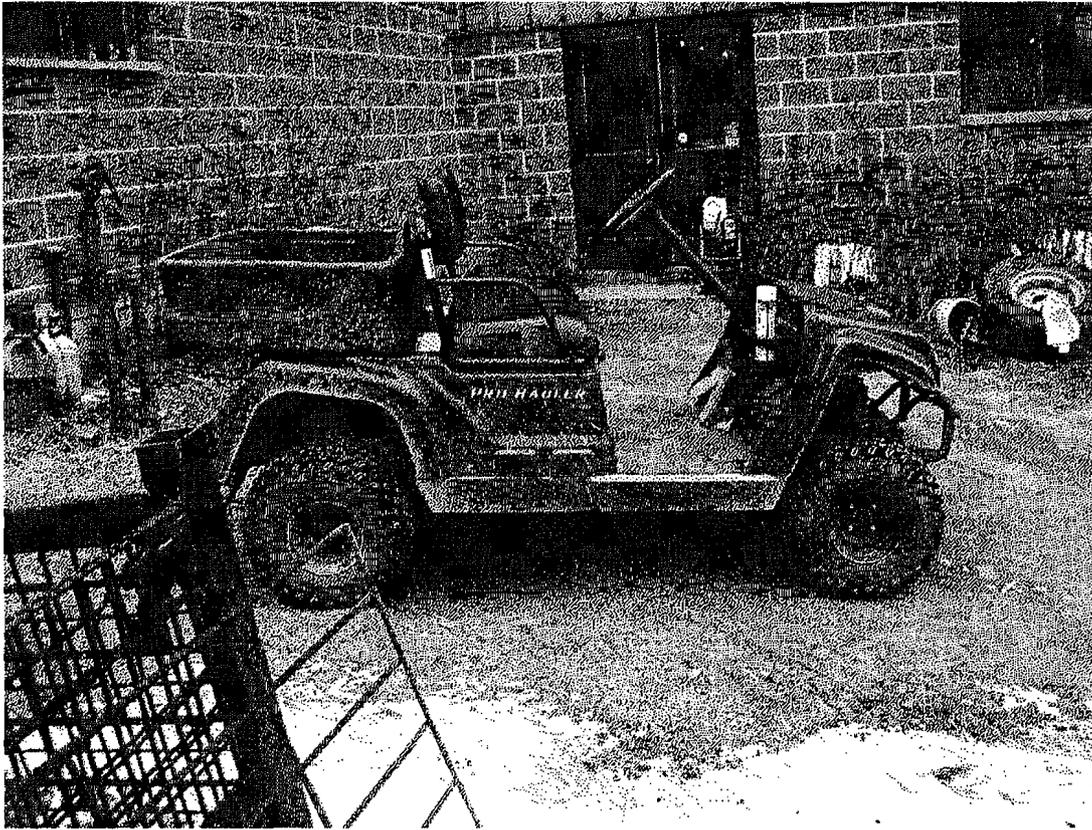
**Exhibit 1.2: Right Side View of Incident Utility Vehicle
IDI # 070122CCC1264**

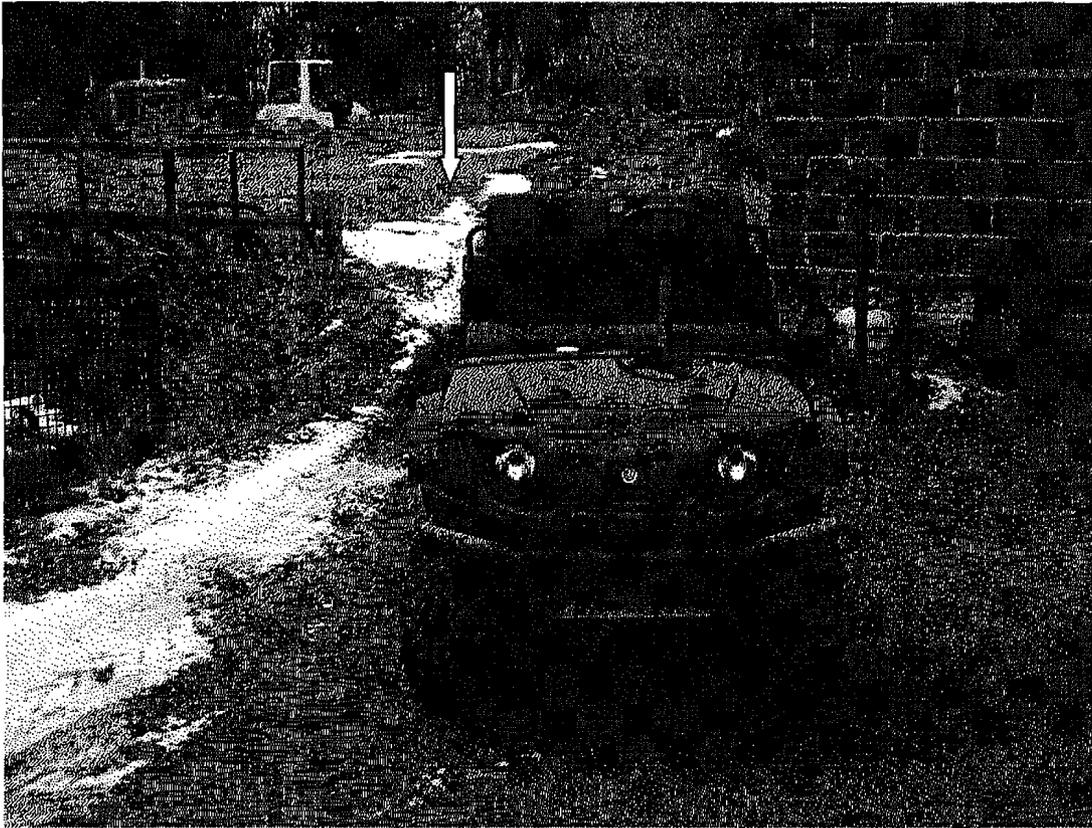
**Exhibit 1.3: Front View of Incident Utility Vehicle (View also shows 1st
incident location / hill designated by arrow)
IDI # 070122CCC1264**

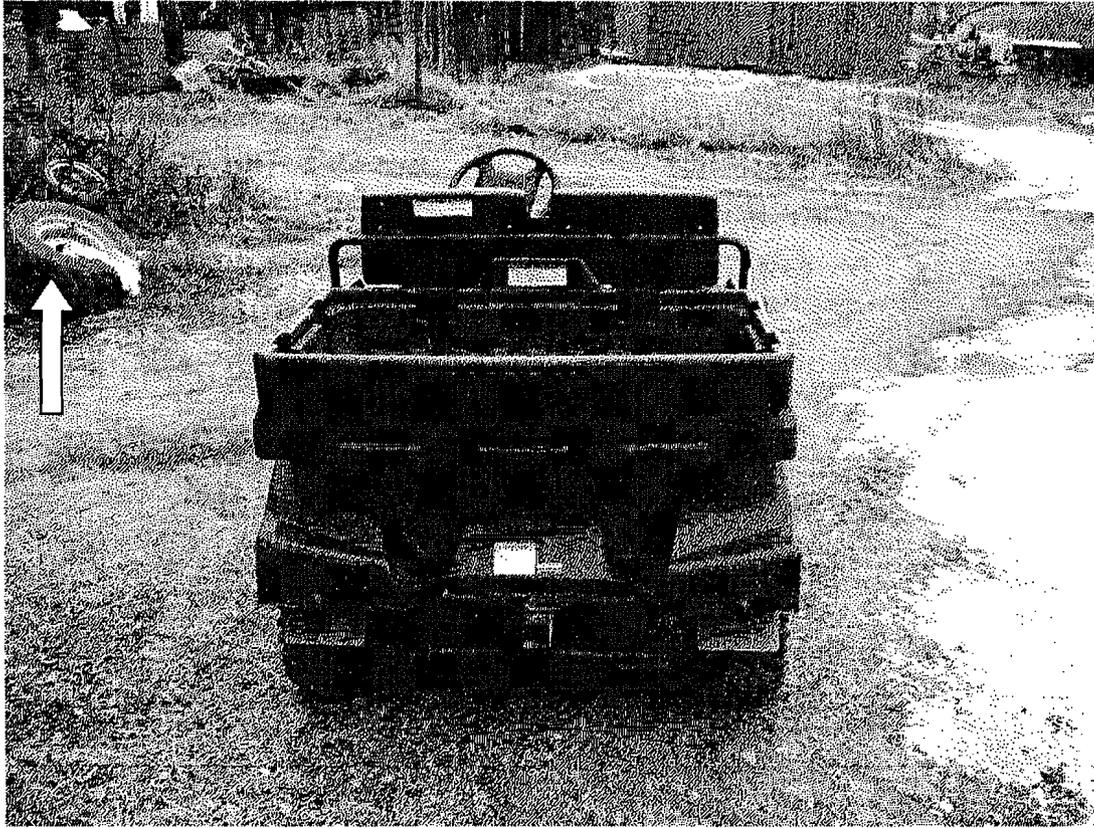
**Exhibit 1.4: Rear View of Incident Utility Vehicle (arrow points to discarded tire that utility vehicle hit during second reported incident)
IDI # 070122CCC1264**

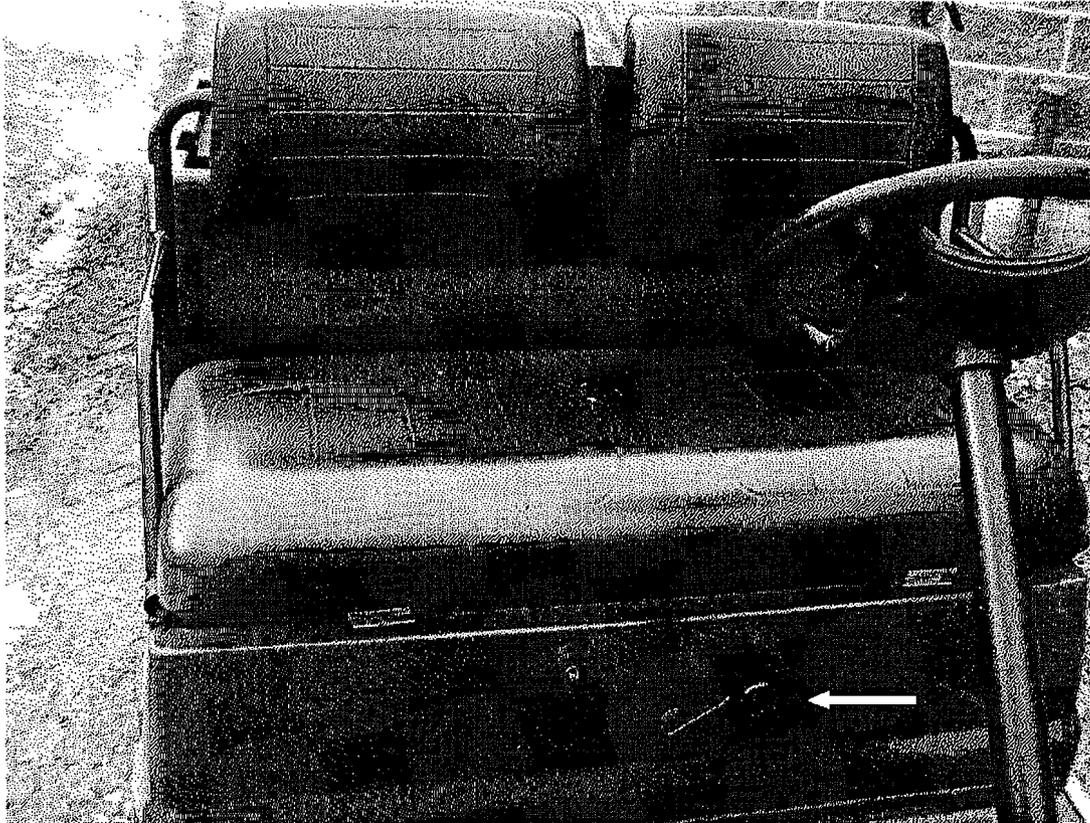
Exhibit 1.5: View of Seat portion of Incident Utility Vehicle & Forward/Reverse selector switch (see arrow)
ID1 # 070122CCC1264

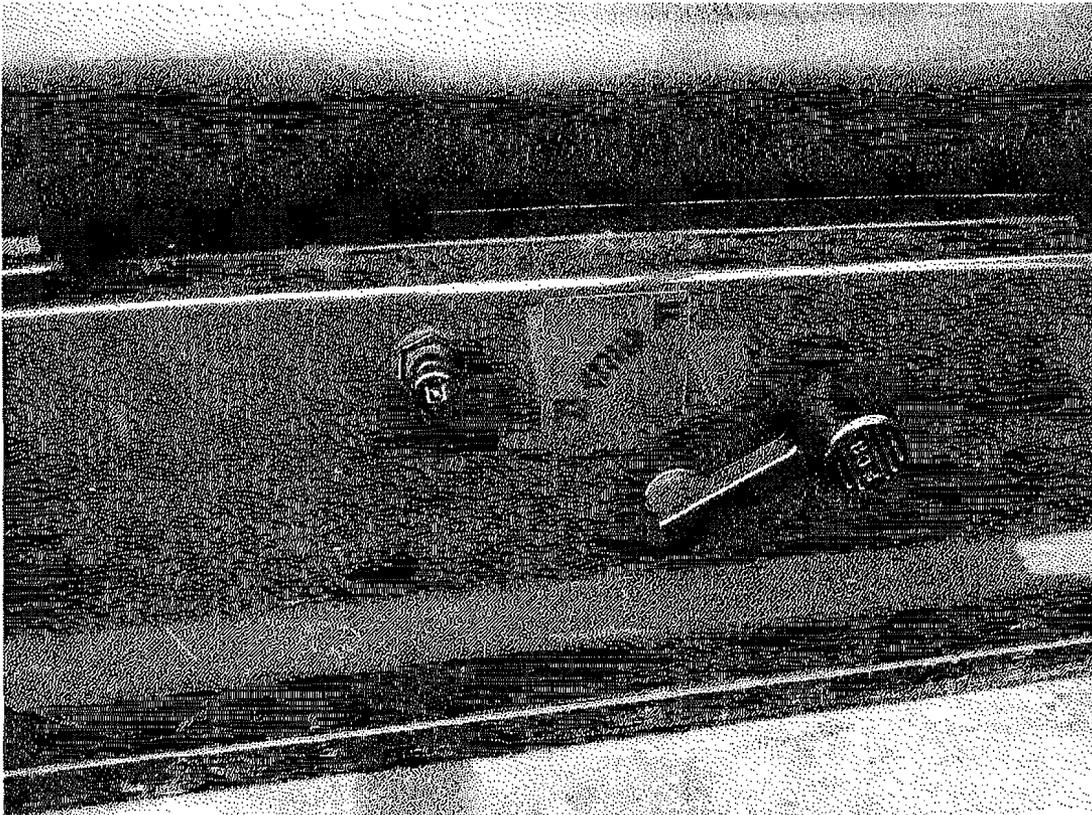
**Exhibit 1.6: Close Up View of Forward/Reverse Selector Switch
IDI # 070122CCC1264**

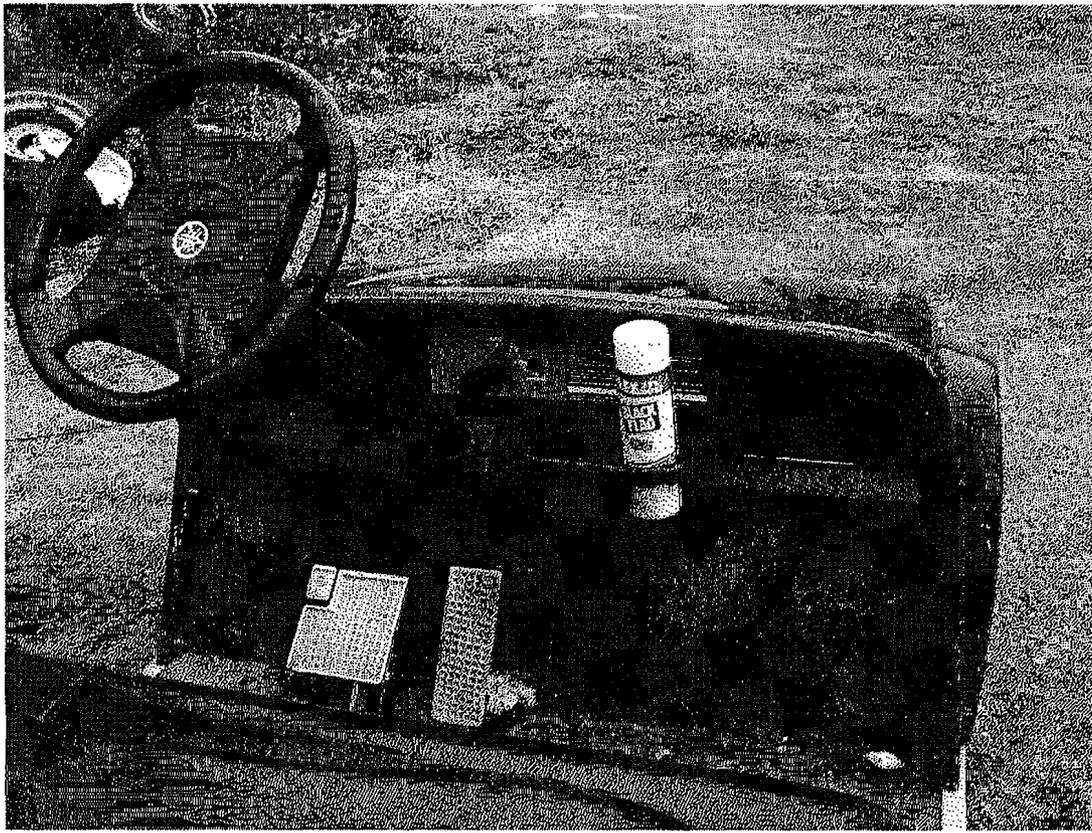
**Exhibit 1.7: View of Steering Wheel / Foot controls on Incident Utility Vehicle
IDI # 070122CCC1264**

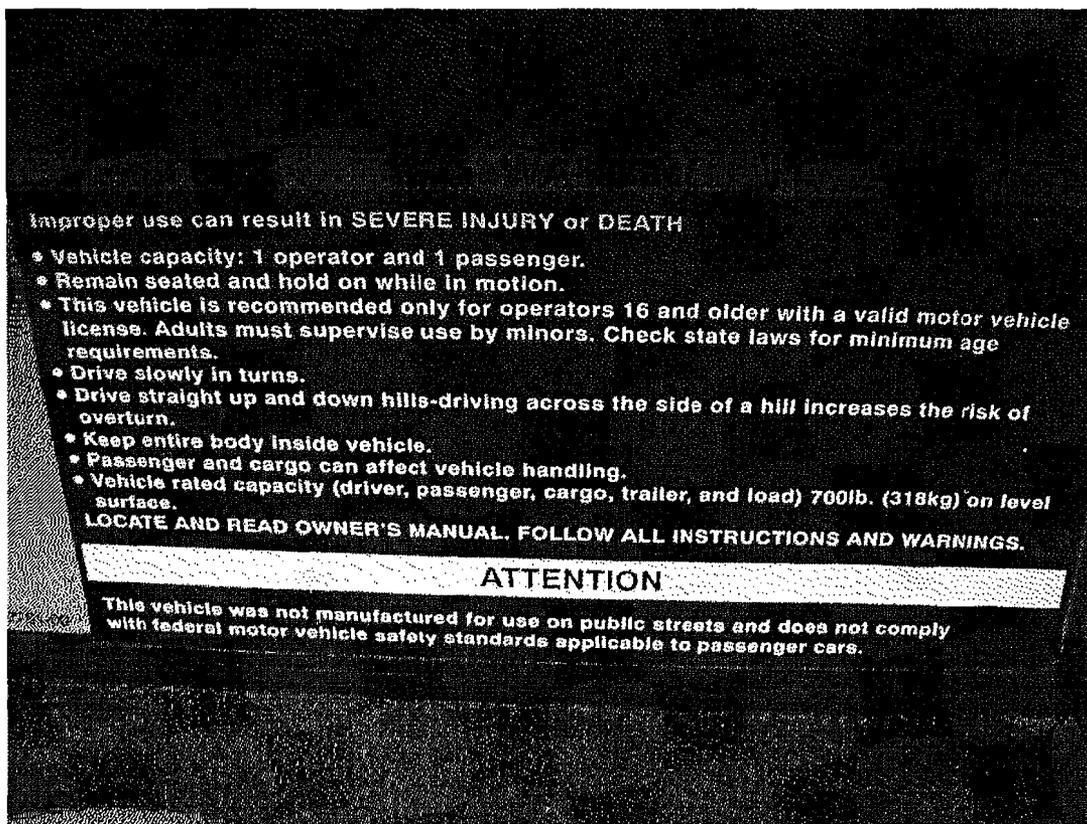
Exhibit 1.8: View of Warning Label affixed to front control panel portion of Utility Vehicle

Label reads in part, "****WARNING***Improper use can result in SEVERE INJURY or DEATH***Vehicle capacity: 1 operator and 1 passenger***Remain seated and hold on while in motion***This vehicle is recommended only for operators 16 and older with a valid motor vehicle license. Adults must supervise use by minors. Check state laws for minimum age requirements.***Drive slowly in turns***Drive straight up and down hills – driving across the side of a hill increases the risk of overturn.***Keep entire body inside vehicle***Passenger and cargo can affect vehicle handling.***Vehicle rated capacity (driver, passenger, cargo, trailer and load) 700 lb (318kg) on level surface***LOCATE AND READ OWNER'S MANUAL. FOLLOW ALL INSTRUCTIONS AND WARNINGS.***ATTENTION***This vehicle was not manufactured for use on public streets and does not comply with federal motor vehicle safety standards applicable to passenger cars.***"

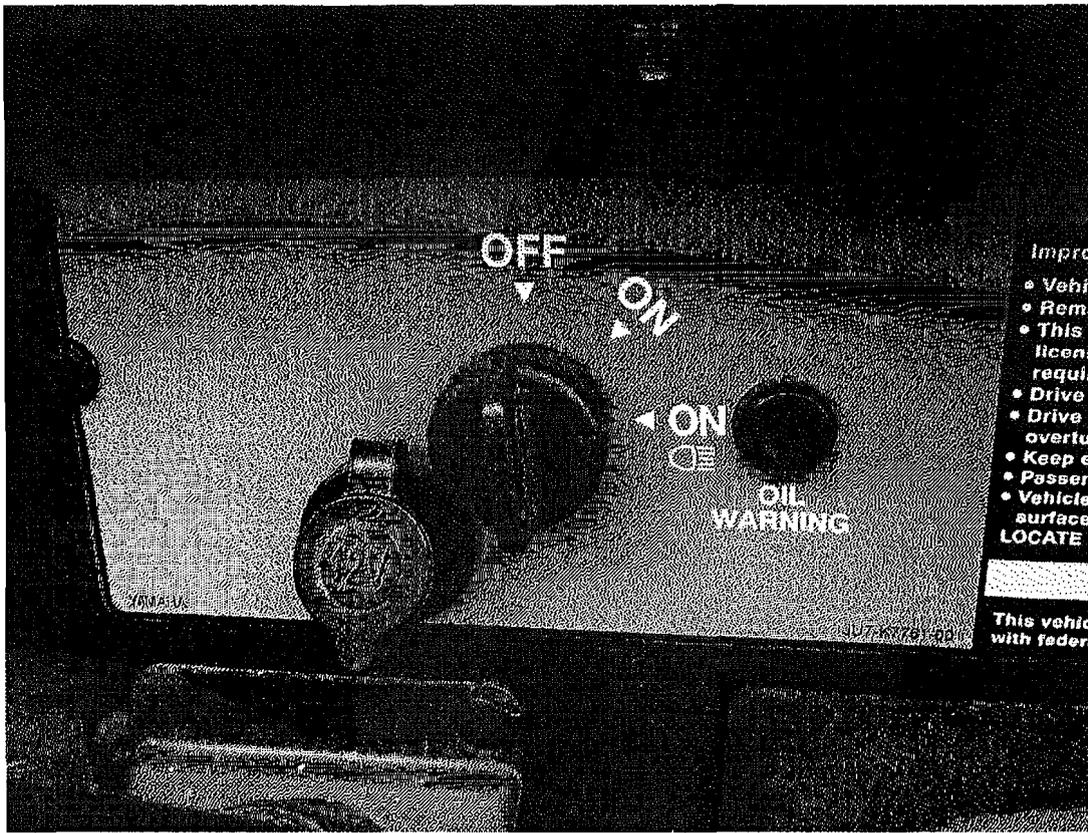
**Exhibit 1.9: Close Up of On/Off Selector switch, headlight selector switch and oil warning light on incident Utility Vehicle
IDI # 070122CCC1264**

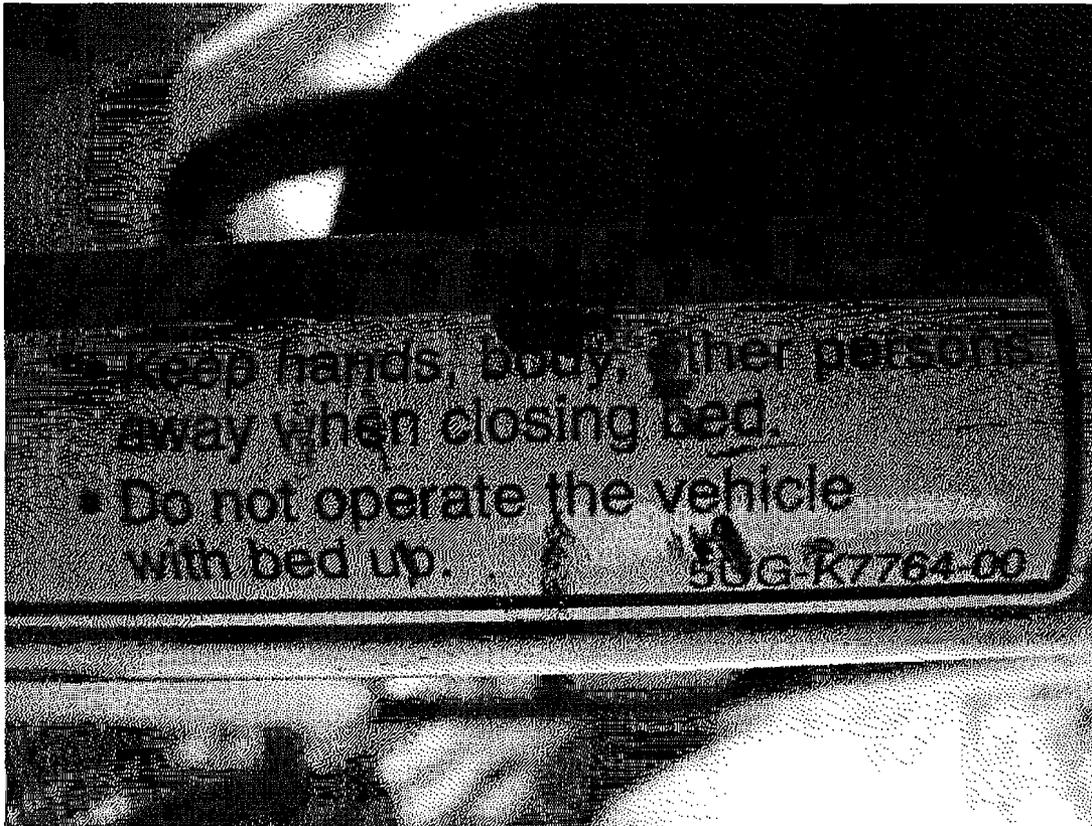
**Exhibit 1.11: Label affixed to seat back bar on incident Utility Vehicle
IDI # 070122CCC1264**

Label reads in part, “*WARNING***Keep hands, body, other persons away
when closing bed.***Do not operate the vehicle with bed up.***”**

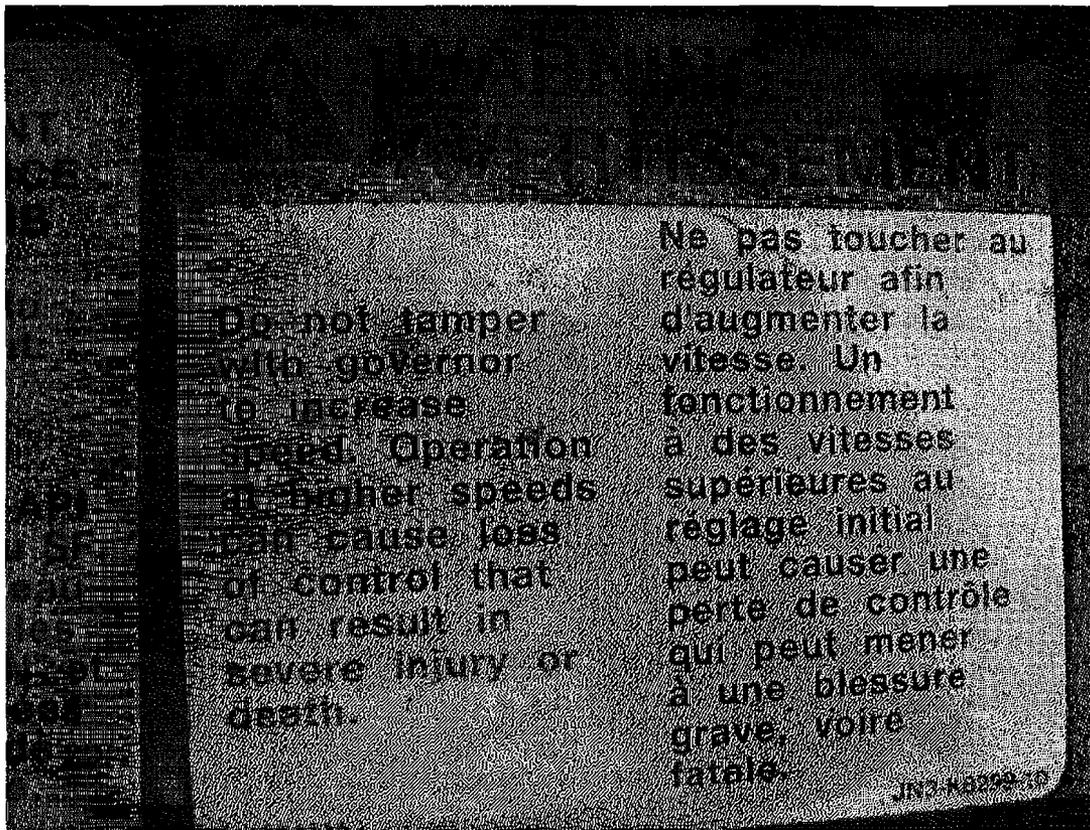
**Exhibit 1.19: Warning Label affixed to Incident Utility Vehicle
IDI # 070122CCC1264**

Label reads in part, “*Do not tamper with governor to increase speed.***Operation at higher speeds can cause loss of control that can result in severe injury or death.***”**

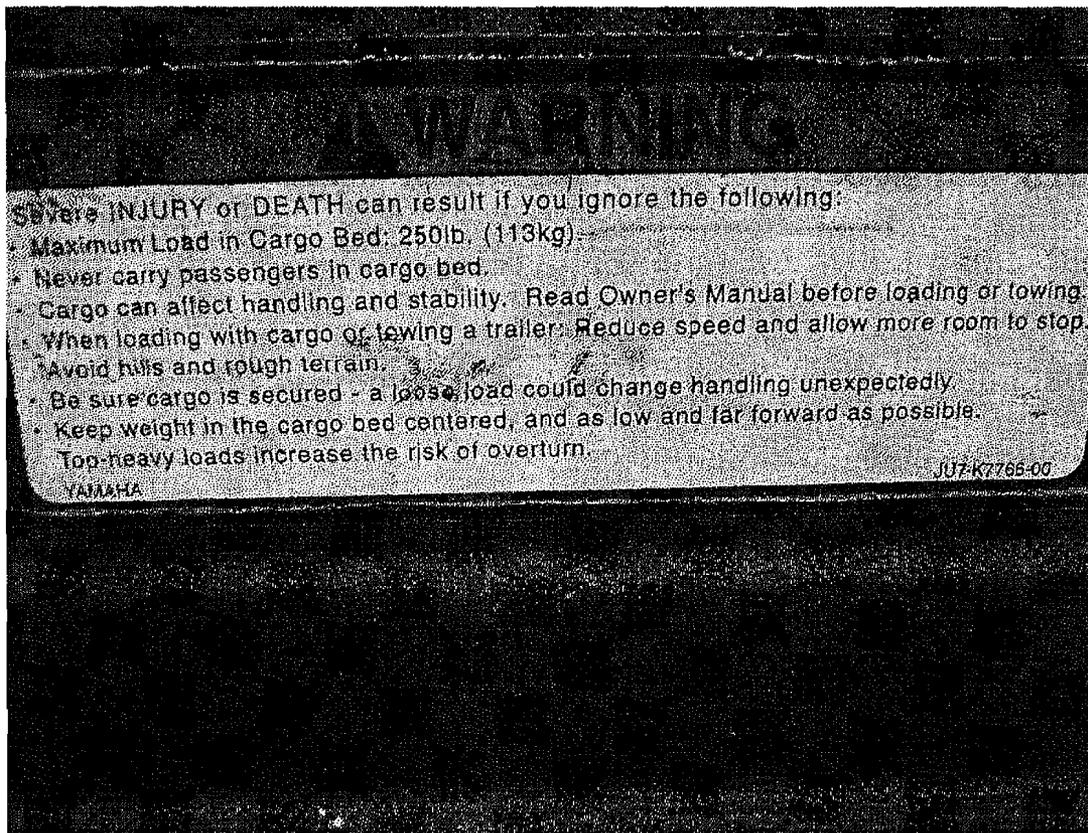
Exhibit 1.20: Warning Label affixed to incident Utility Vehicle
IDI # 070122CCC1264

Label reads in part, *****WARNING***Severe INJURY or DEATH can result if you ignore the following:***Maximum Load in Cargo Bed: 250 lb. (113kg)***Never carry passengers in cargo bed.***Cargo can affect handling and stability. Read Owner's Manual before loading or towing.***When loading with cargo or towing a trailer: Reduce speed and allow more room to stop***Avoid hills and rough terrain***Be sure cargo is secured – a loose load could change handling unexpectedly.***Keep weight in the cargo bed centered, and as low and far forward as possible.***Top-heavy loads increase the risk of overturn.***"**

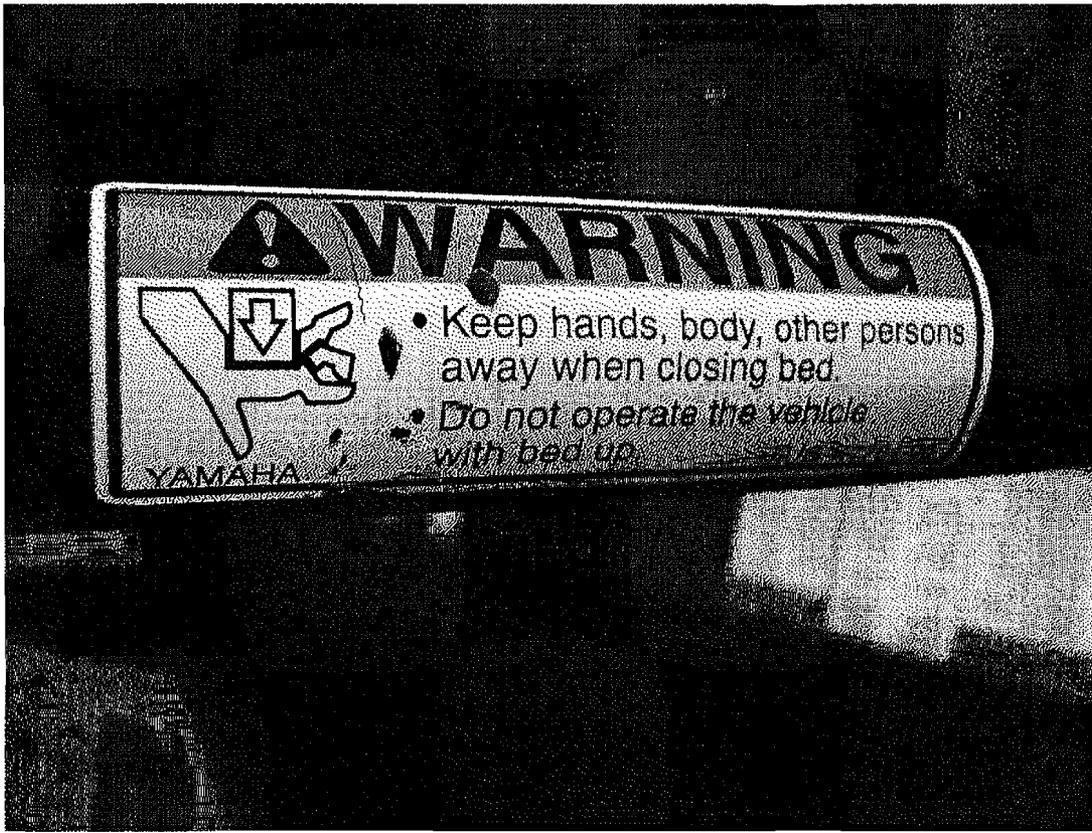
Exhibit 1.21: Warning Label affixed to incident Utility Vehicle
IDI # 070122CCC1264

Label reads in part, "***WARNING***Keep hands, body, other persons away when closing bed.***Do not operate vehicle with bed up.***YAMAHA***"

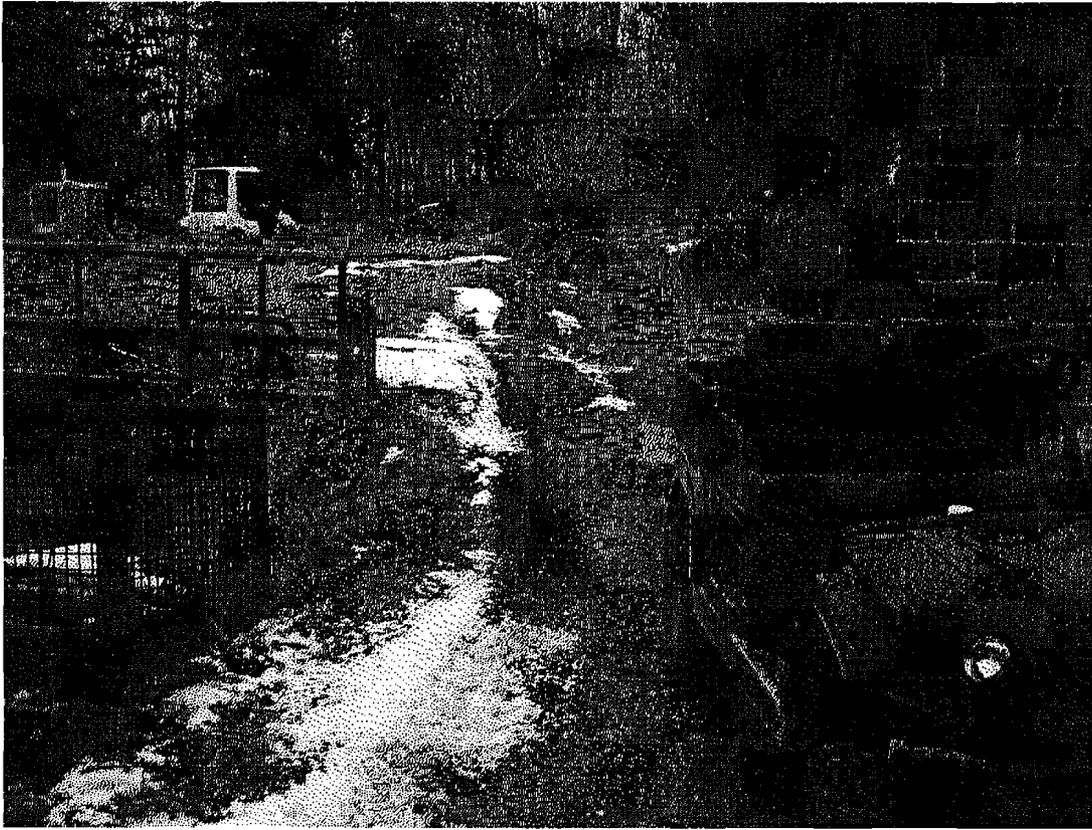
**Exhibit 1.22: View of Incident “incline” that incident Utility Vehicle was traveling down at the time of the first incident
IDI # 070122CCC1264**

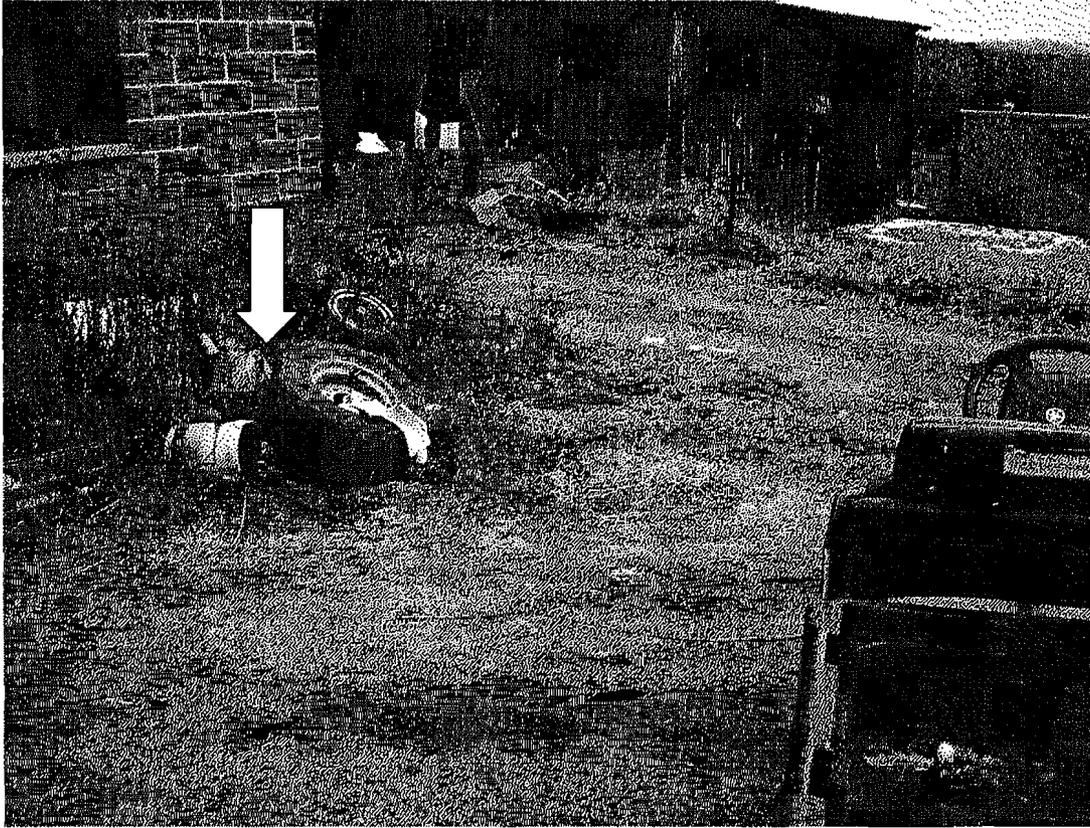
Exhibit 1.23: View of location where incident Utility Vehicle came to a rest at conclusion of second incident (Consumer reported there were two or three more tires at location at time of incident.)

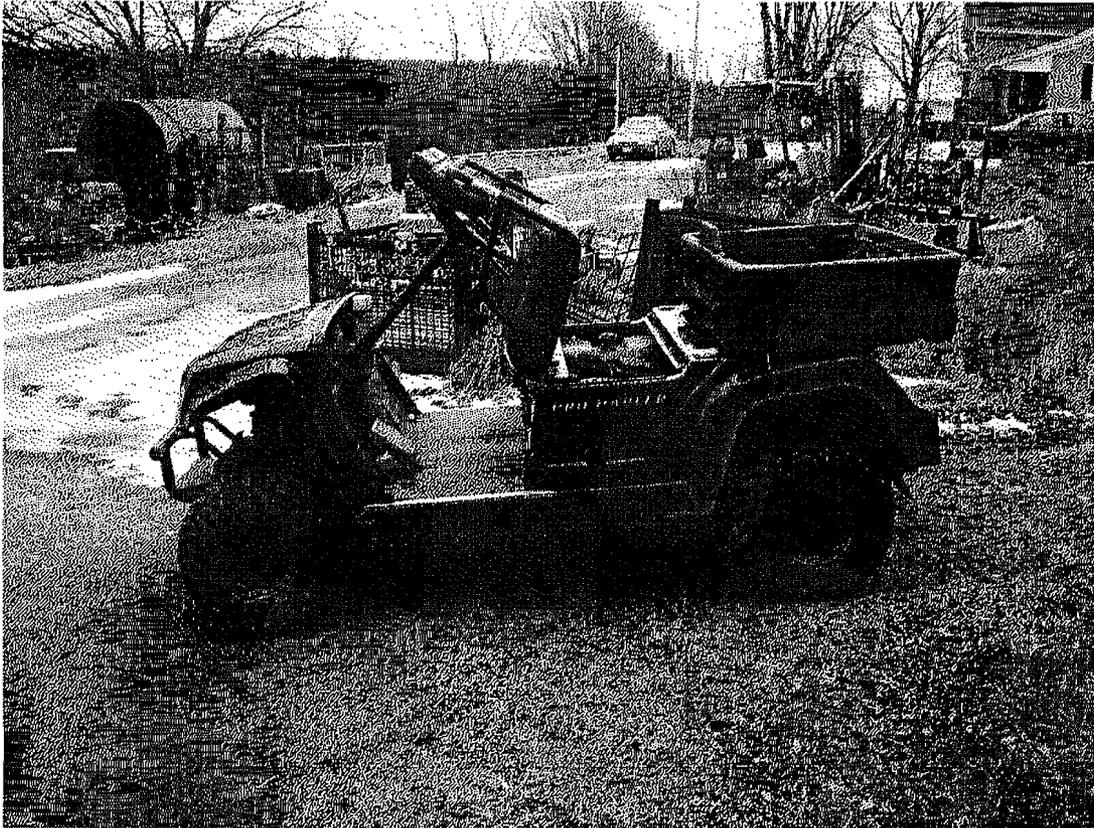
Exhibit 1.24: View of Incident Utility Vehicle with Seat portion in lifted position (fuel tank & motor under seat) Complainant's residential home seen in upper right background

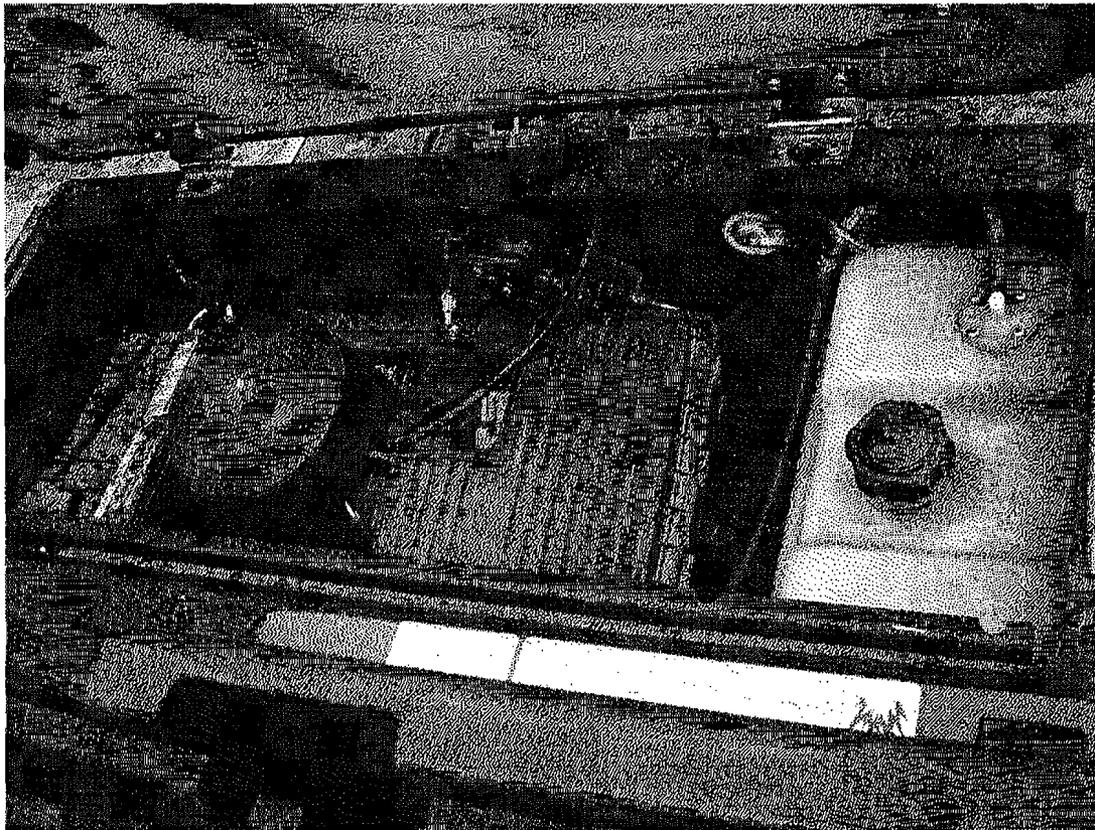
**Exhibit 1.25: View of Utility Vehicle components under seat
IDI # 070122CCC1264**

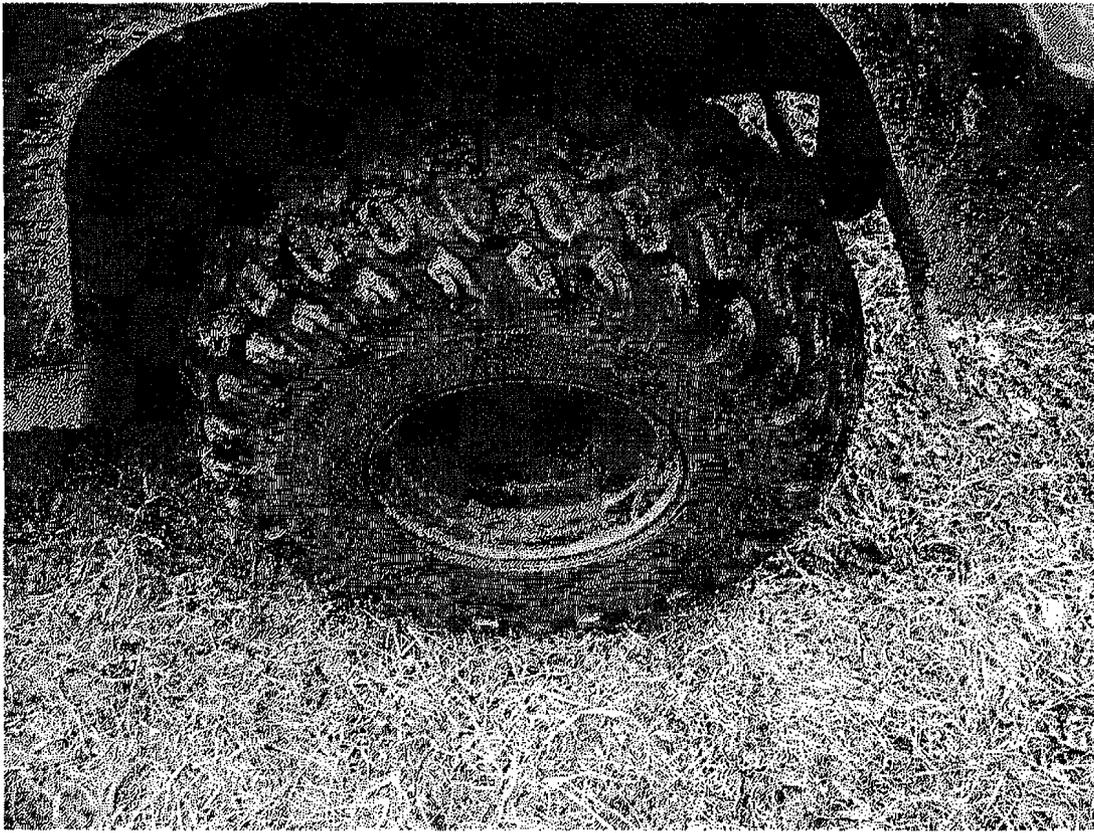
**Exhibit 1.27: View of Original Tires installed on incident Utility Vehicle
IDI # 070122CCC1264**

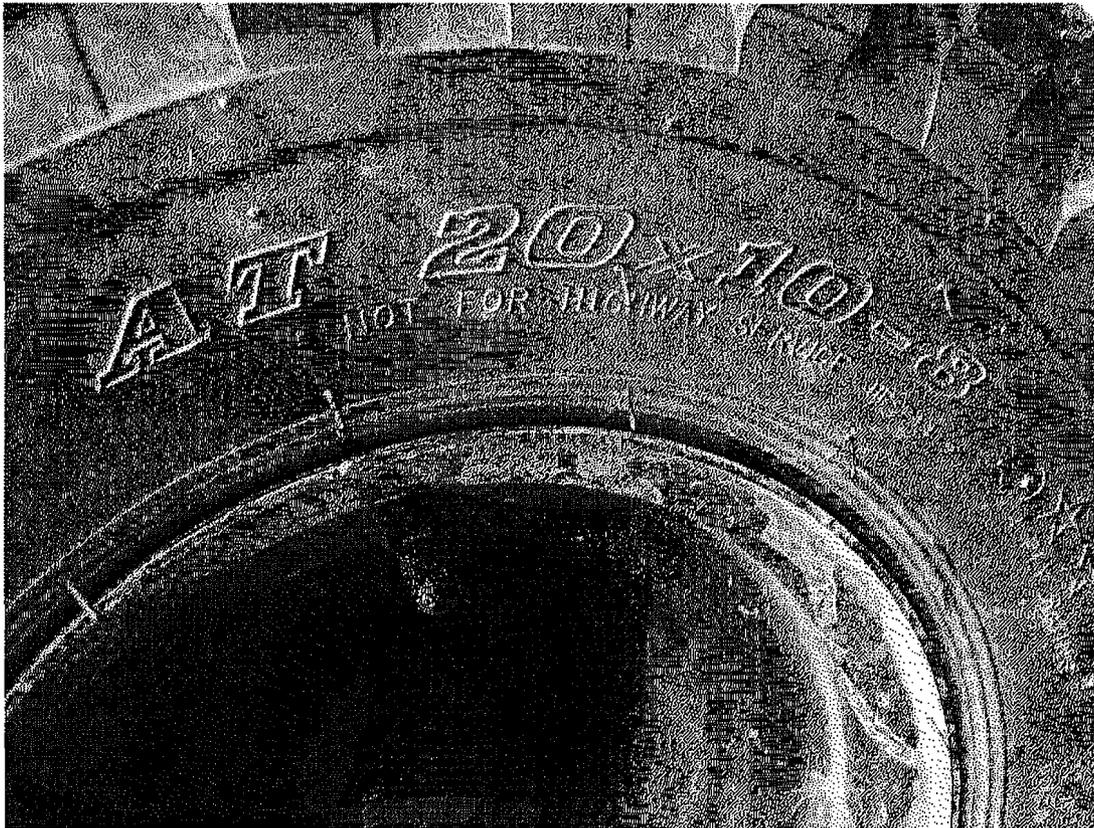
**Exhibit 1.28: Close Up View of labeling on tires installed on incident Utility Vehicle
IDI # 070122CCC1264
Labeling reads in part, "****AT**20 X 10-8**NOT FOR HIGHWAY
SERVICE**4 PLY RATING****"**

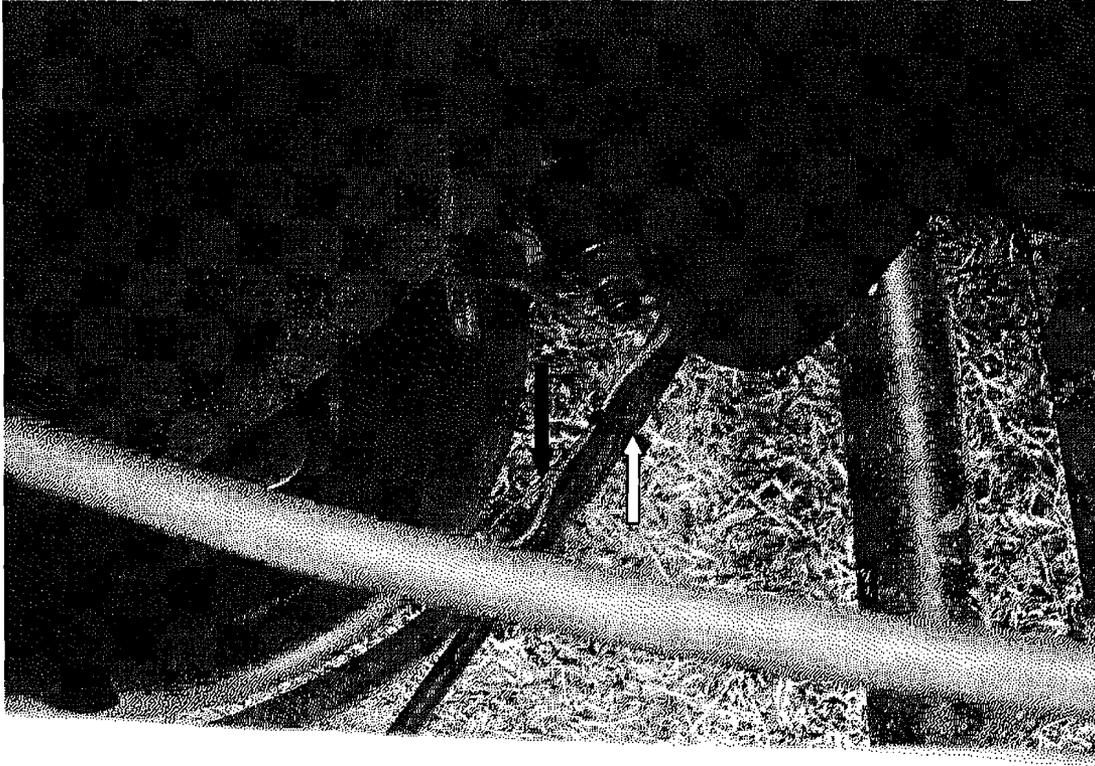
**Exhibit 1.32: View of opposite end of Incident Wire as that seen in Exhibits 1.29 – 1.30; Yellow arrow points to electrical tie added by complainant to partially “fix” alleged defect; Red arrow points to wire extension added by complainant to partially “fix” alleged defect
IDI # 070122CCC1264**

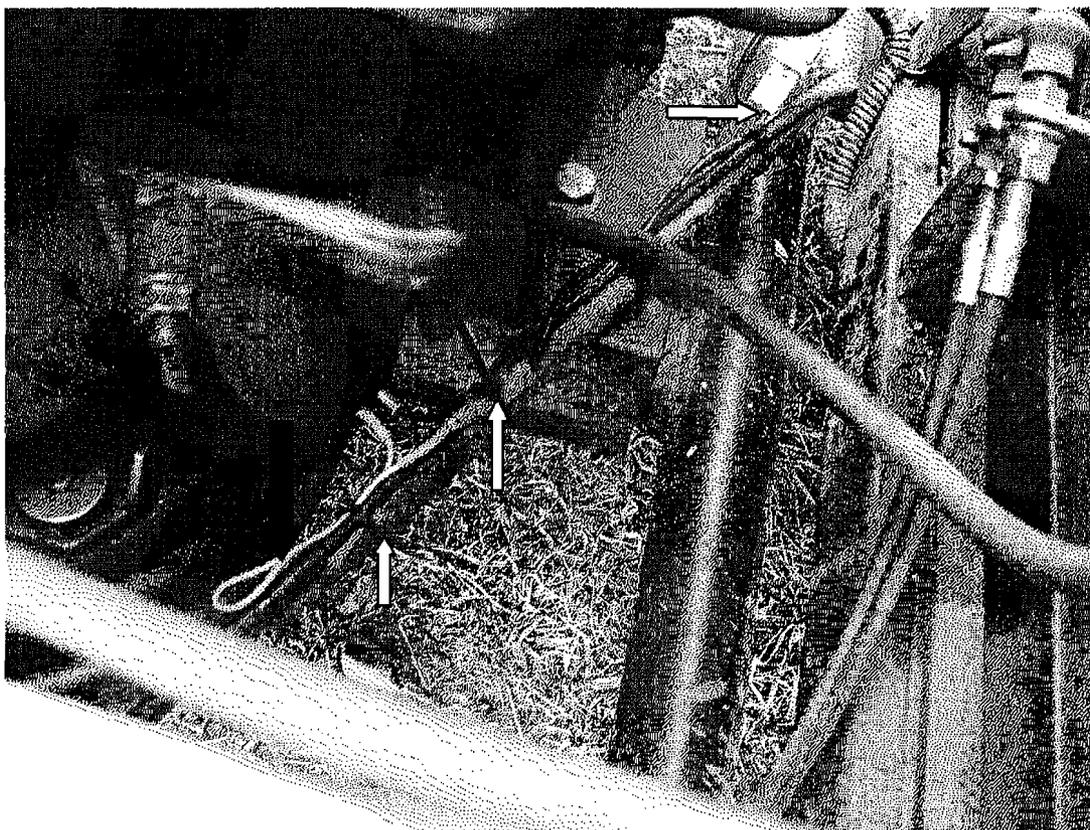
Exhibit 1.33: Alternate View of area seen in Exhibit 1.32; yellow arrows point to electrical ties added by complainant; Red arrow points to wire extension added by complainant and green arrow points to front portion of incident wire as seen in Exhibits 1.29-1.31

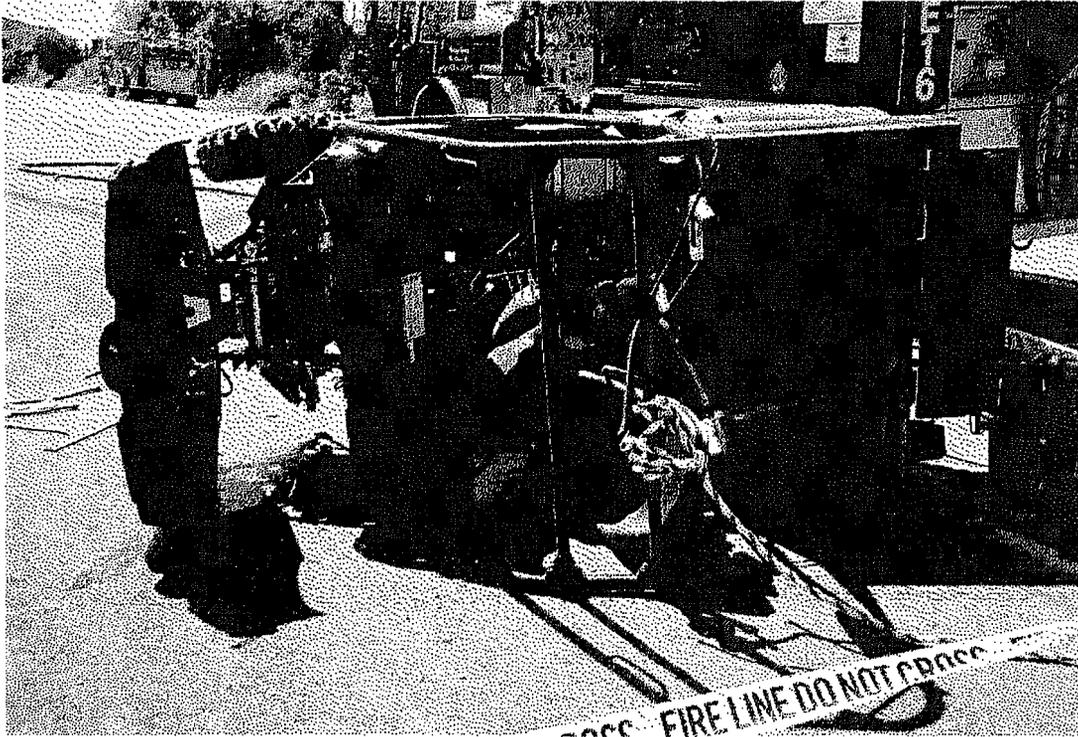
Photo 1 Incident product (Utility Vehicle).

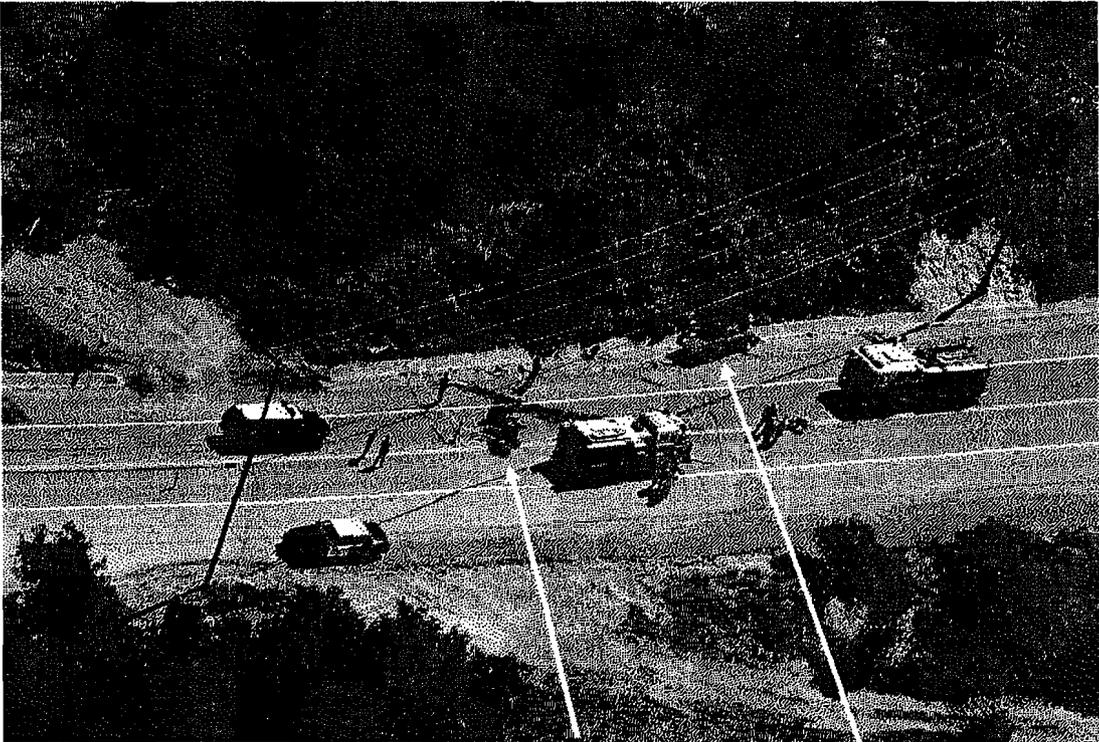
Photo 4 Arial view showing the incident product and the other vehicle involved in the incident.
