<b>1. Task Number</b> 080911HCC3891		<b>2. Investigator's ID</b> 9086		<b>EPIDEMIOLOGIC INVESTIGATION REPORT</b>
<b>3. Office Code</b> 840	<b>4. Date of Accident</b> YR MO DAY 2007 09 30	<b>5. Date Initiated</b> YR MO DAY 2008 09 16		
<b>6. Synopsis of Accident or Complaint</b> <b>UPC</b>  The victim is a 19-year-old male who was a passenger, standing on the rear bed of a 4-wheeled utility vehicle, holding onto a roll bar while riding. The driver of this utility vehicle collided with a pickup truck which was going 40 mph. The victim was ejected and died at the scene from his injuries.  <b>MFR/PRVLBB NOTIFIED</b>  COMMENTS: <input type="checkbox"/> YES <input checked="" type="checkbox"/> NO <input type="checkbox"/> OVERRULED; <input type="checkbox"/> ATTACHED  <input checked="" type="checkbox"/> EXCISIONS/FOIA EXS. 259; 6  <input checked="" type="checkbox"/> DO NOT RE-NOTIFY <input type="checkbox"/> RE-NOTIFY  <i>5/18/09</i>

This incident occurred on 09-30-07, and involved a 19 year old male victim and a four wheeled, off-road utility type vehicle being used recreationally in a recreational area near Victorville, CA. All of the information comes from the medical examiner's office.

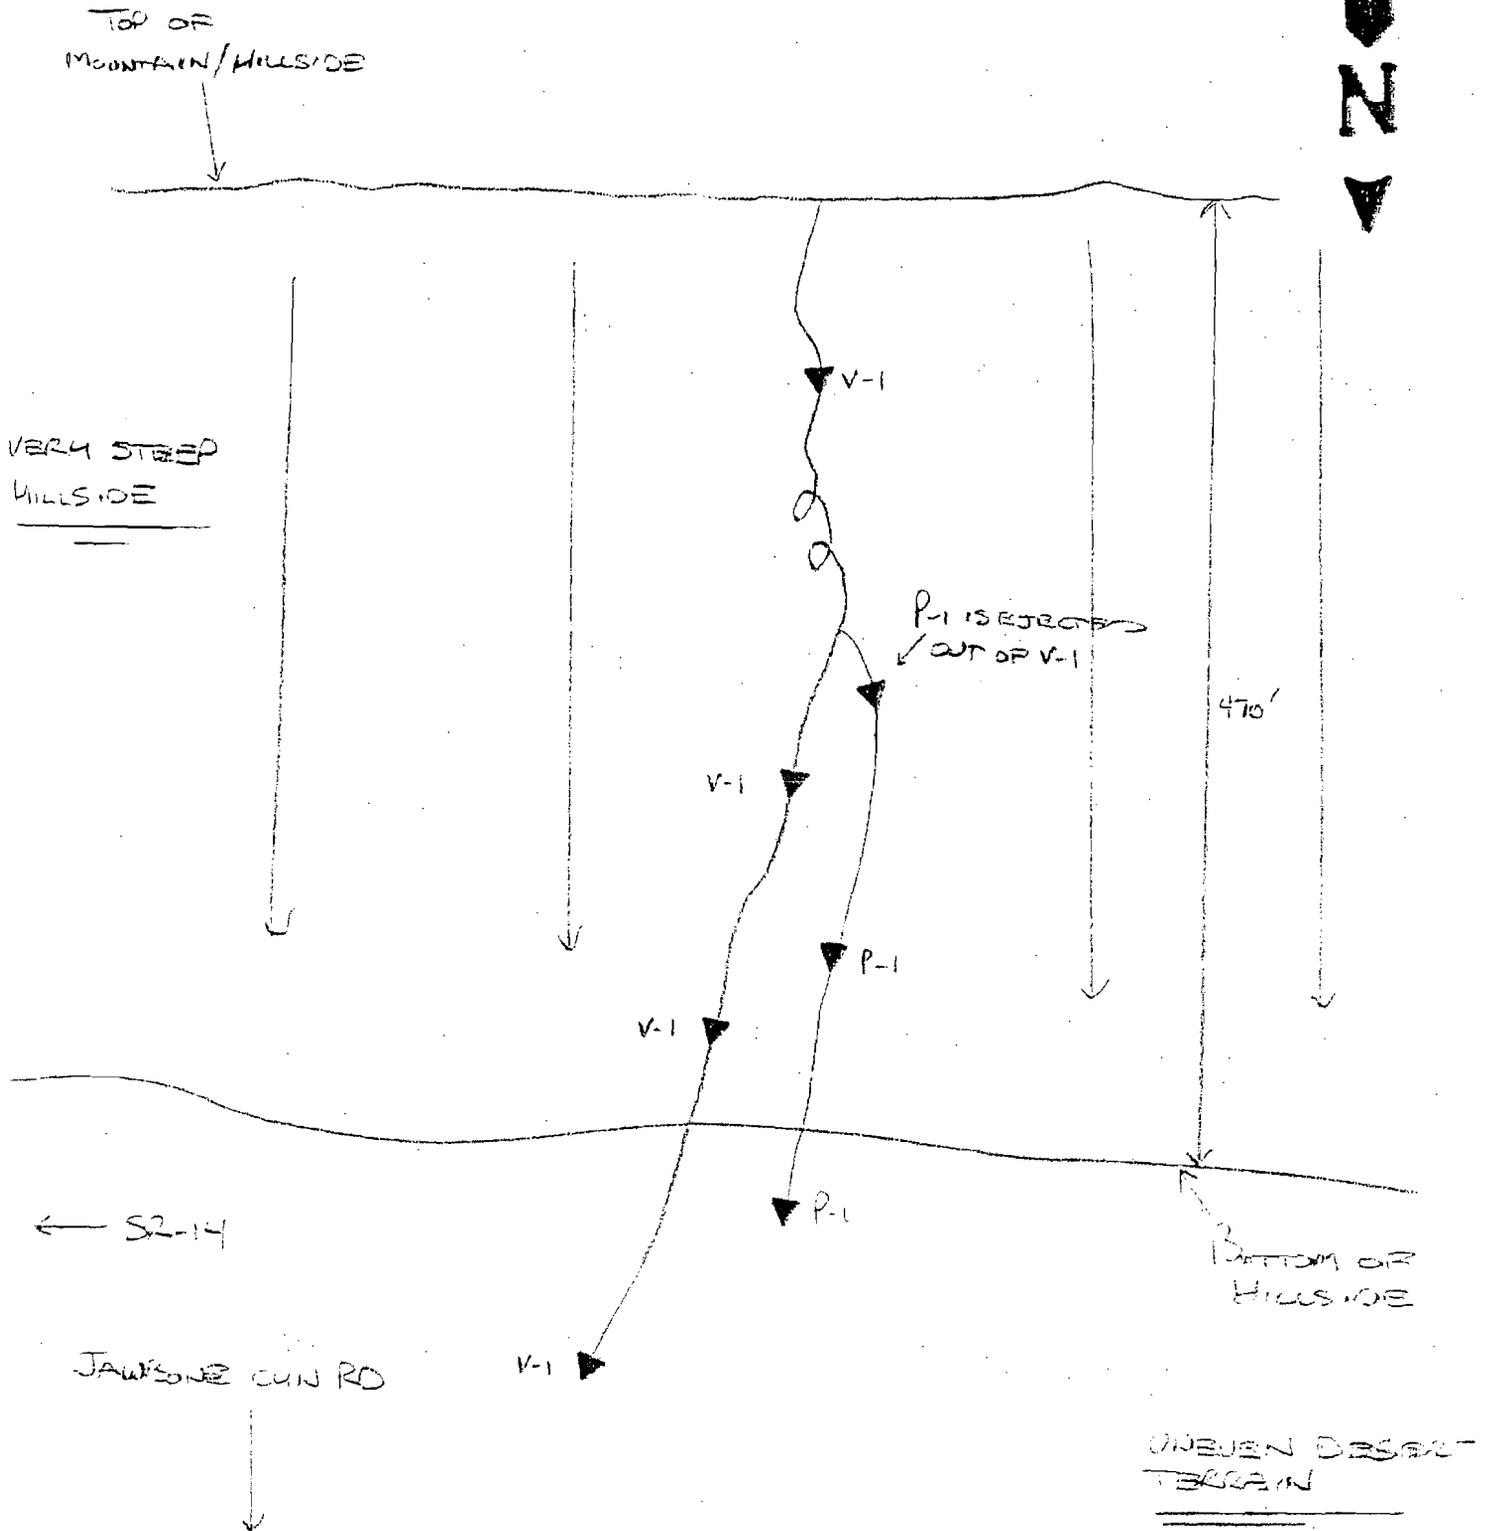
STATE OF CALIFORNIA  
FACTUAL DIAGRAM

1 **Vehicle # 1 (Yamaha Rhino)** was in an upright position upon my arrival, and came to rest as  
 2 indicated on the factual diagram. V-1 received total roll over damage. I conducted a visual  
 3 inspection on V-1's left front seat belt. The seat belt was a latch / link 5 way type restraint and was  
 4 not fastened together in any way when I looked at it. The seat belt appeared to be in good working  
 5 order.

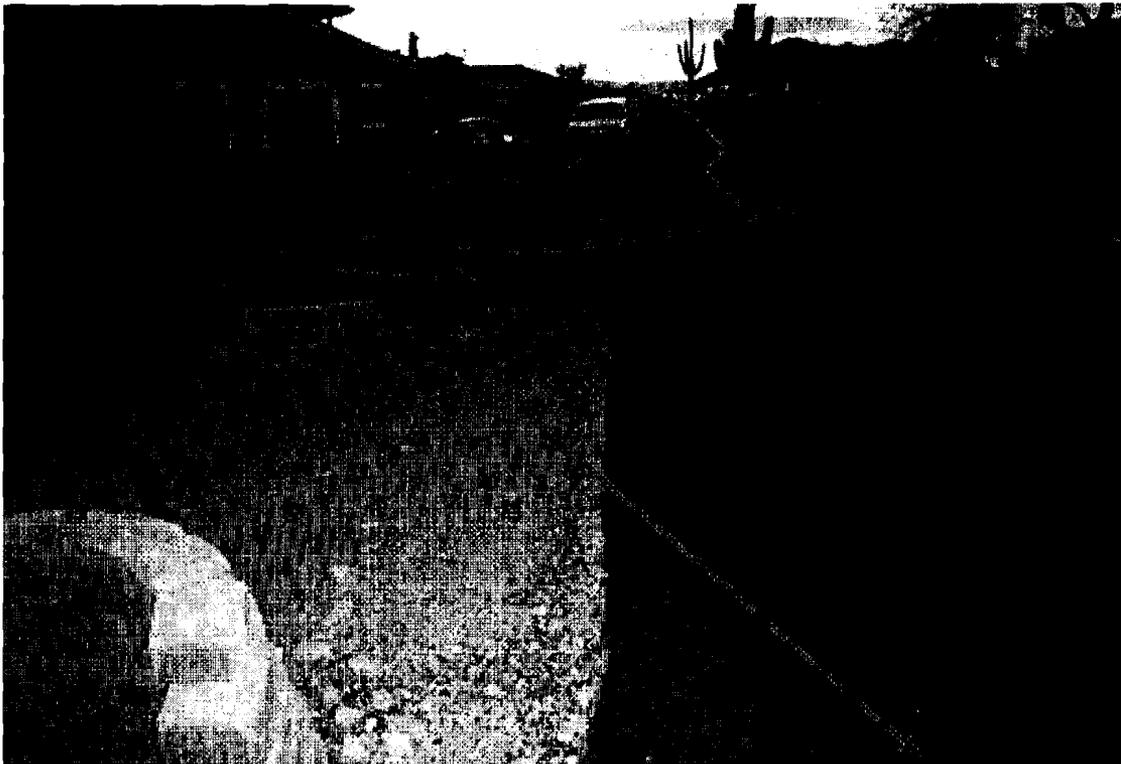
Photo # 4 – The vehicle ran off the driveway and crashed into this decorative wall.

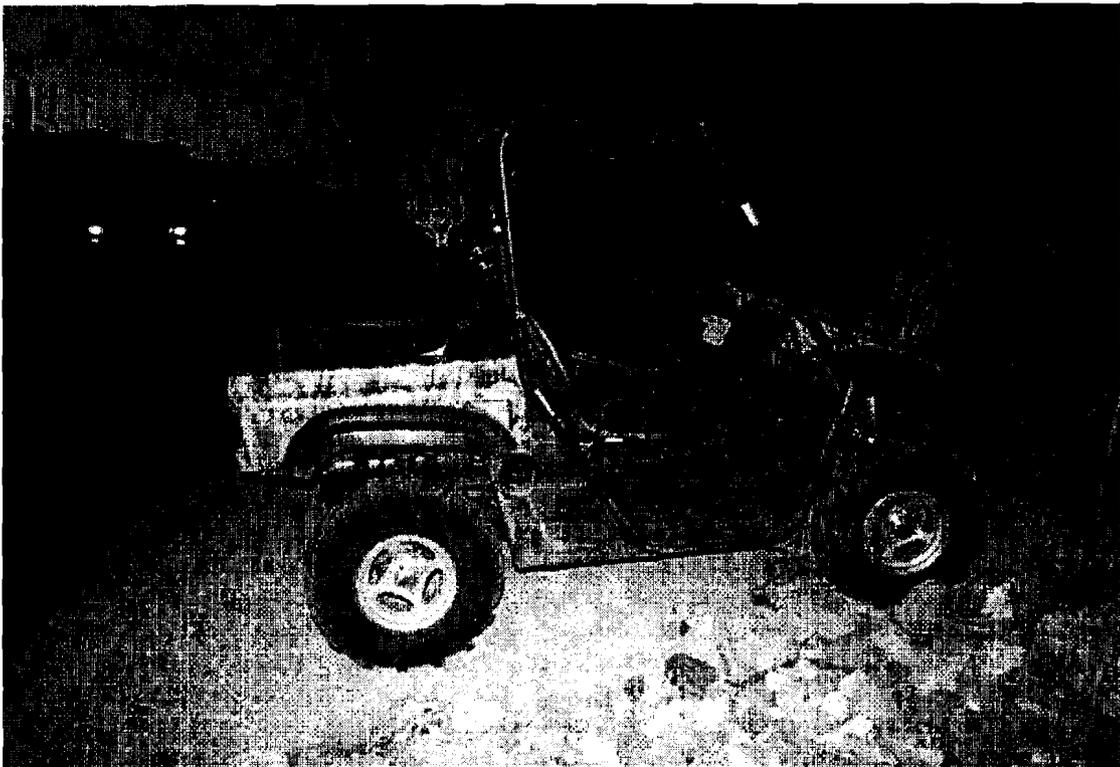
Photo # 6 – Side view of the vehicle.

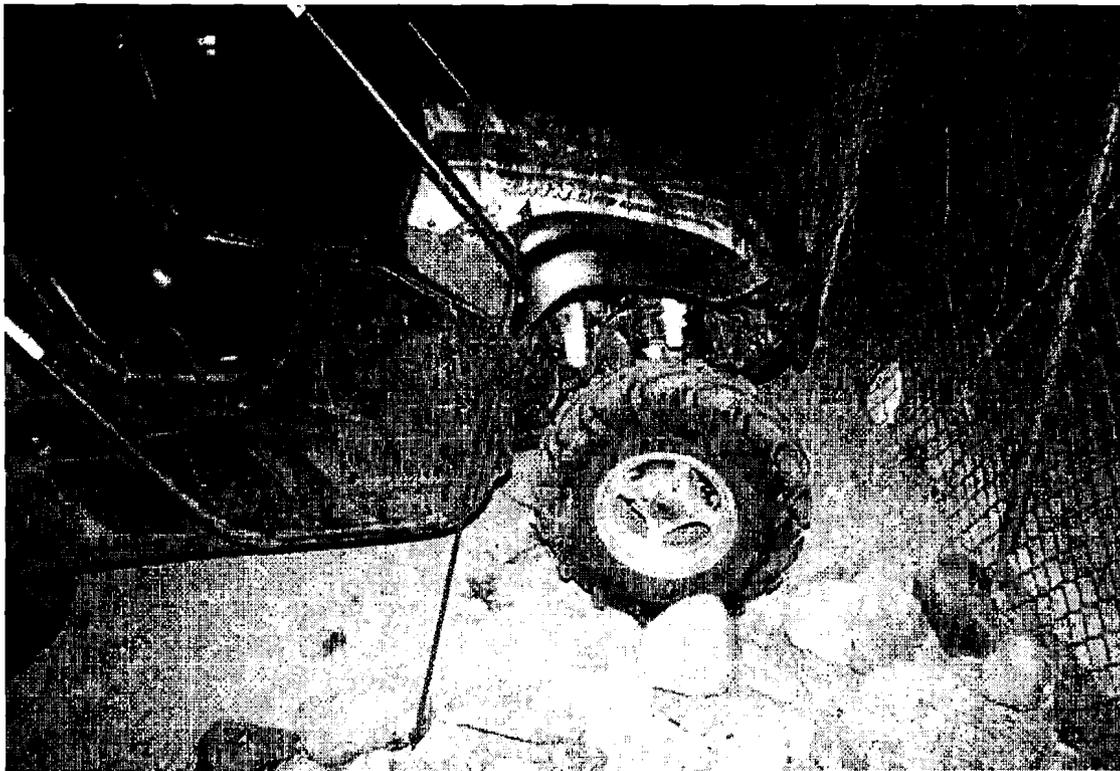
Photo # 7 – The model name "RHINO" is located on the hood of this vehicle.

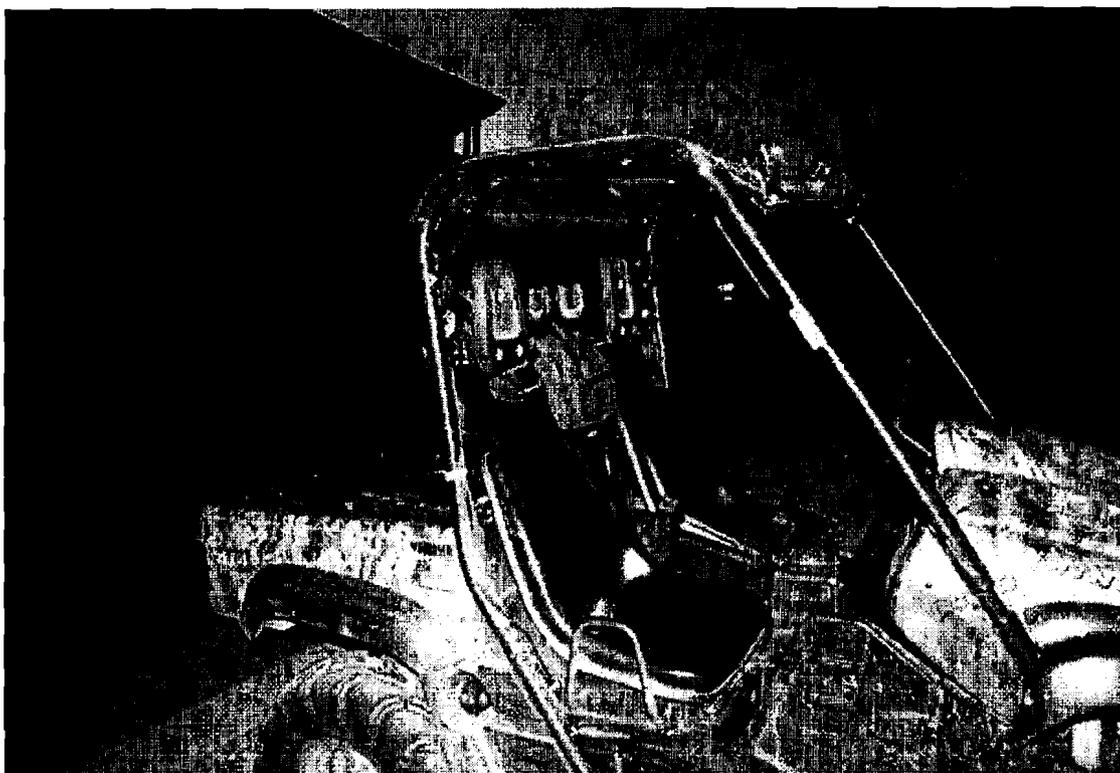
Photo # 8 – This vehicle has two front seats and a steering wheel for the driver.

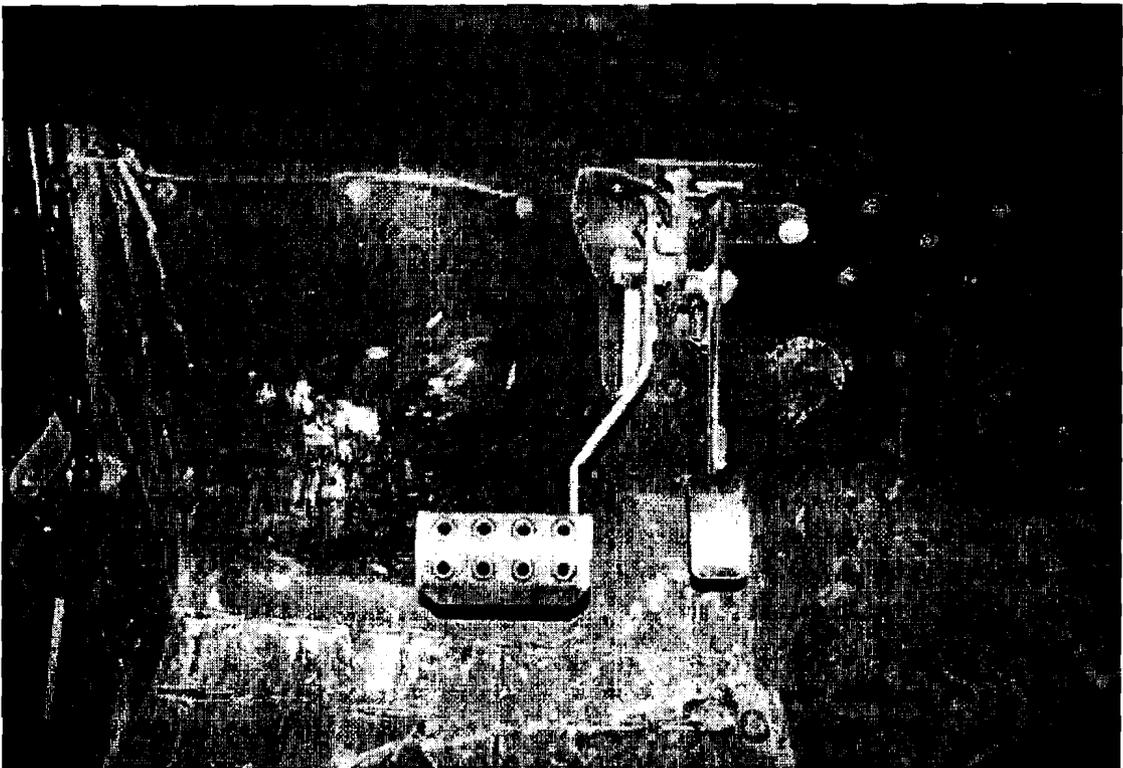
Photo # 12 – Petal controls for the driver.

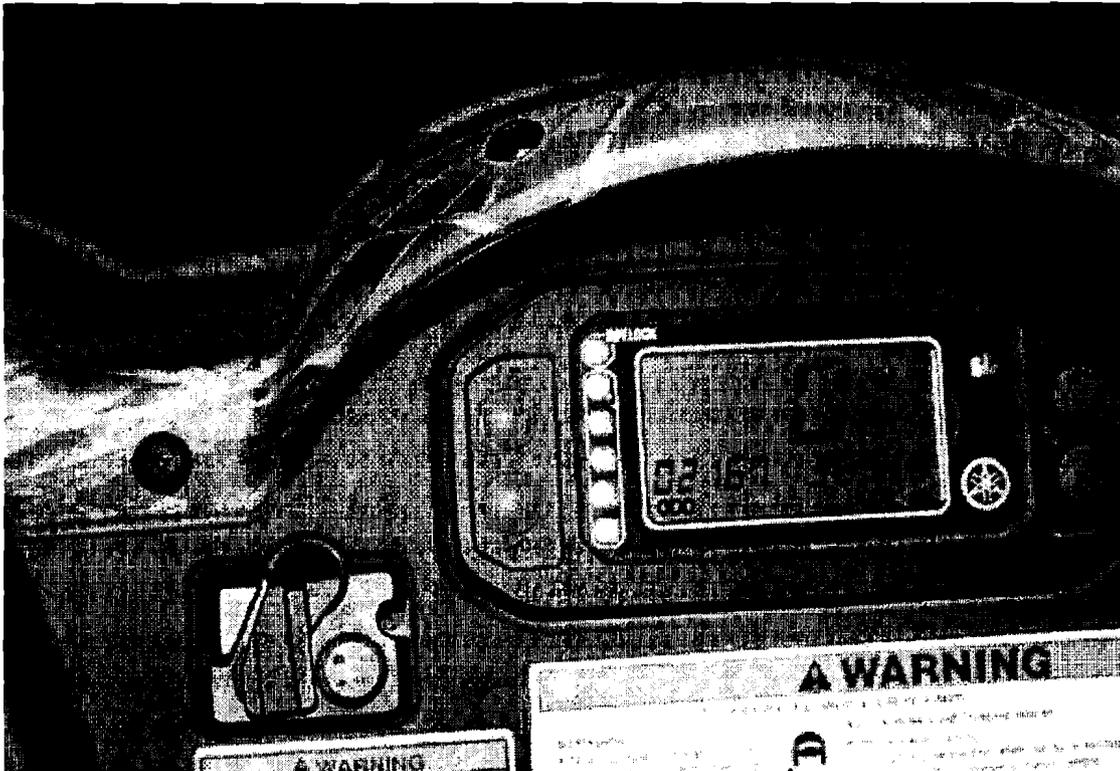
Photo # 13 – Digital display on dash of vehicle.

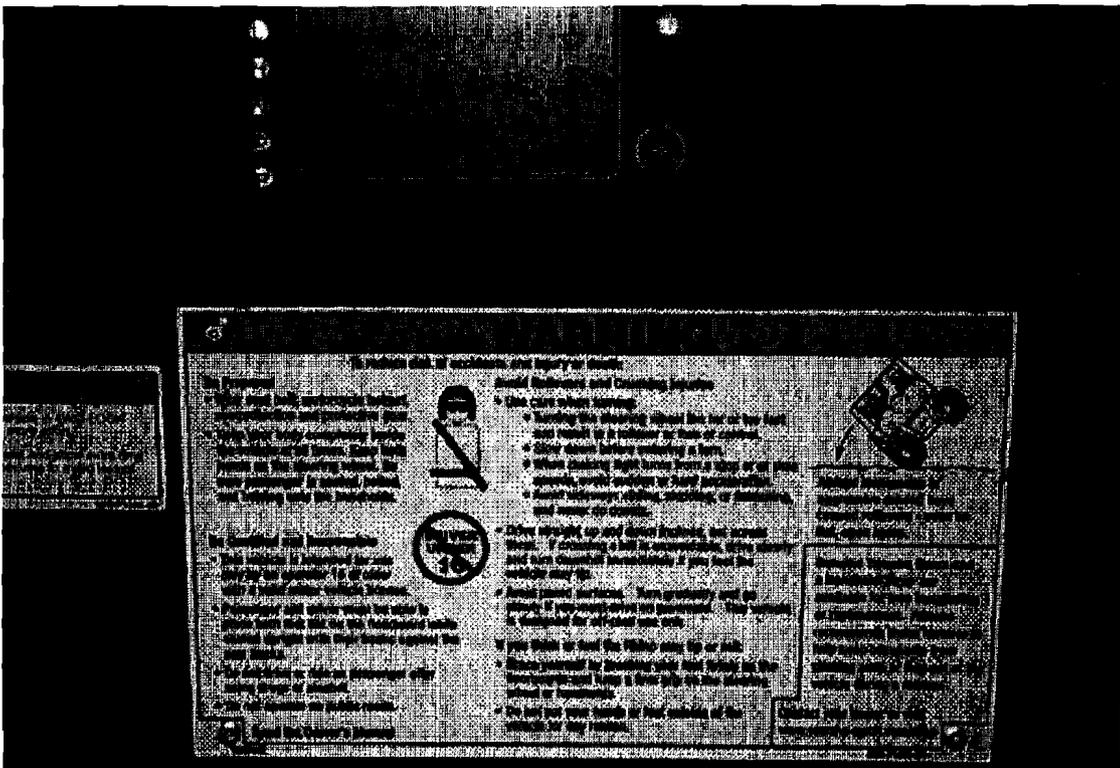
Photo # 14 – Warning label on the vehicle.
