1. Task Number 090810CBB1947		2. Investigator's ID 2248		EPIDEMIOLOGIC INVESTIGATION REPORT
3. Office Code 810	4. Date of Accident YR MO DAY 2009 04 01	5. Date Initiated YR MO DAY 2009 08 10

6. Synopsis of Accident or Complaint UPC The consumer, his wife and 2 children moved into a new home in December 2006. It was reported that Chinese drywall in the home has caused several health issues. Appliances have ceased to function. Blackening and discoloration of copper pipes and metal fixtures throughout the home have been observed. Corrosion within the 2 AC units is evident. Product identification on the drywall is unknown. <div style="text-align: right;"> <p>CPSC (6/01/1) CLEARED for PUBLIC</p> <p>✓ NO MFRS/PRVT LBRS OR PRODUCTS IDENTIFIED</p> <p>EXCEPTED BY: PETITION RULEMAKING ADMIN. PRCDG</p> <p>✓ WITH PORTIONS REMOVED: <u>4, 262</u></p> <p style="font-size: 1.2em; margin-left: 20px;">WJC 5/19/10</p> </div>

090810CBB1947

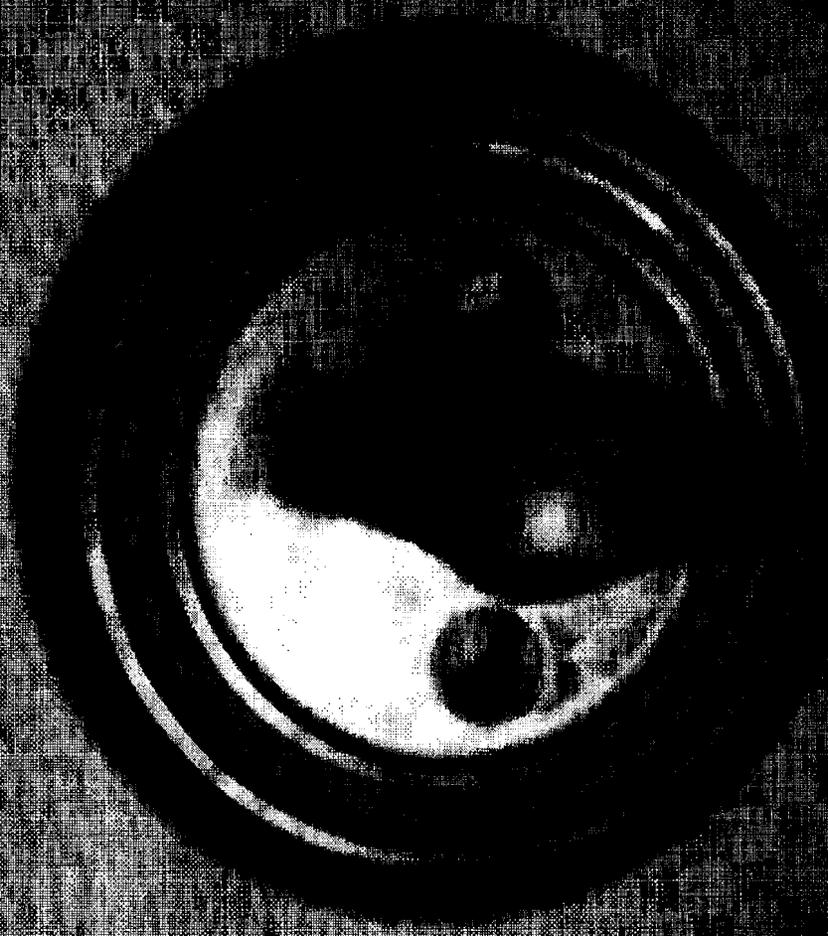
Discolored door
lock.

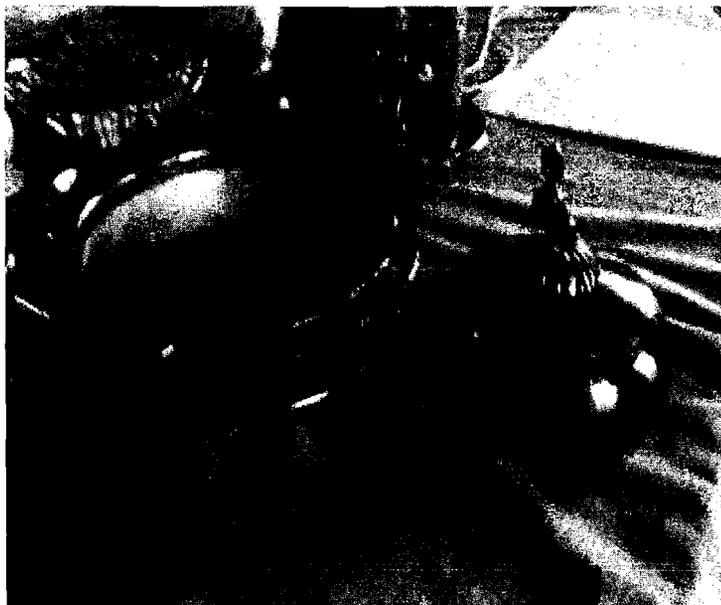
The female homeowner had several antique pieces of silver that had been passed down to her from her grandmother. Since they have lived in this house, the silver has turned black. She stated she had these pieces for many years and they have never turned black until they moved into this house (Attachment 1, Photos 10 – 12).

PHOTO 10 – View of some antique silver that has signs of blackening and pitting marks

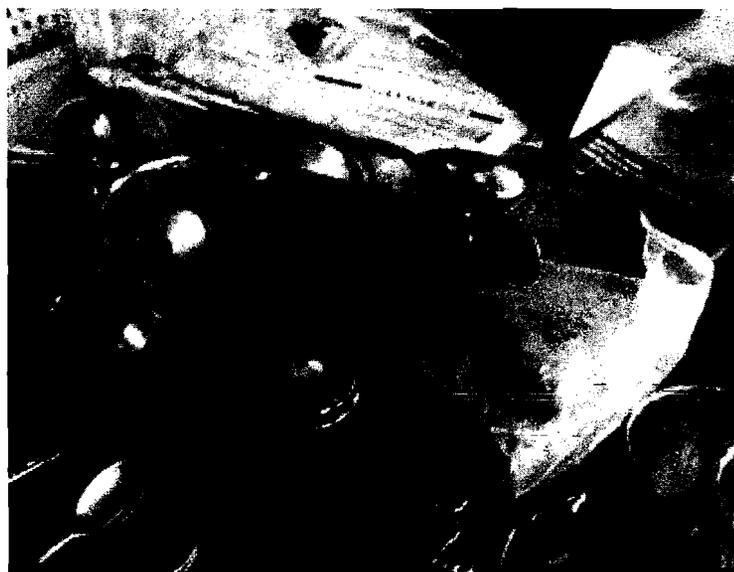
PHOTO 11 – View of an antique gravy bowl that has signs of blackening and pitting marks

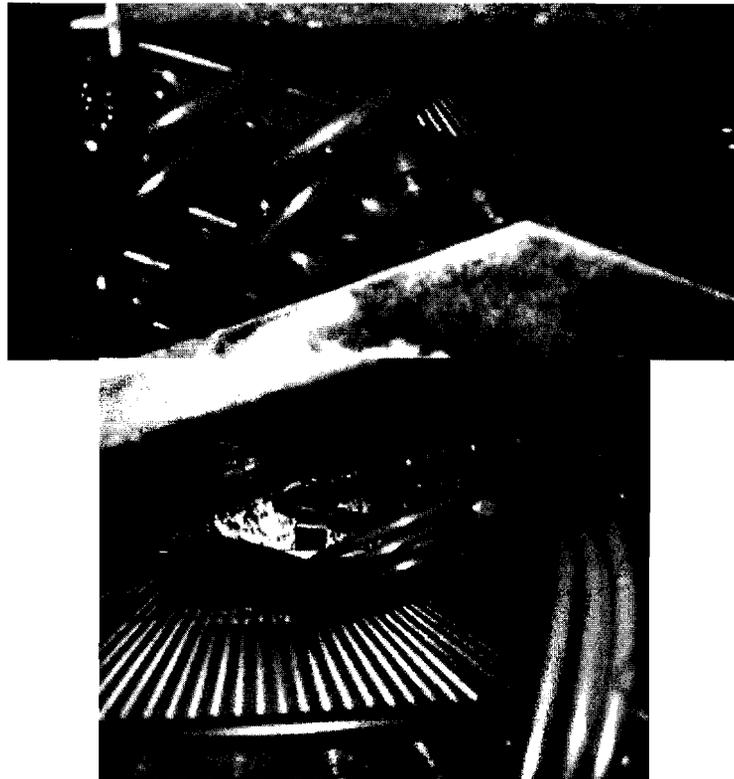
The consumer has experienced electrical appliances not working properly in the house. He has noticed that the dryer is not working properly; it takes longer to dry a normal load of clothing. The television shows a distorted image on the screen and after several minutes the image is corrected. The air conditioning unit has been recharged due to leaking refrigerant on numerous occasions. The consumer was able to provide the work invoices (Exhibit 2) from the air conditioning company. The evaporator coils have been replaced on three occasions. The consumer received a "coated" air conditioning coil during the last installation. He was informed that the "coated" coils would solve the issues that he has been experiencing. The air conditioning was not working at the time of the on-site interview and a fourth evaporator coil was expected for installation a week after the interview. The photographs below show the current "coated" air conditioning coils that are not working.

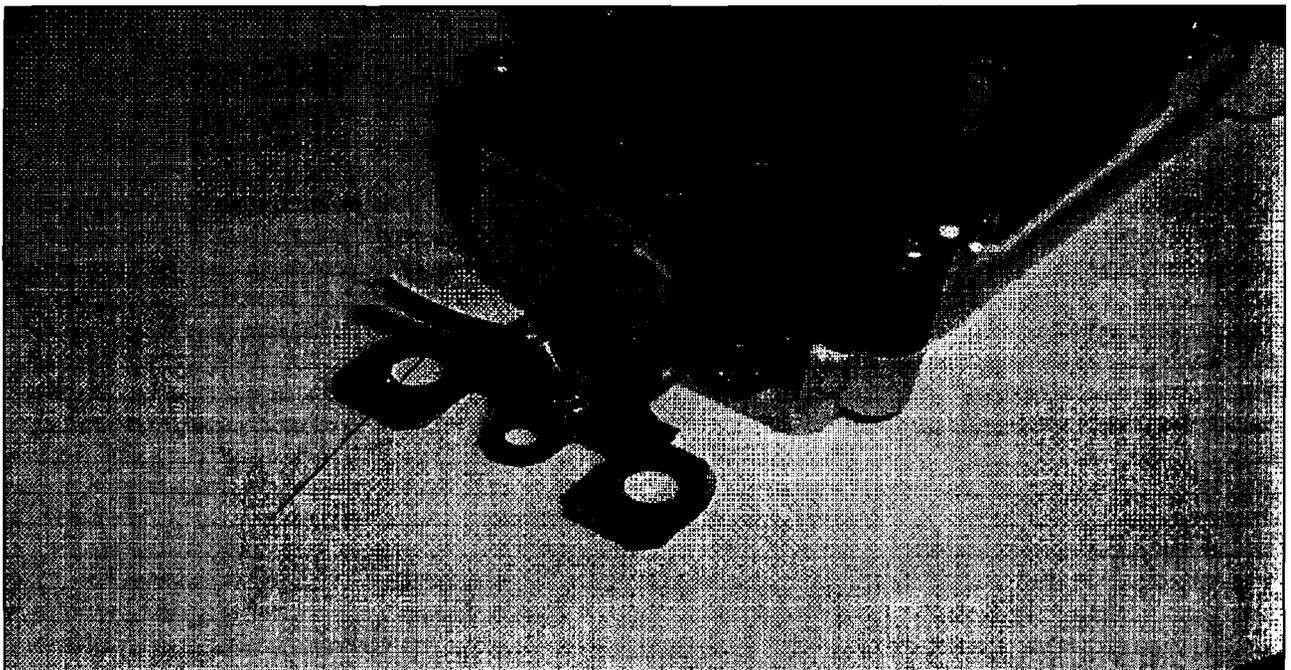
Figure #11: Another view of the copper wire coming out of the GCFI outlet. The arrow is pointing to where the copper wire has turned black.

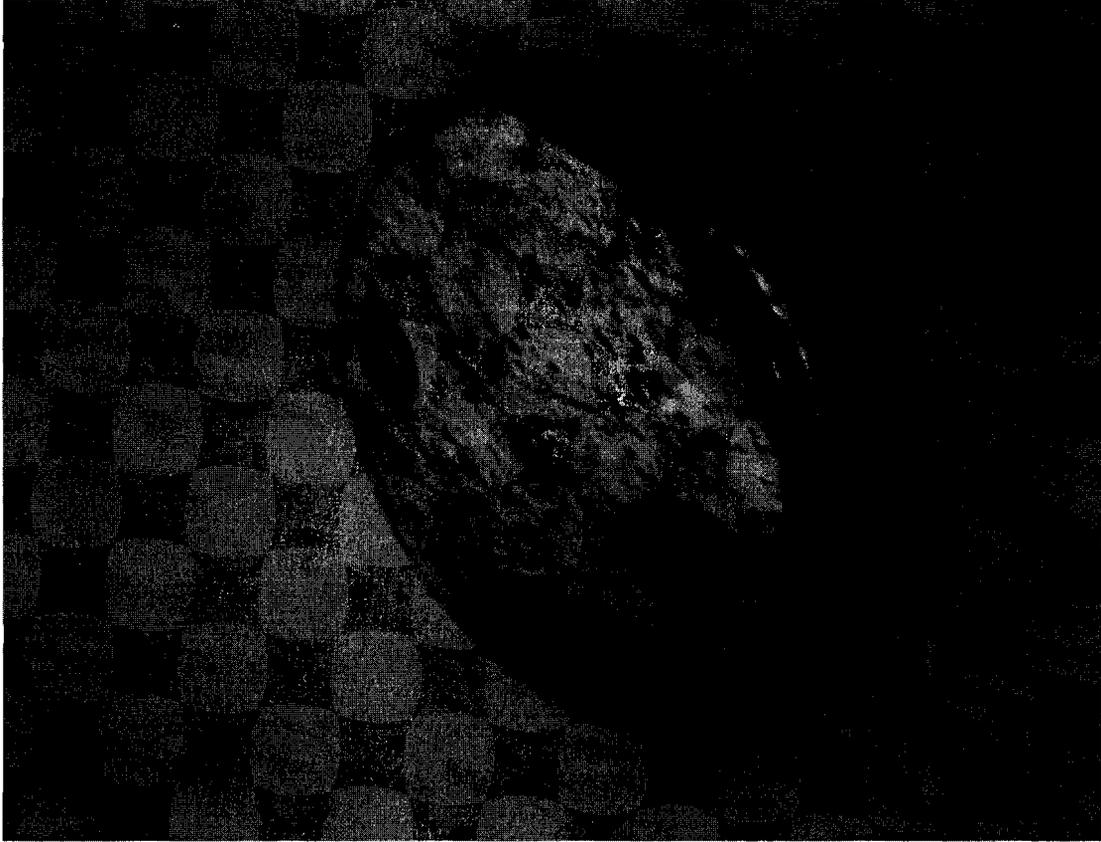
Photo 9 – View of the black pitting on the metal in the bathtub

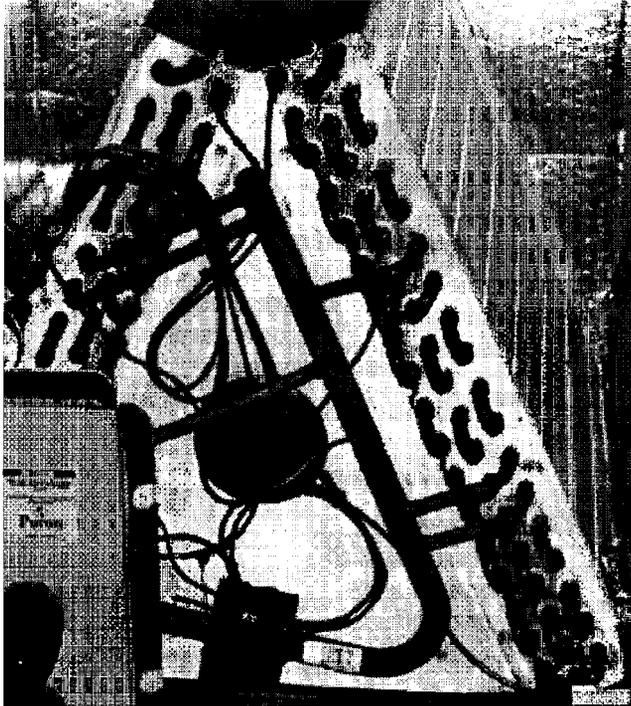
The consumer has also had problems with the air conditioning unit since moving into the home. The consumer has had the air conditioning unit serviced in April 2008, May 2008, and July 2009. Each time the unit was serviced with refrigerant and/or replacement of evaporator coils. The thermostat began to stop working properly and was serviced on one occasion. The consumer provided service invoices, included as Exhibit 2. The consumer reported that she became suspicious of the problem that was occurring with the air conditioning unit because the builder agreed to pay for the service.

Photo shows blackened and corroded evaporator coils in the air conditioning unit.

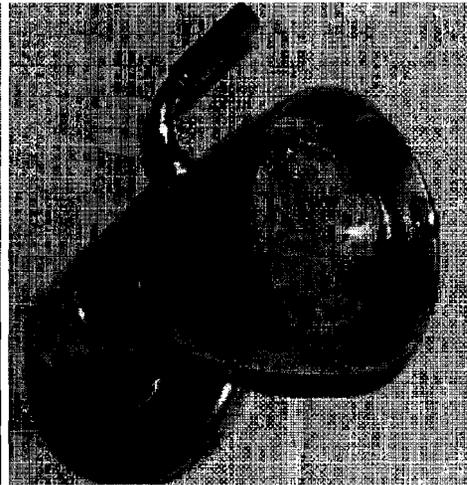
Photo shows pitting on shower head.

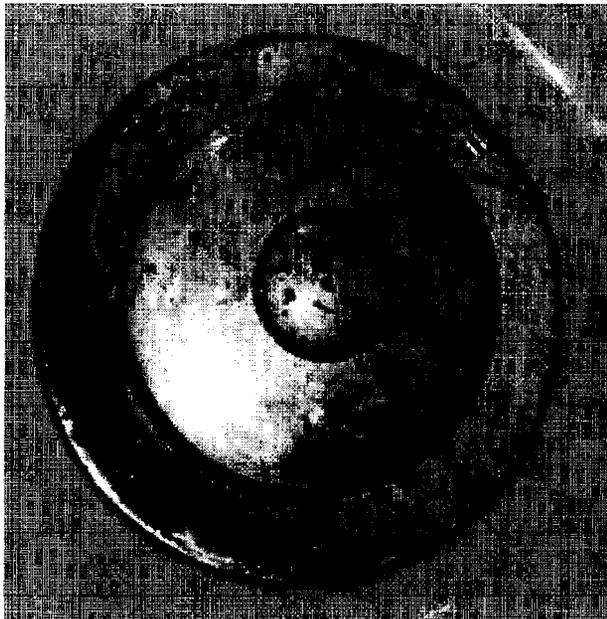
Photo shows pitting on a drain.

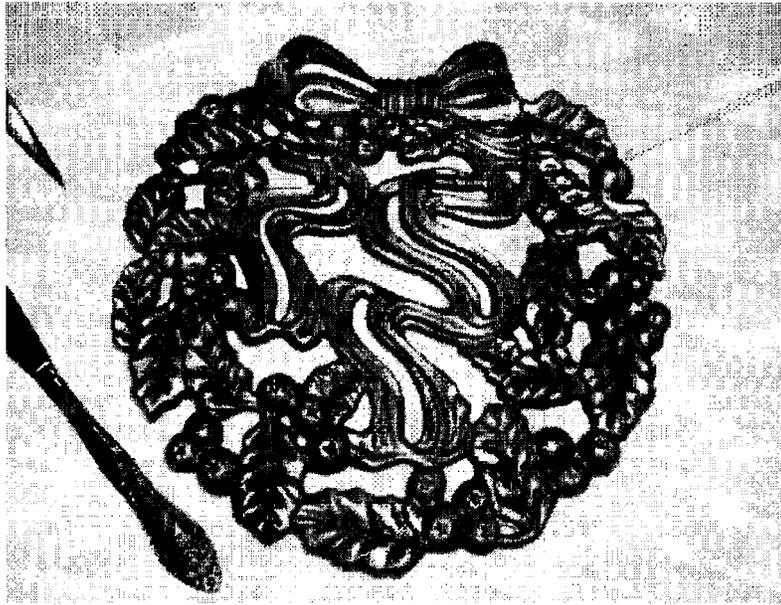
Photo shows blackening on a metal wall decoration.

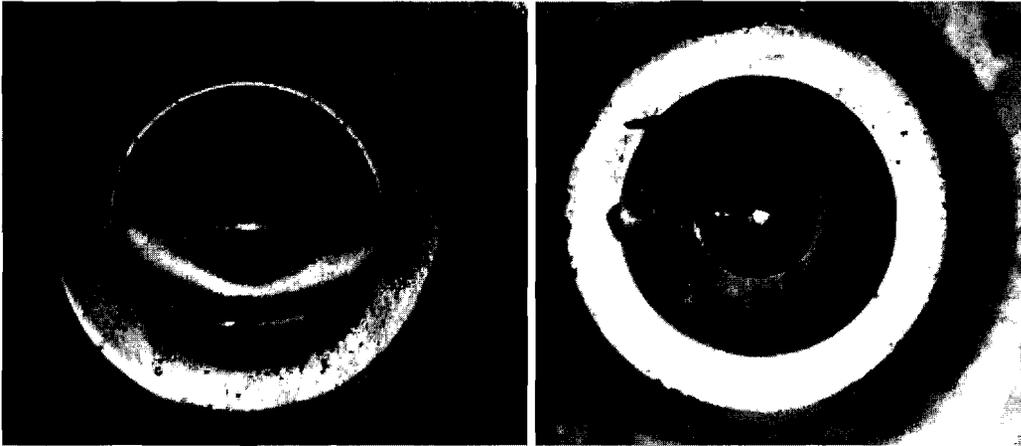
Photographs show visible signs of pitting of drains.

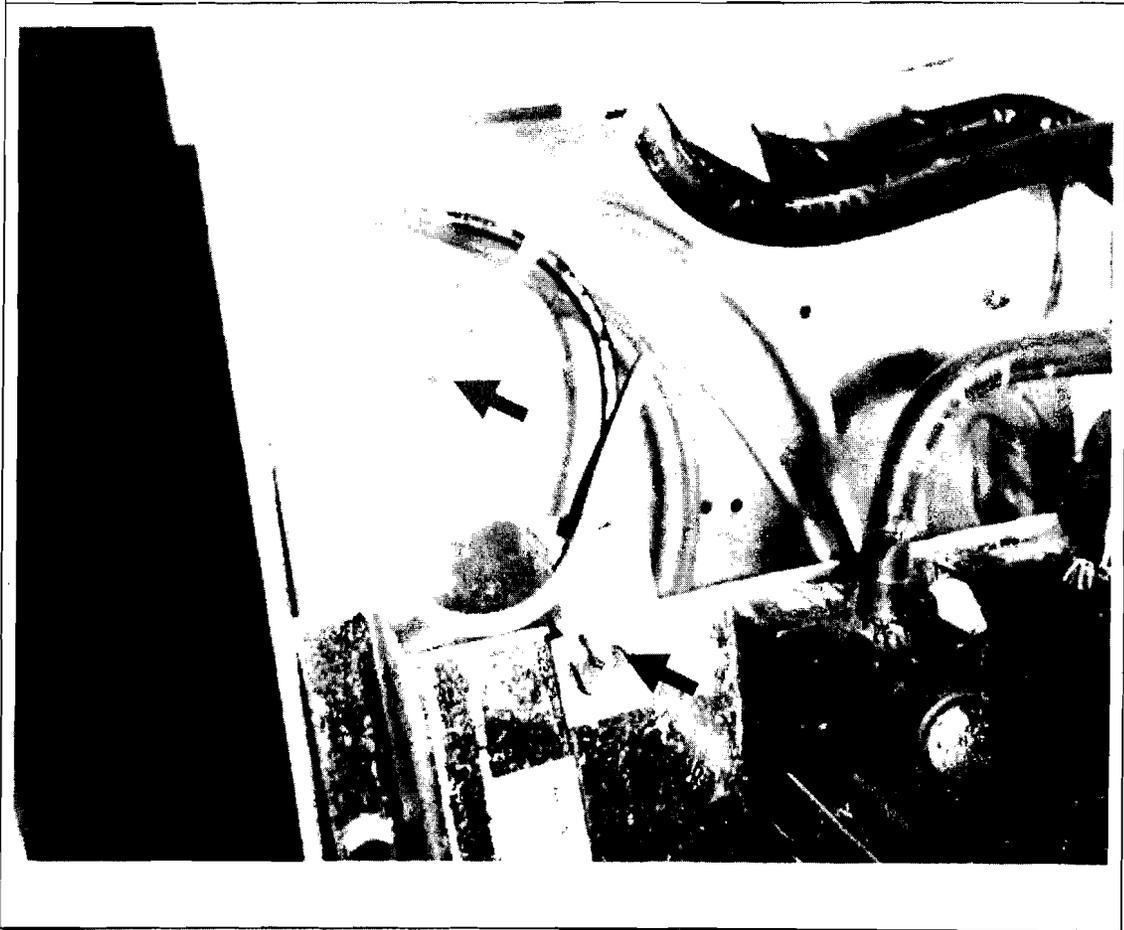
PHOTO ID:	002	LOCATION:					DESCRIPTION:
		GARAGE ATTIC – AHU					
LOCATION OR ITEM SAMPLED		VCDD	<input checked="" type="checkbox"/>	VCDN		OCDO	<input checked="" type="checkbox"/>
							PREMATURE BLACKENING OF COPPER WIRES WITHIN AHU

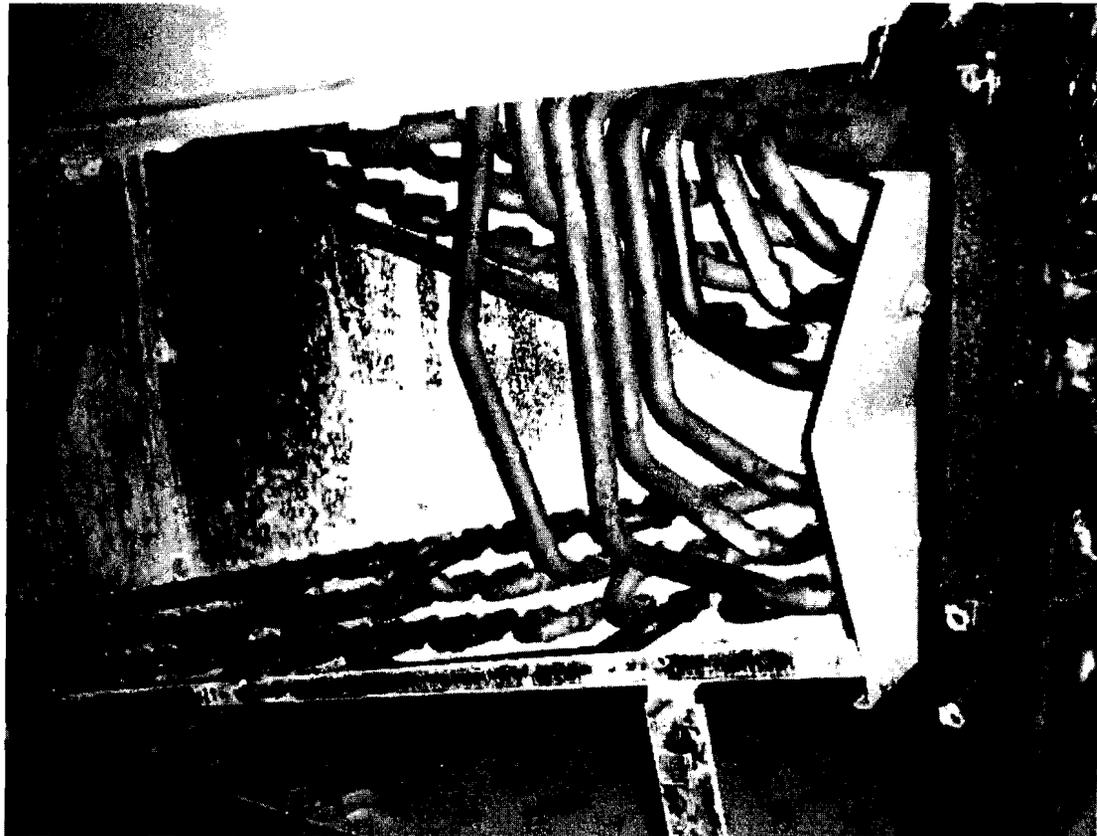
PHOTO ID:	003	LOCATION:				DESCRIPTION:	
		GARAGE ATTIC – AHU					
LOCATION OR ITEM SAMPLED		VCDD	<input checked="" type="checkbox"/>	VCDN		OCDO	<input checked="" type="checkbox"/>
		PREMATURE BLACKENING OF COILS

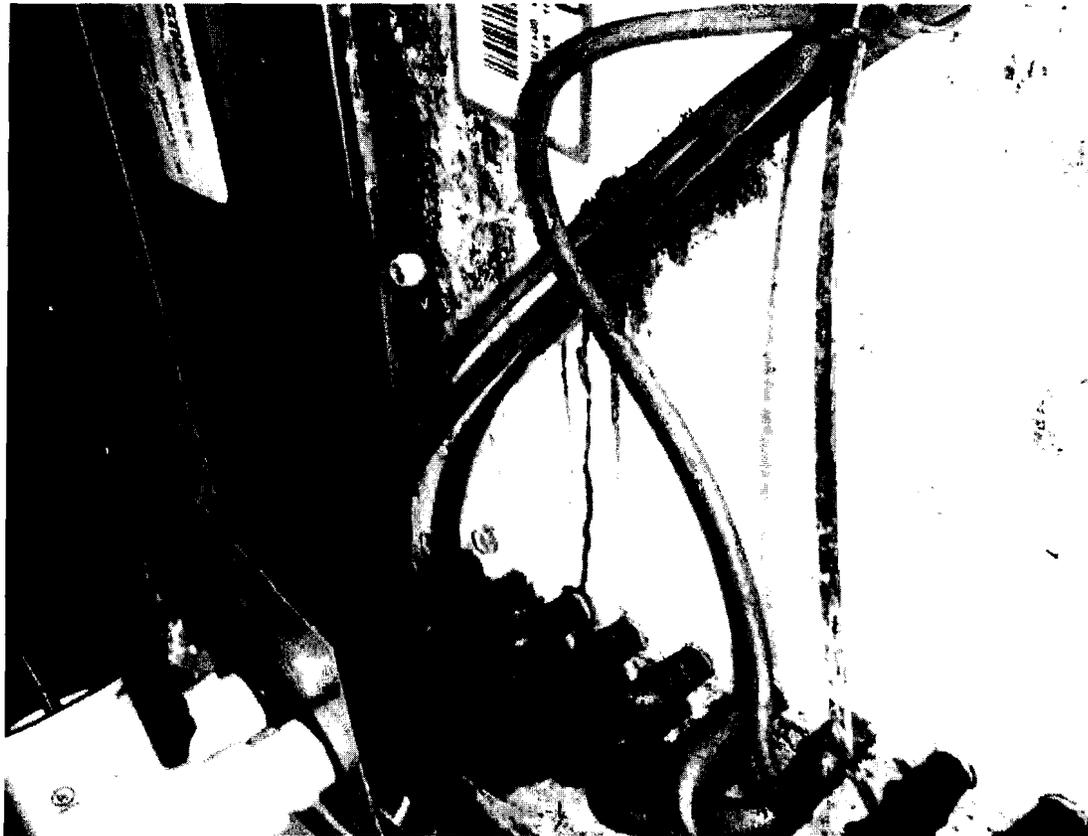
PHOTO ID:	004	LOCATION:				DESCRIPTION:	
		GARAGE ATTIC - AHU				PREMATURE BLACKENING OF COILS	
LOCATION OR ITEM SAMPLED		VCDD	<input checked="" type="checkbox"/>	VCDN		OCDO	<input checked="" type="checkbox"/>

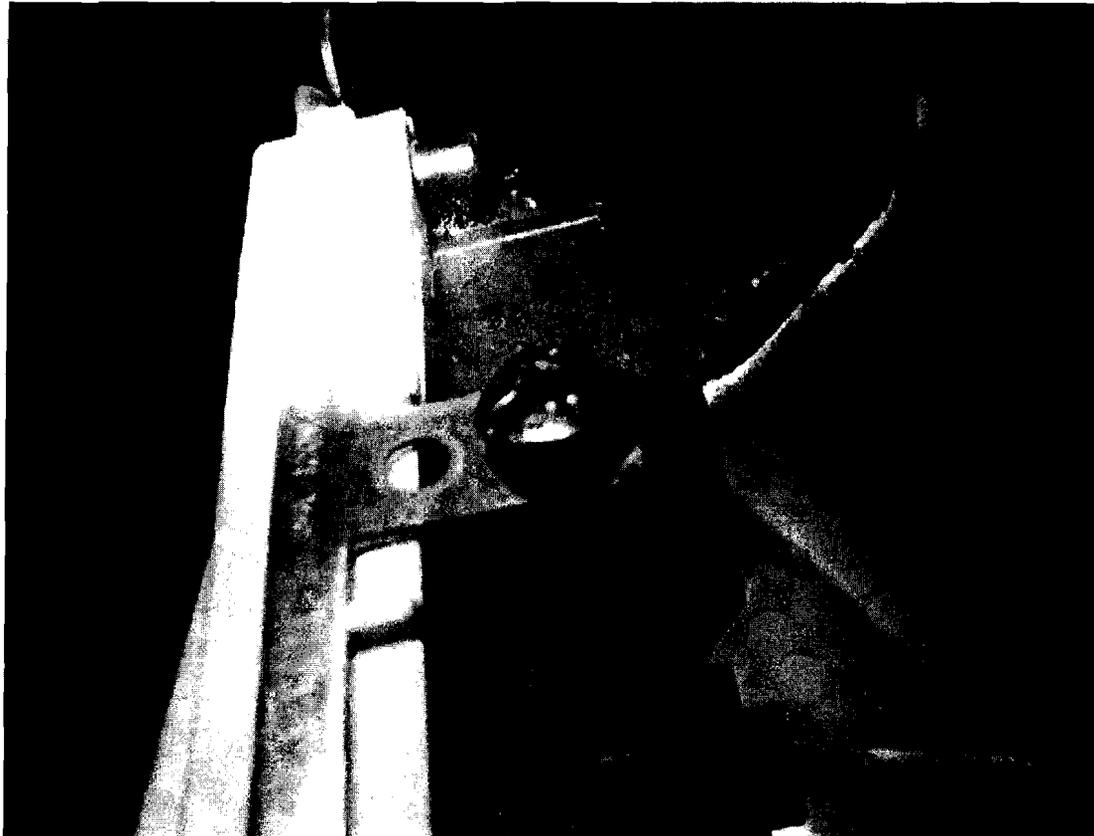
PHOTO ID:	005	LOCATION:					DESCRIPTION:
		LAUNDRY - SWITCH					PREMATURE BLACKENING OF WIRES
LOCATION OR ITEM SAMPLED		VCDD	<input checked="" type="checkbox"/>	VCDN		OCDO

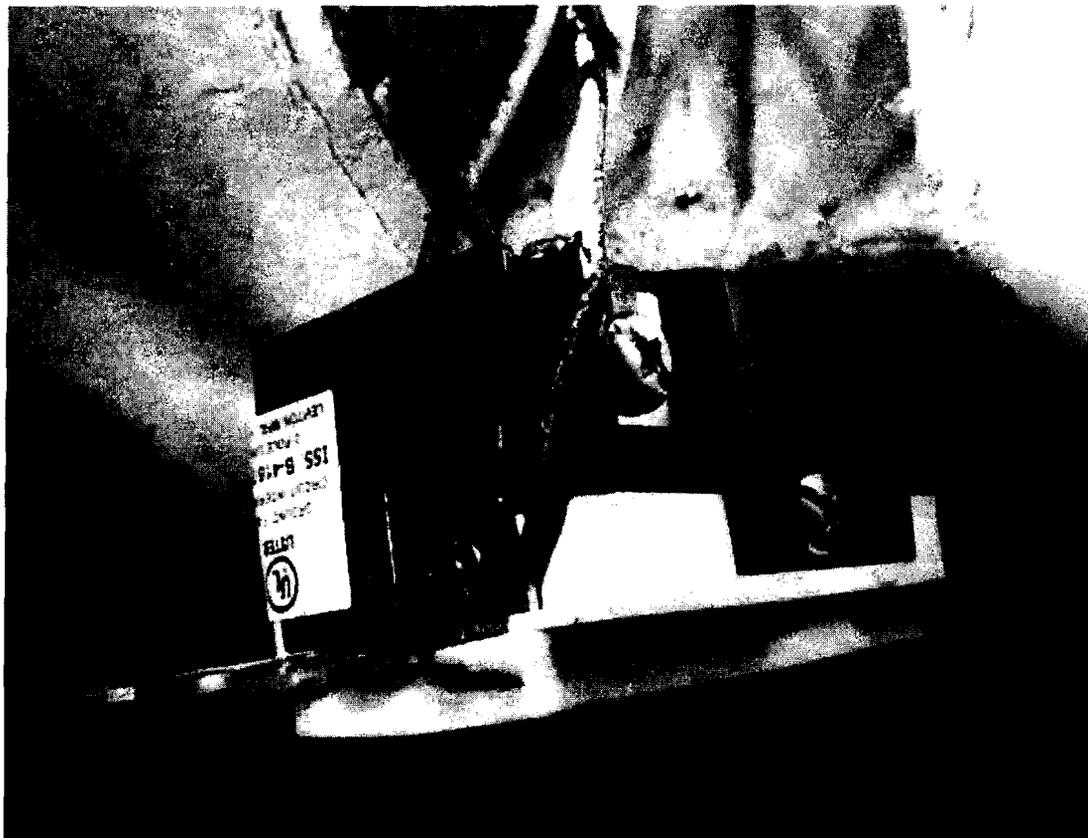
PHOTO ID:	006	LOCATION:					DESCRIPTION:
		LAUNDRY - OUTLET					
LOCATION OR ITEM SAMPLED		VCDD	<input checked="" type="checkbox"/>	VCDN		OCDO	<input checked="" type="checkbox"/>

PREMATURE BLACKENING OF WIRES

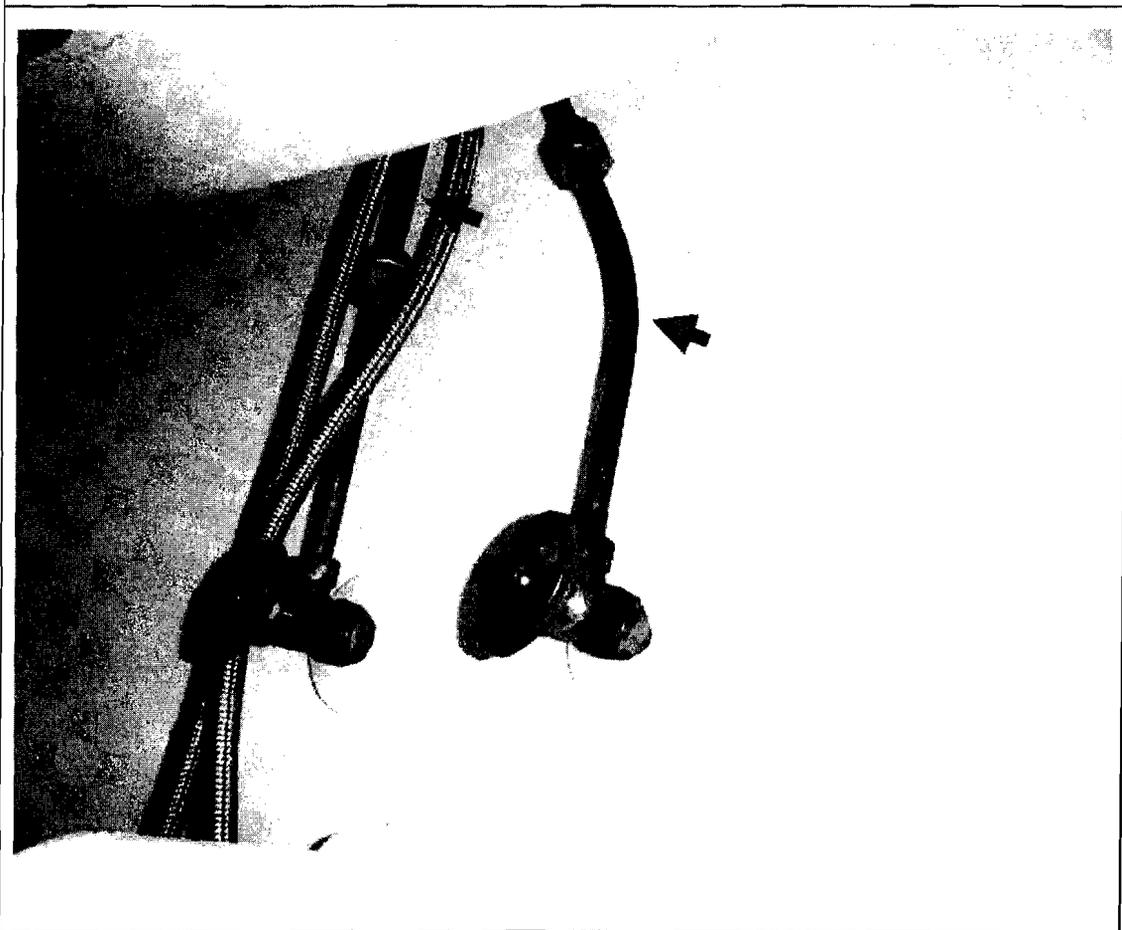
PHOTO ID:	007	LOCATION:				DESCRIPTION:	
		LAUNDRY - SINK				PREMATURE BLACKENING OF COPPER	
LOCATION OR ITEM SAMPLED		VCDD	<input checked="" type="checkbox"/>	VCDN			OCDO

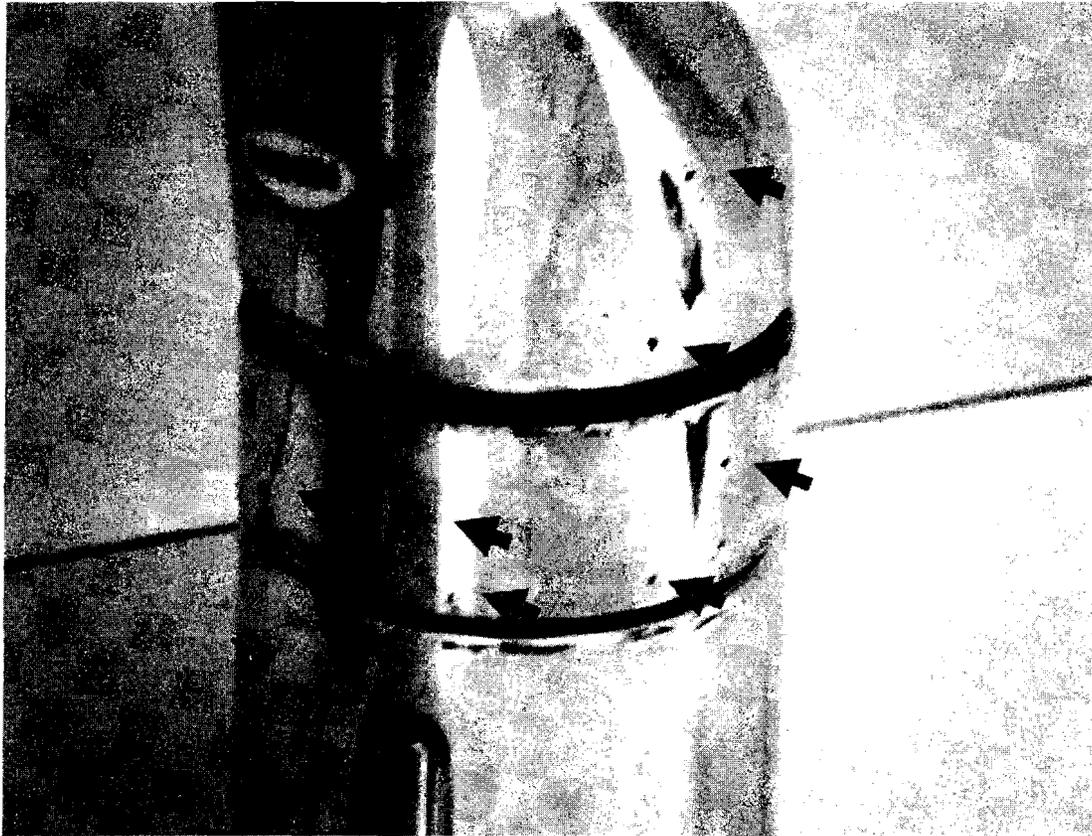
PHOTO ID:	008	LOCATION:				DESCRIPTION:	
		LAUNDRY ROOM				PITTING OF SINK FIXTURE	
LOCATION OR ITEM SAMPLED		V added	<input checked="" type="checkbox"/>	V added			OCDO

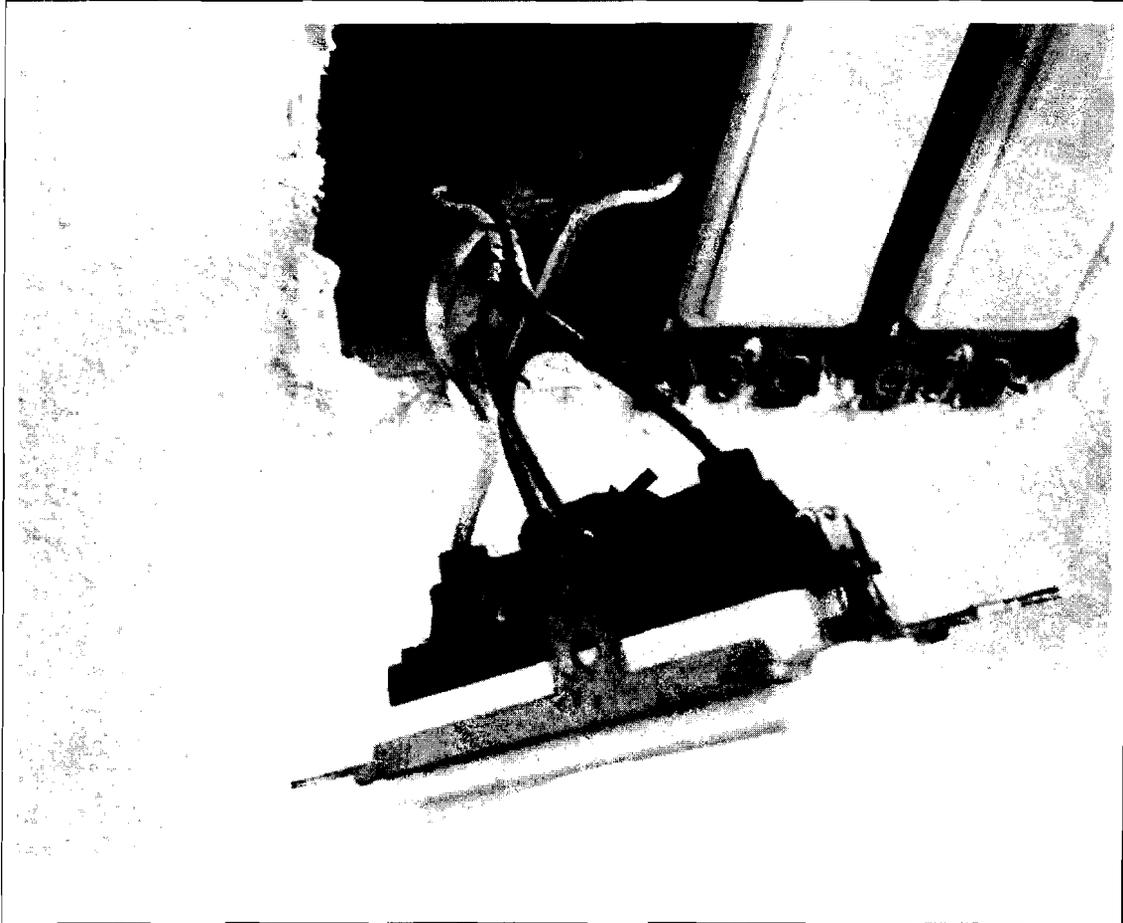
PHOTO ID:	010	LOCATION:				DESCRIPTION:	
		LIVING ROOM – SOUTH WALL SWITCH				PREMATURE BLACKENING OF WIRES	
LOCATION OR ITEM SAMPLED		VCDD	<input checked="" type="checkbox"/>	VCDN			OCDO

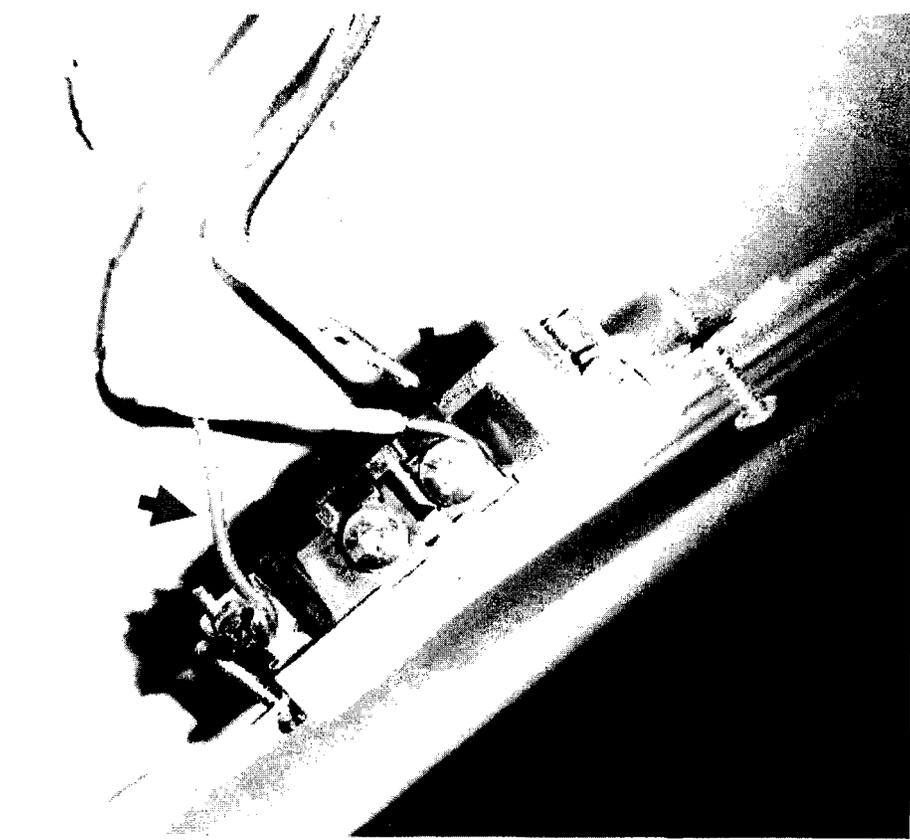
PHOTO ID:	011	LOCATION:				DESCRIPTION:
		LIVING ROOM – NORTH WALL OUTLET				PREMATURE BLACKENING OF WIRES
LOCATION OR ITEM SAMPLED	VCDD	<input checked="" type="checkbox"/>	VCDN	OCDO	<input checked="" type="checkbox"/>	
NOTE: Not all photos taken during the site visit are included. Additional photos which were taken are retained in our files.

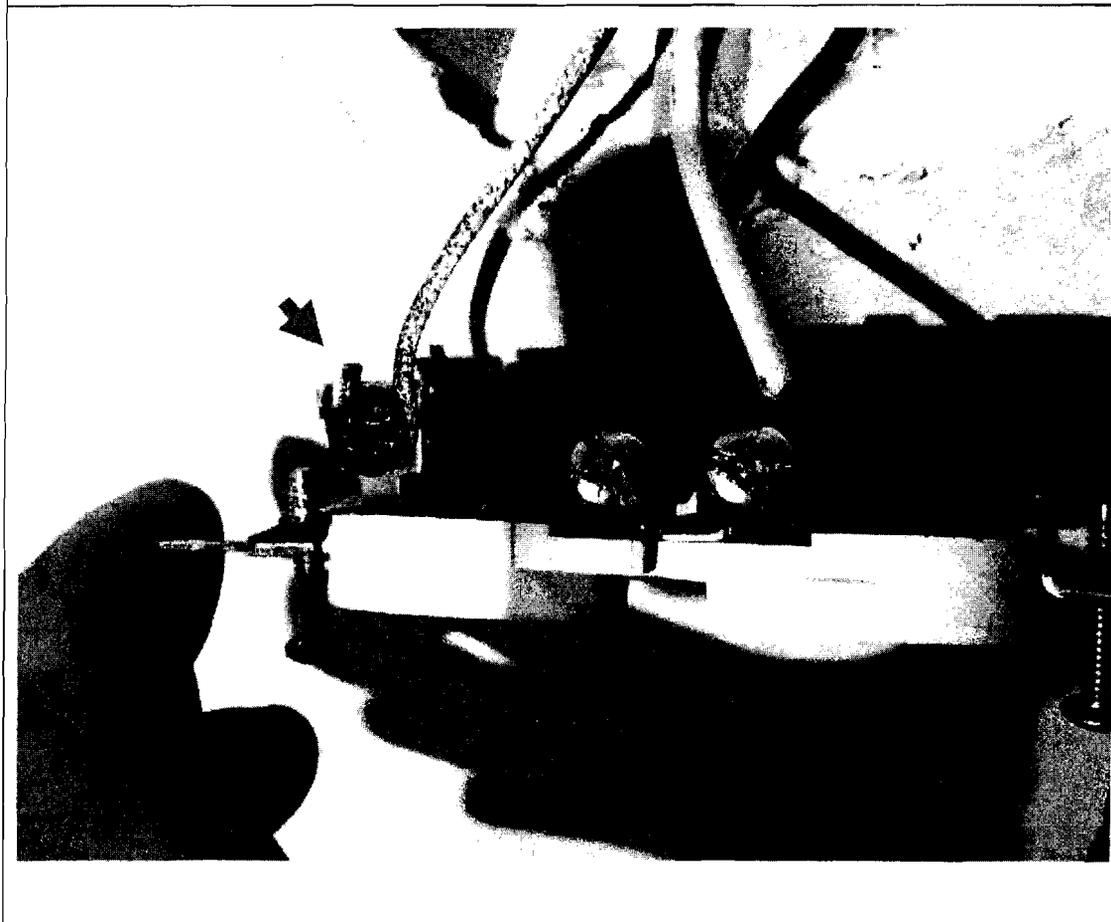
PHOTO ID:	012	LOCATION:				DESCRIPTION:	
		POWDER BATHROOM				PREMATURE BLACKENING OF WIRES	
LOCATION OR ITEM SAMPLED		VCDD	<input checked="" type="checkbox"/>	VCDN			OCDO

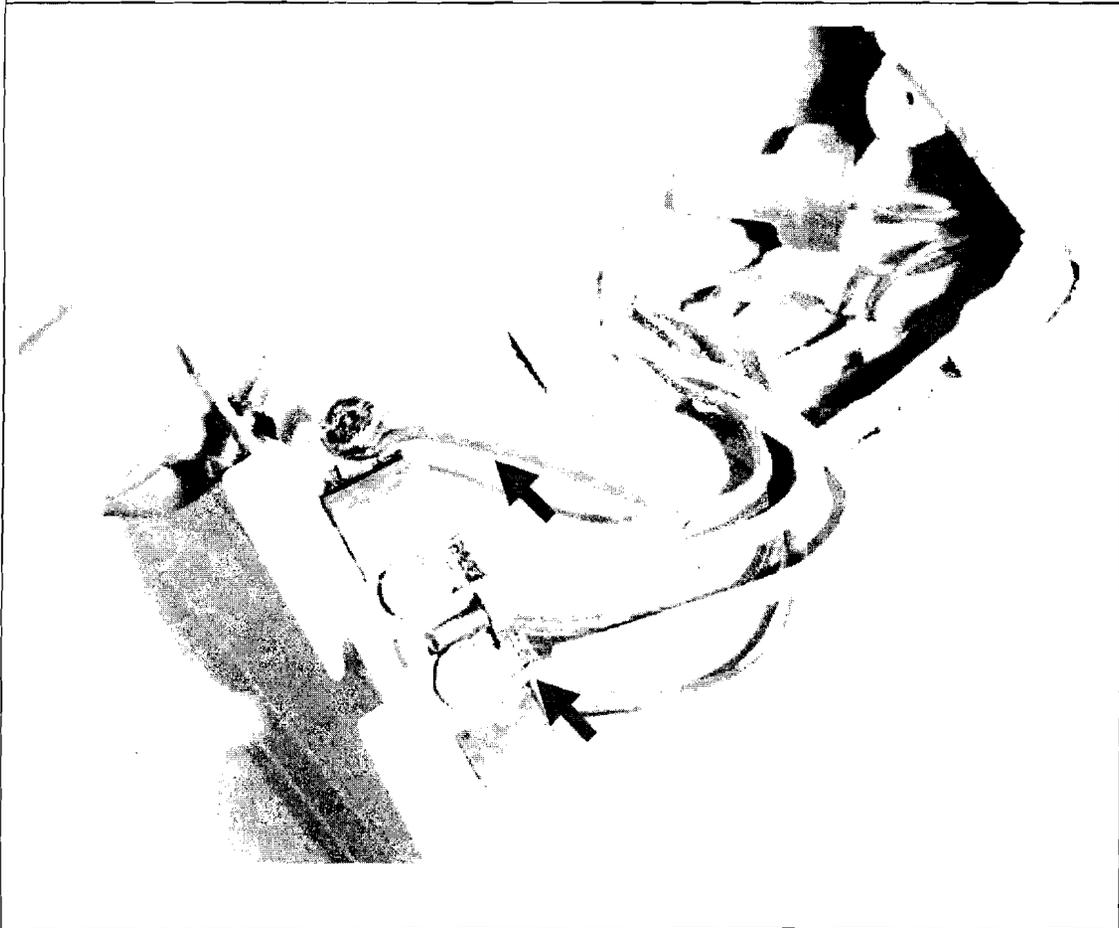
PHOTO ID:	015	LOCATION:					DESCRIPTION:
		DINETTE AREA					
LOCATION OR ITEM SAMPLED		VCDD	<input checked="" type="checkbox"/>	VCDN		OCDO	<input checked="" type="checkbox"/>
							PREMATURE BLACKENING OF WIRES SW WALL OUTLET

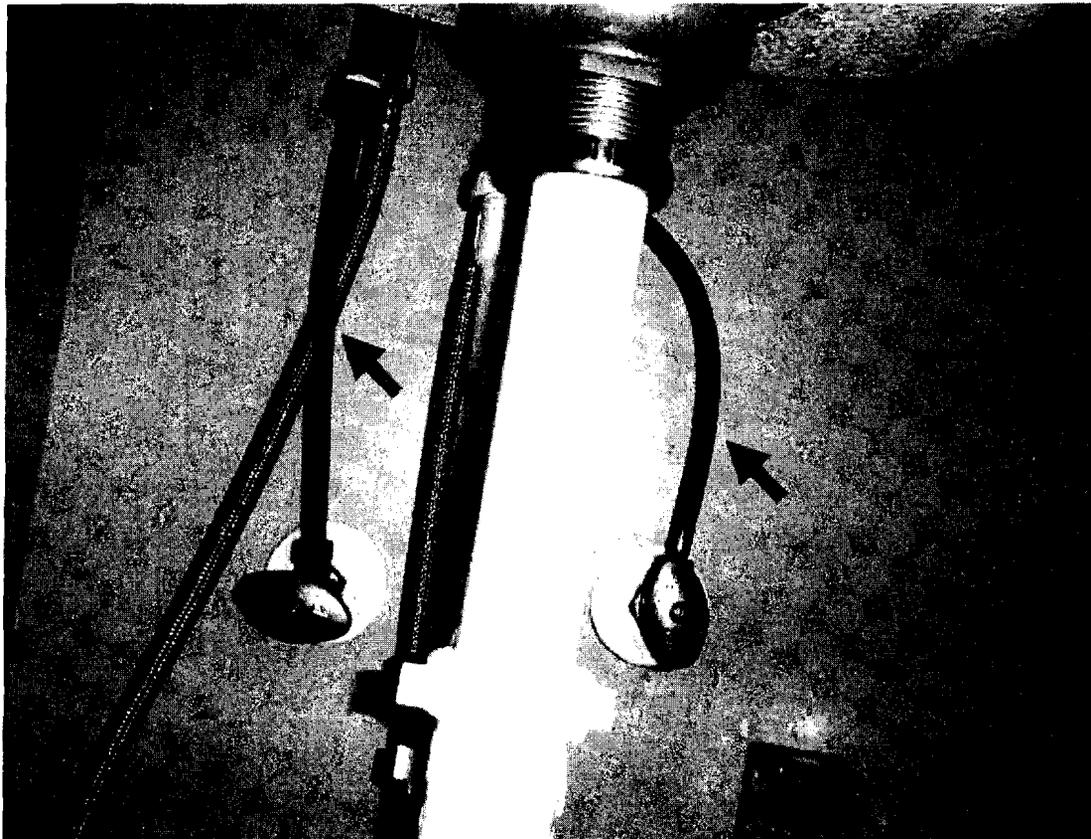
PHOTO ID:	016	LOCATION:				DESCRIPTION:	
		WETBAR					
LOCATION OR ITEM SAMPLED		VCDD	<input checked="" type="checkbox"/>	VCDN		OCDO	<input checked="" type="checkbox"/>

PREMATURE BLACKENING OF COPPER PIPES

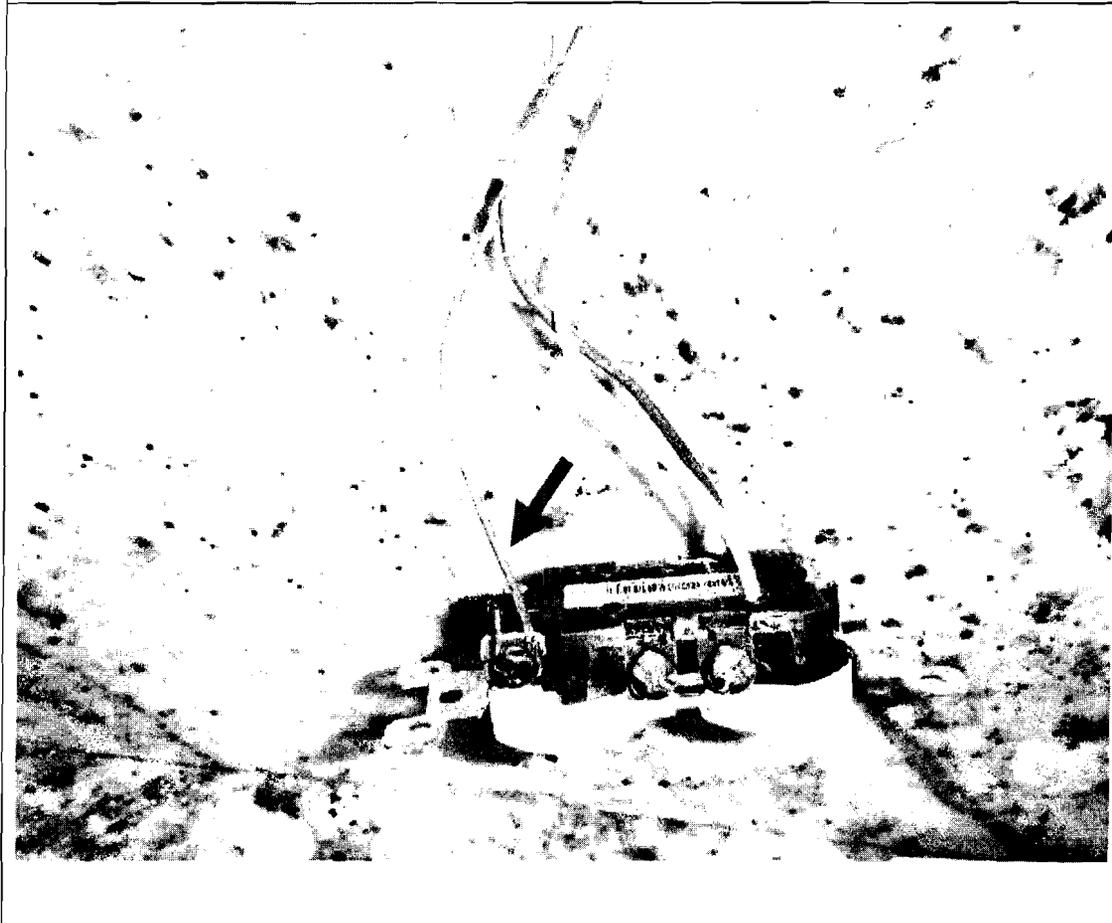
PHOTO ID:	019					LOCATION:		DESCRIPTION:	
						WETBAR OUTLET		PREMATURE BLACKENING OF WIRES	
LOCATION OR ITEM SAMPLED	VCDD	<input checked="" type="checkbox"/>	VCDN	OCDO	<input checked="" type="checkbox"/>

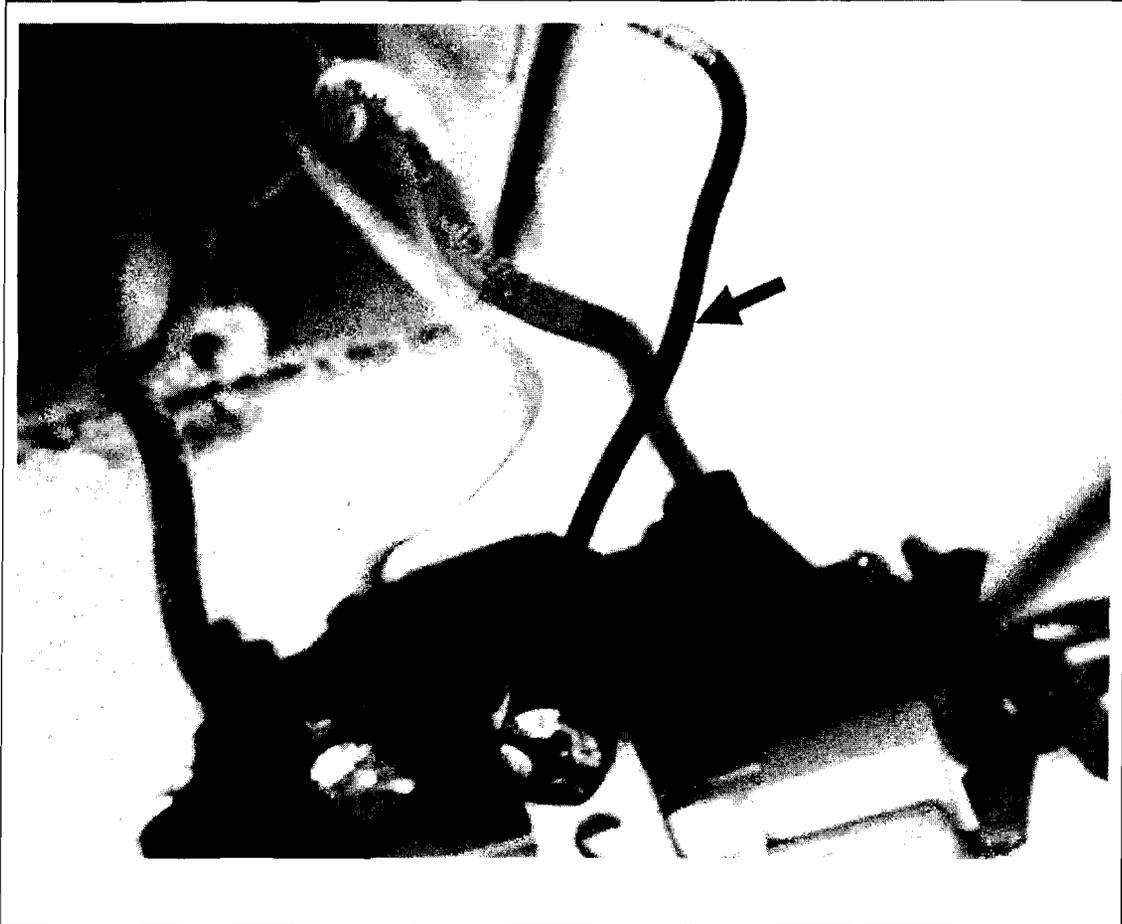
PHOTO ID:	020	LOCATION:				DESCRIPTION:	
		FAMILY ROOM					
LOCATION OR ITEM SAMPLED		VCDD	<input checked="" type="checkbox"/>	VCDN		OCDO	<input checked="" type="checkbox"/>
PREMATURE BLACKENING OF WIRES OUTLET SOUTH WALL

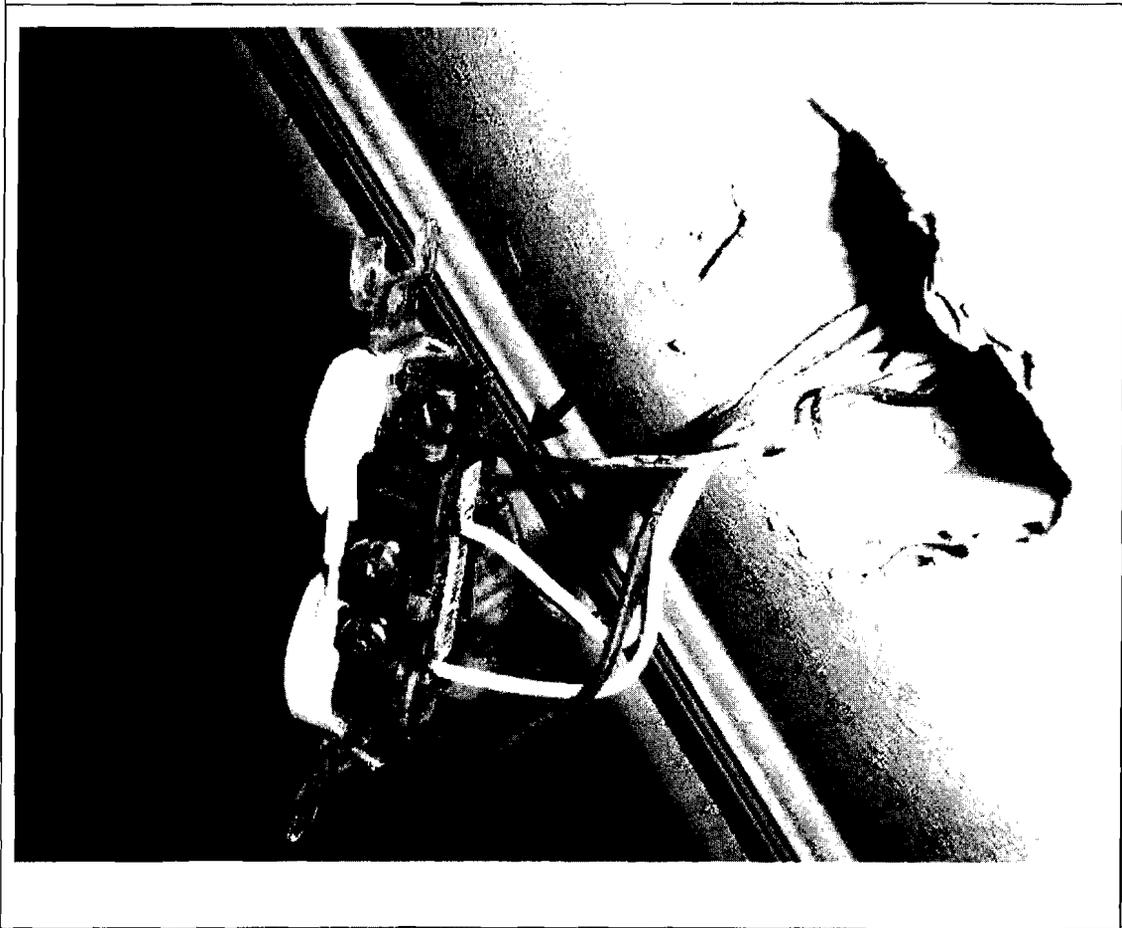
PHOTO ID:	021	LOCATION:				DESCRIPTION:	
		MASTER BEDROOM				PREMATURE BLACKENING OF WIRES OUTLET NORTH WALL	
LOCATION OR ITEM SAMPLED		VCDD	<input checked="" type="checkbox"/>	VCDN			OCDO
