1. Task Number 090810CBB1947		2. Investigator's ID 2248		EPIDEMIOLOGIC INVESTIGATION REPORT
3. Office Code 810	4. Date of Accident YR MO DAY 2009 04 01	5. Date Initiated YR MO DAY 2009 08 10

6. Synopsis of Accident or Complaint UPC The consumer, his wife and 2 children moved into a new home in December 2006. It was reported that Chinese drywall in the home has caused several health issues. Appliances have ceased to function. Blackening and discoloration of copper pipes and metal fixtures throughout the home have been observed. Corrosion within the 2 AC units is evident. Product identification on the drywall is unknown. <div style="text-align: right;"> <p>CPSC (6/01/1) CLEARED for PUBLIC</p> <p>✓ NO MFRS/PRVT LBRS OR PRODUCTS IDENTIFIED</p> <p>EXCEPTED BY: PETITION RULEMAKING ADMIN. PRCDG</p> <p>✓ WITH PORTIONS REMOVED: <u>4, 262</u></p> <p style="font-size: 1.2em; margin-left: 20px;">WJC 5/19/10</p> </div>

090810CBB1947

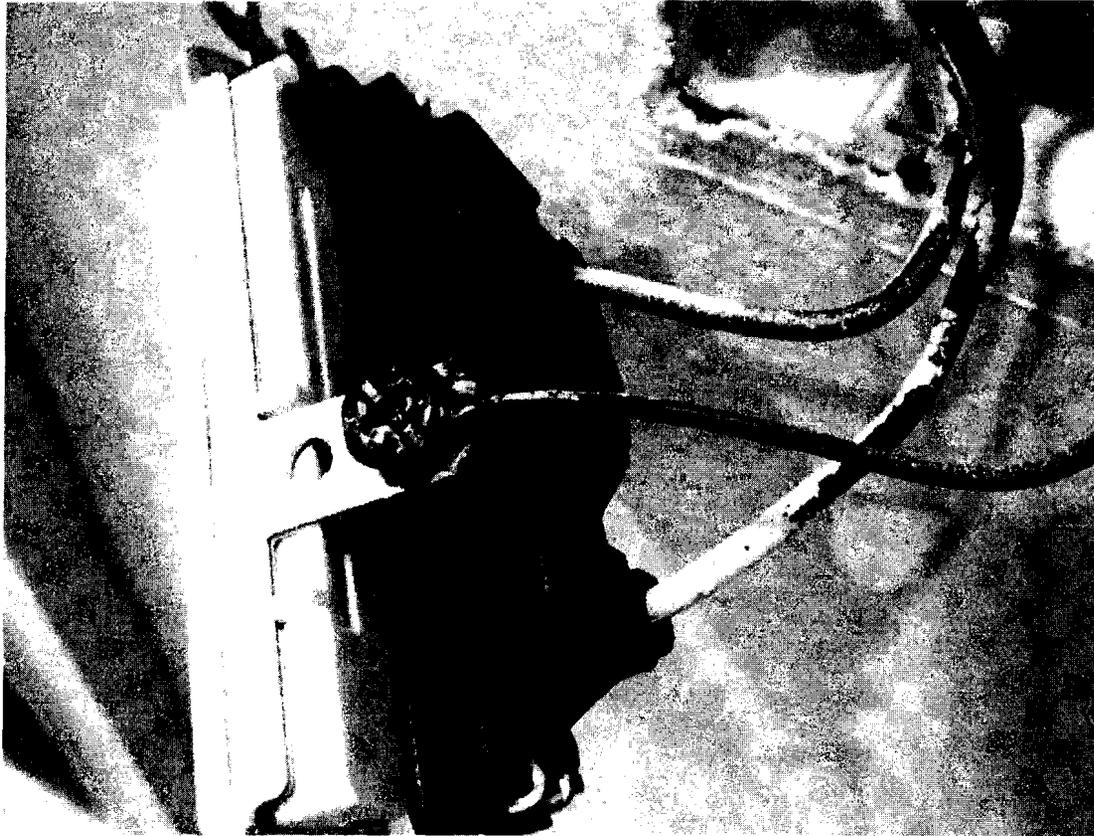
PHOTO ID:	022	LOCATION:					DESCRIPTION:
		MASTER BATHROOM					
LOCATION OR ITEM SAMPLED		VCDD	<input checked="" type="checkbox"/>	VCDN		OCDO	<input checked="" type="checkbox"/>

PREMATURE BLACKENING OF LIGHT SWITCH WIRES

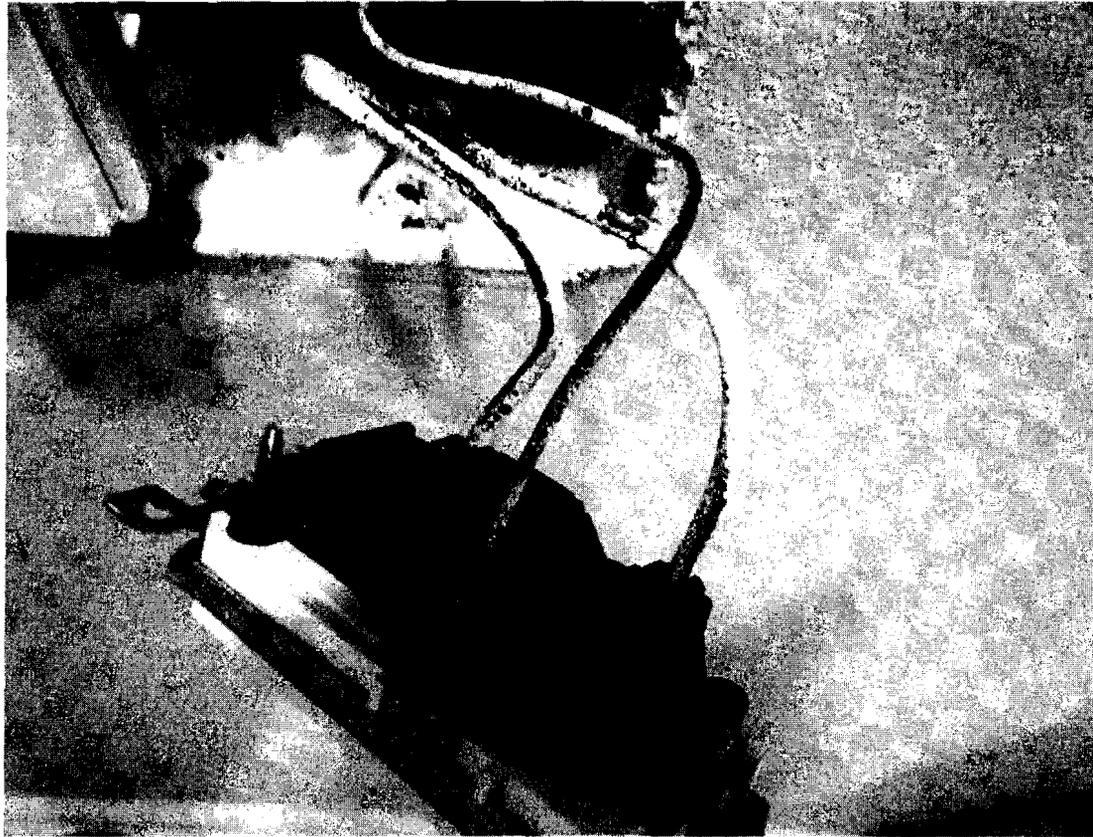
PHOTO ID:	023	LOCATION:				DESCRIPTION:	
		MASTER BATHROOM WATER CLOSET					
LOCATION OR ITEM SAMPLED		VCDD	<input checked="" type="checkbox"/>	VCDN		OCDO	<input checked="" type="checkbox"/>
						PREMATURE BLACKENING OF LIGHTSWITCH WIRES

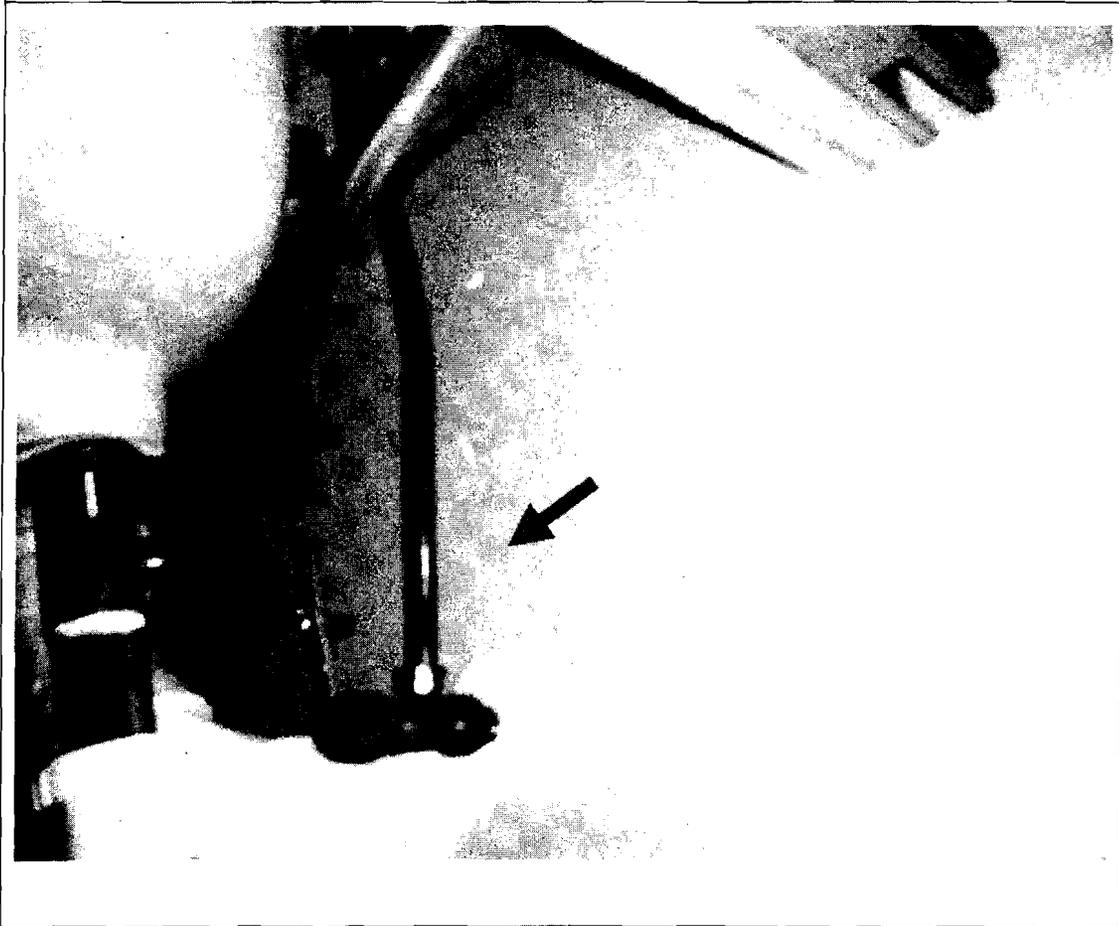
PHOTO ID:	024	LOCATION:				DESCRIPTION:		
		MASTER BATHROOM						
LOCATION OR ITEM SAMPLED		VCDD	<input checked="" type="checkbox"/>	VCDN	<input type="checkbox"/>	OCDO	<input checked="" type="checkbox"/>	PREMATURE BLACKENING OF COPPER PIPE NORTH SINK

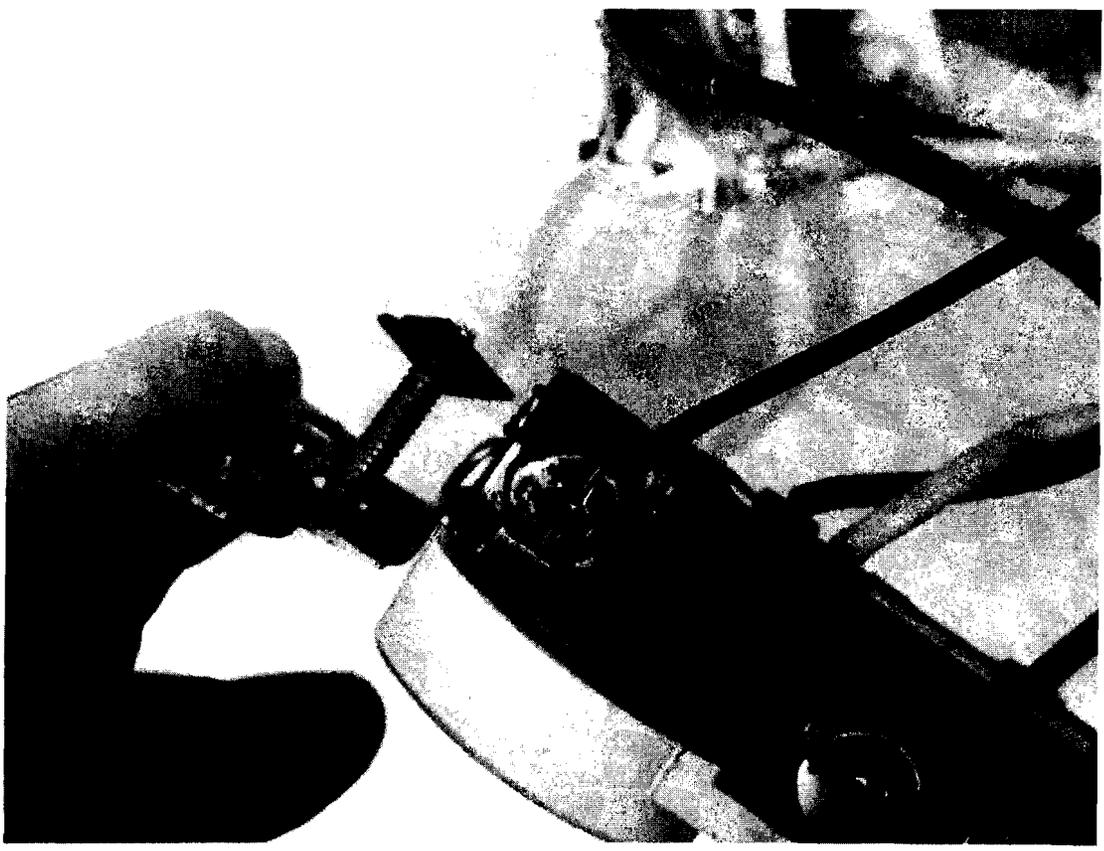
PHOTO ID:	026	LOCATION:				DESCRIPTION:
		LOFT				
LOCATION OR ITEM SAMPLED		VCDD	<input checked="" type="checkbox"/>	VCDN		PREMATURE BLACKENING OF OUTLET WIRES SOUTH WALL
				OCDO	<input checked="" type="checkbox"/>	
NOTE: Not all photos taken during the site visit are included. Additional photos which were taken are retained in our files.

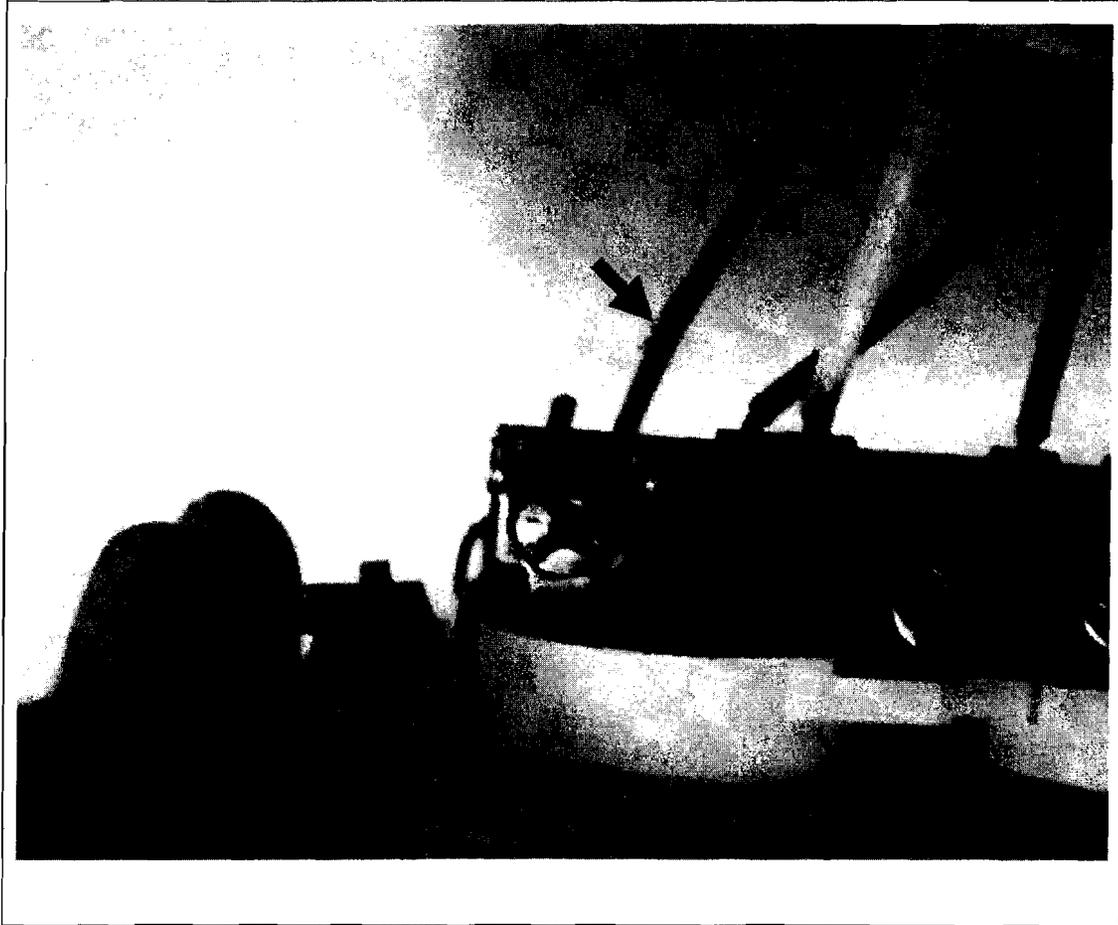
PHOTO ID:	027	LOCATION:				DESCRIPTION:	
		SE SPARE BEDROOM					
LOCATION OR ITEM SAMPLED		VCDD	<input checked="" type="checkbox"/>	VCDN		OCDO	<input checked="" type="checkbox"/>

PREMATURE BLACKENING OF WIRES OUTLET WEST WALL

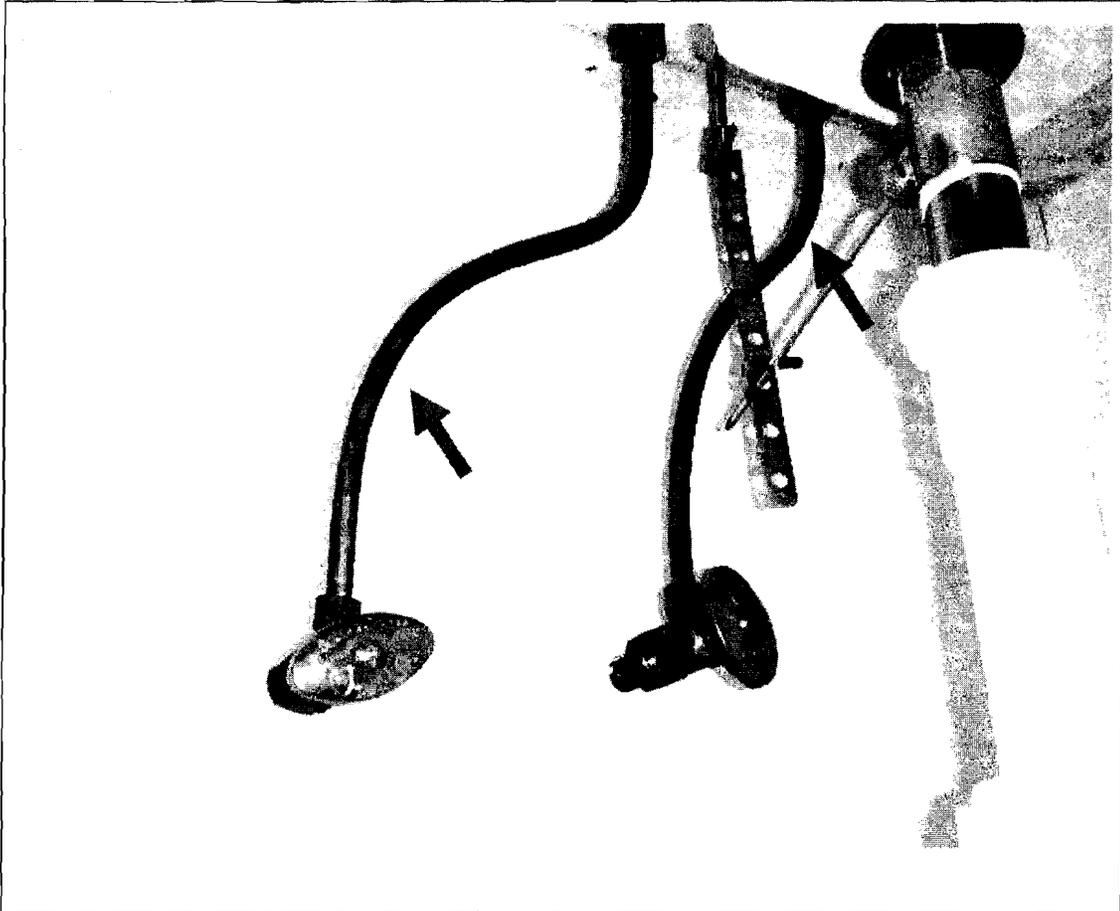
PHOTO ID:	028	LOCATION:				DESCRIPTION:	
		SPARE BATHROOM					
LOCATION OR ITEM SAMPLED		VCDD	<input checked="" type="checkbox"/>	VCDN		OCDO	<input checked="" type="checkbox"/>

PREMATURE BLACKENING OF COPPER PIPES BELOW SINK

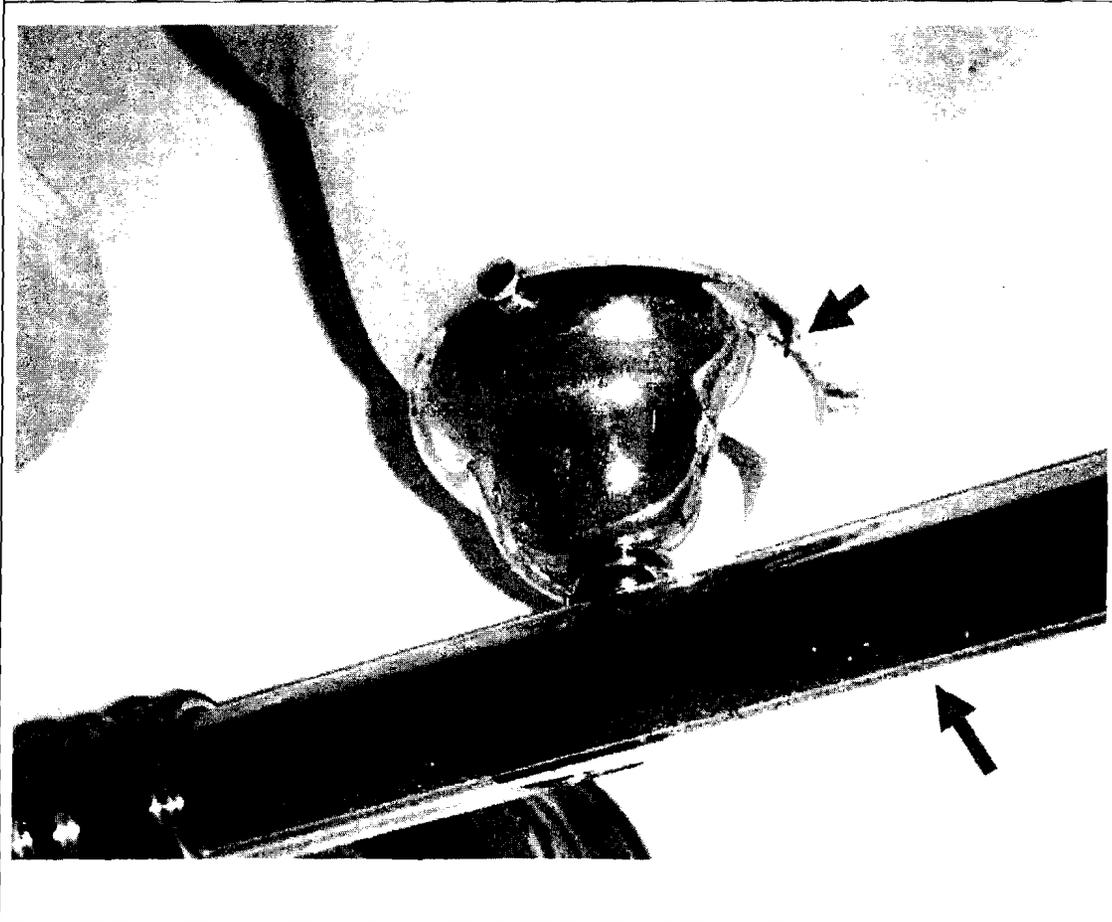
PHOTO ID:	029	LOCATION:				DESCRIPTION:	
		SPARE BATHROOM					
LOCATION OR ITEM SAMPLED		VCDD	<input checked="" type="checkbox"/>	VCDN		OCDO	<input checked="" type="checkbox"/>

PREMATURE PITTING OF CHROME PLATING ON LIGHTBAR

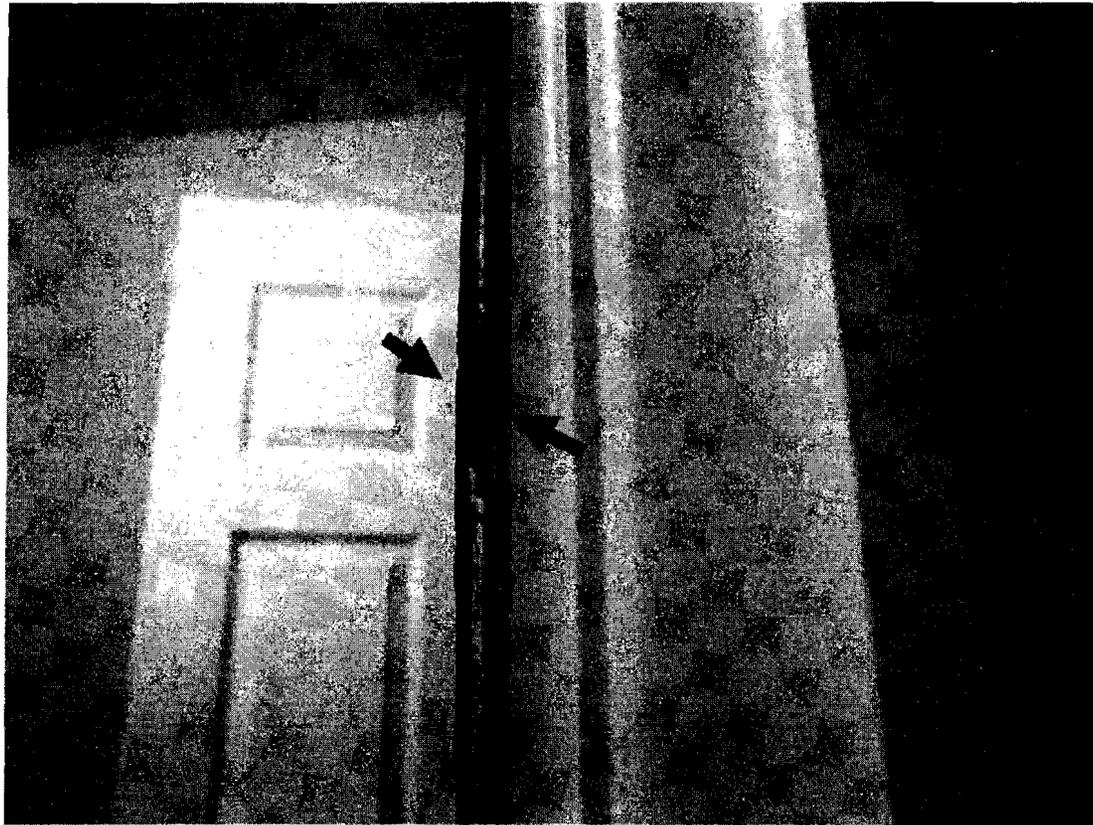
- ✓ Presence of sulfur-like unusual odors categorized as that which would be equated to a “sulfur smell after striking a match” or “of a rotten egg with sulfur overtones”;
- ✓ Air Handlers exhibit copper damage resulting from possible prolonged exposure to Chinese Drywall as evidenced by the copper corrosion, and further indicated by copper pipes which make up a portion of the air handler’s coil system;
- ✓ Multiple electrical outlets were confirmed to have been affected by corrosion of the copper wires servicing the outlets as evidenced by the visible black sooty coating of the copper wires servicing the outlets, posing a potential risk of electrical fire;
- ✓ Visible pitting of corrosion of multiple chrome plated items;
- ✓ Visible early desilvering of the Spare bathroom mirror.

PHOTO ID:	030	LOCATION:				DESCRIPTION:	
		SPARE BATHROOM					
LOCATION OR ITEM SAMPLED		VCDD	<input checked="" type="checkbox"/>	VCDN		OCDO	<input checked="" type="checkbox"/>

DESILVERING OF MIRROR

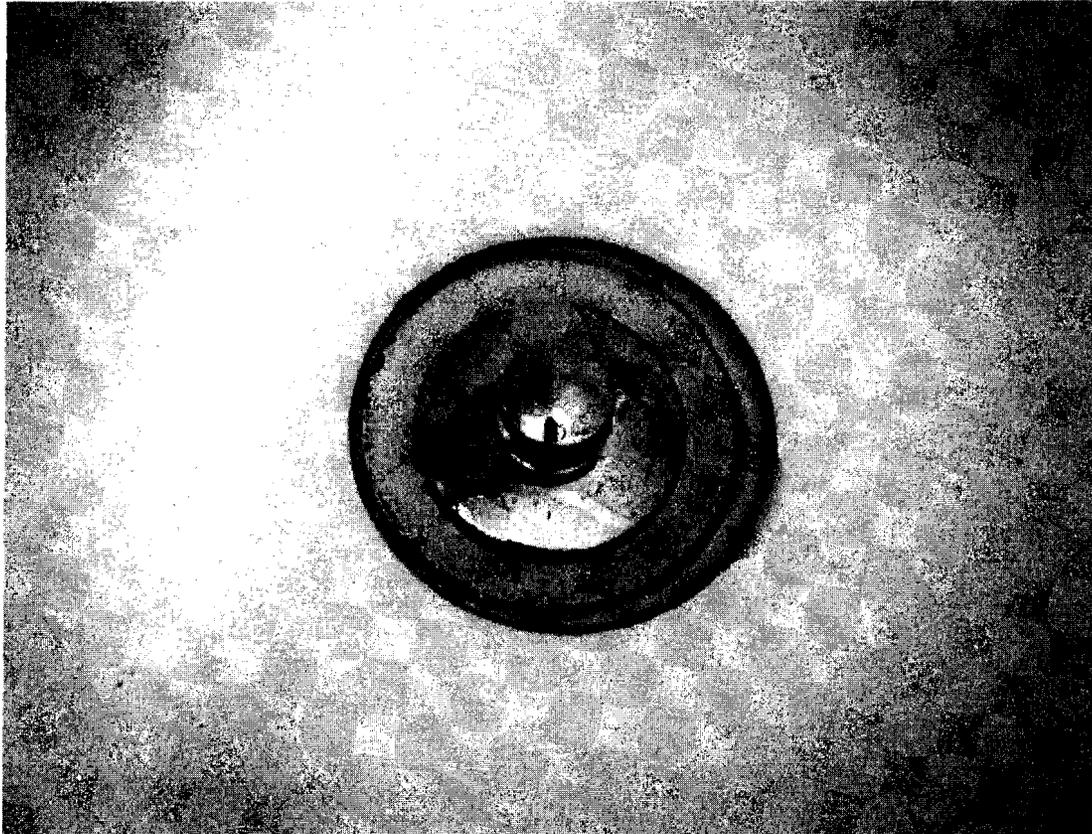
PHOTO ID:	031	LOCATION:				DESCRIPTION:	
		SPARE BATHROOM					
LOCATION OR ITEM SAMPLED		VCDD	<input checked="" type="checkbox"/>	VCDN		OCDO	<input checked="" type="checkbox"/>

PREMATURE PITTING OF CHROME PLATING ON TUB DRAIN STOPPER

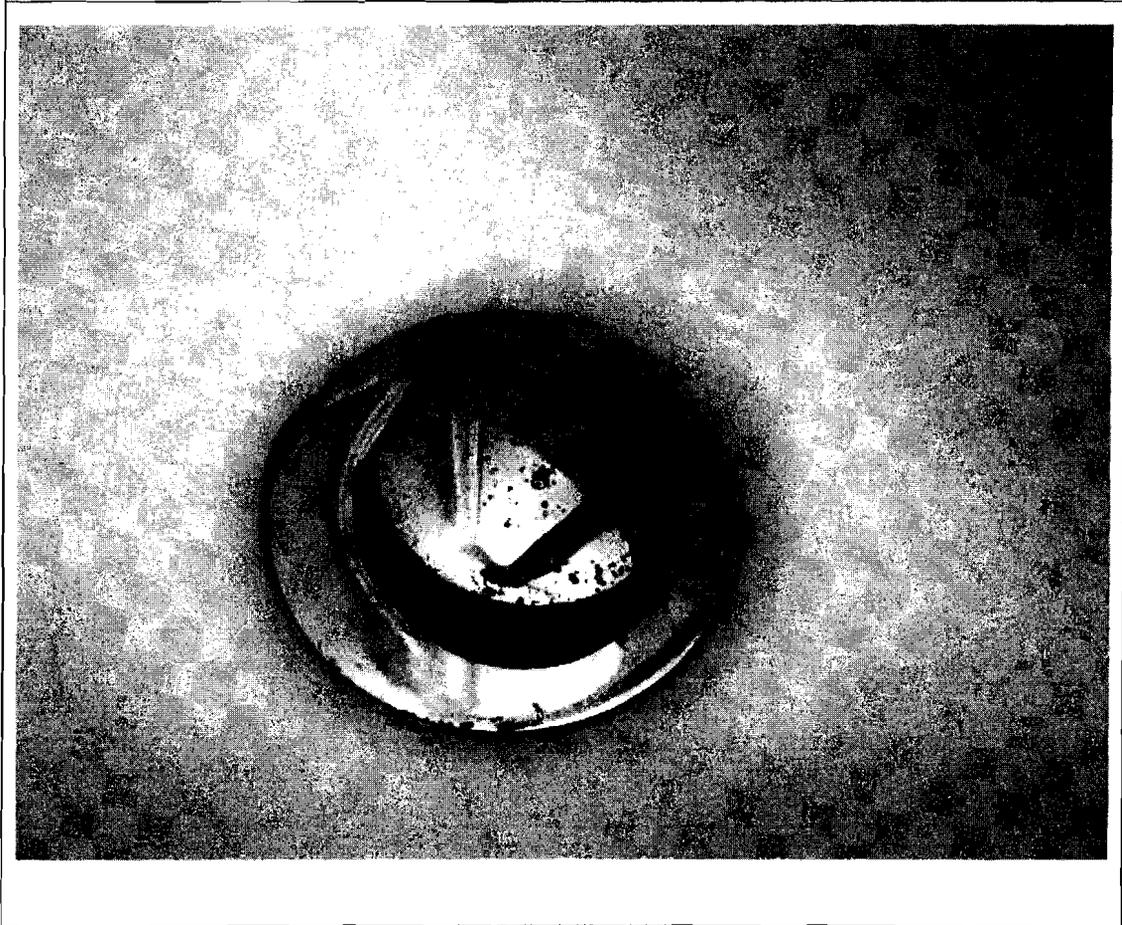
PHOTO ID:	032	LOCATION:				DESCRIPTION:	
		SPARE BATHROOM				PREMATURE PITTING OF CHROME PLATING ON LEFT SINK DRAIN STOPPER	
LOCATION OR ITEM SAMPLED		VCDD	<input checked="" type="checkbox"/>	VCDN			OCDO

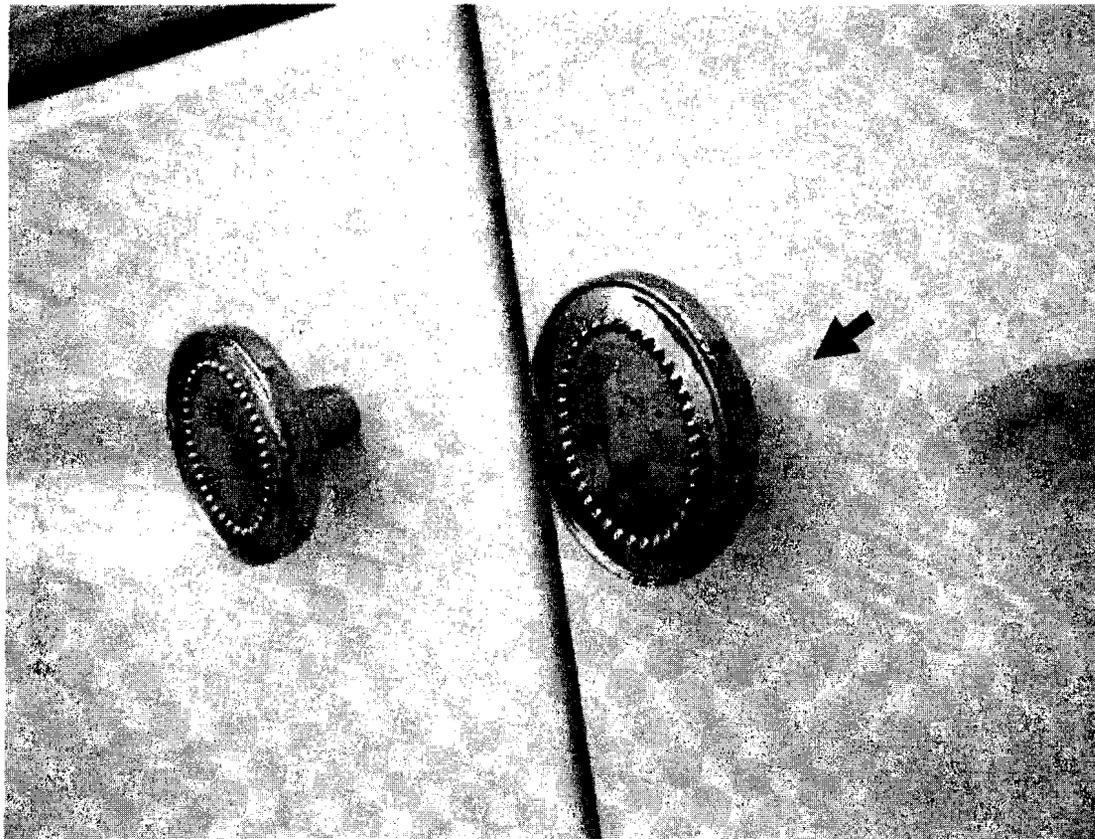
PHOTO ID:	033	LOCATION:				DESCRIPTION:	
		SPARE BATHROOM					
LOCATION OR ITEM SAMPLED		VCDD	<input checked="" type="checkbox"/>	VCDN		OCDO	<input checked="" type="checkbox"/>

PREMATURE PITTING OF CHROME PLATING ON CABINET DOOR KNOB

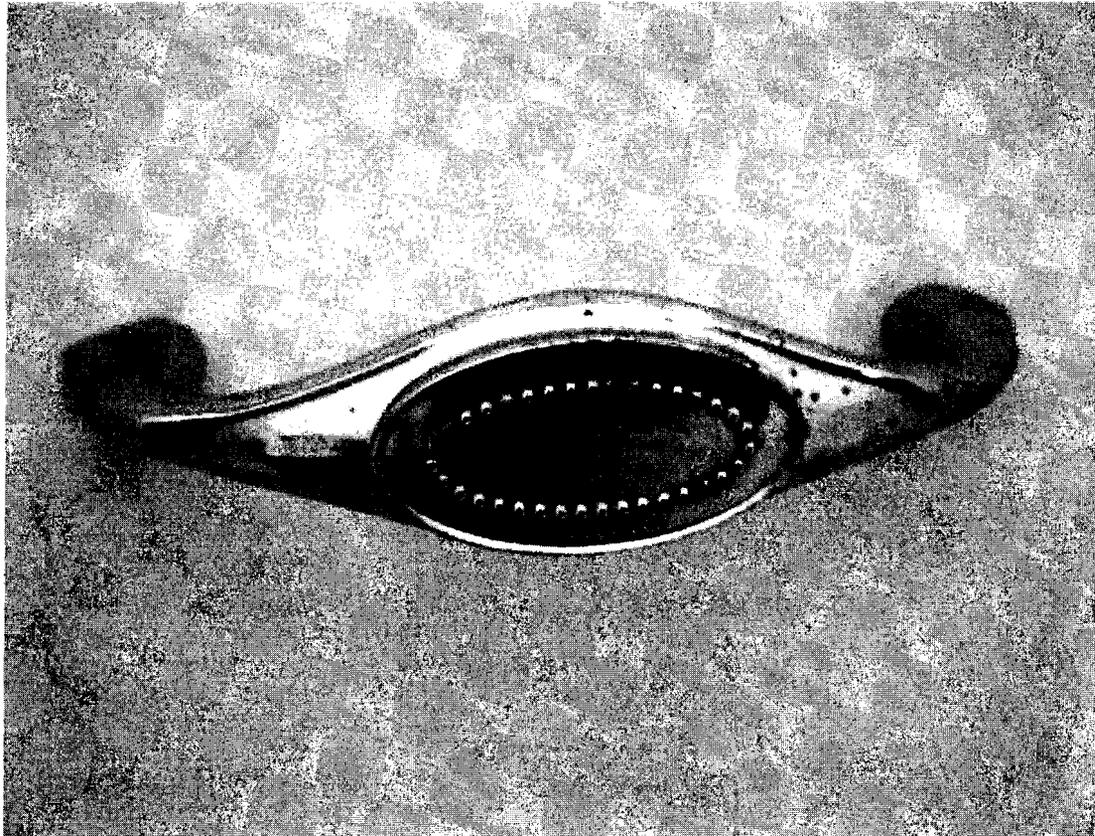
PHOTO ID:	034	LOCATION:				DESCRIPTION:	
		SPARE BATHROOM				PREMATURE PITTING OF CHROME PLATING ON DRAWER PULL	
LOCATION OR ITEM SAMPLED		VCDD	<input checked="" type="checkbox"/>	VCDN		OCDO	<input checked="" type="checkbox"/>

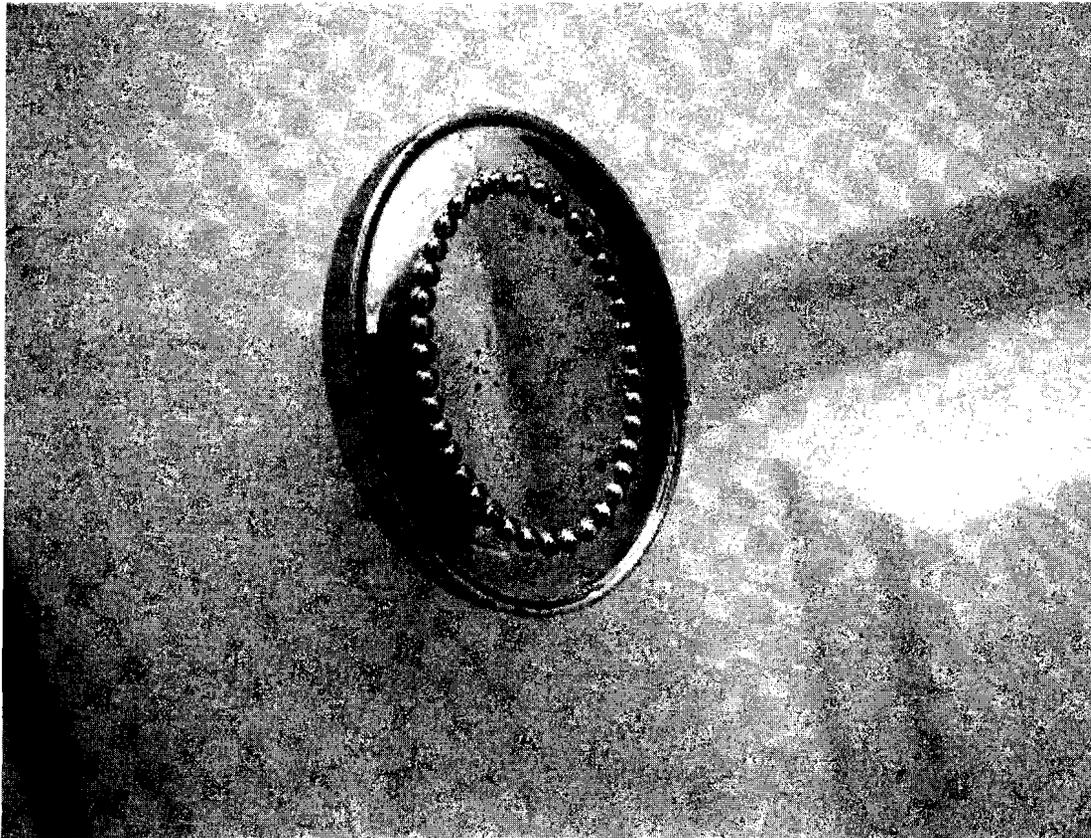
PHOTO ID:	035	LOCATION:				DESCRIPTION:	
		SPARE BATHROOM					
LOCATION OR ITEM SAMPLED		VCDD	<input checked="" type="checkbox"/>	VCDN		OCDO	<input checked="" type="checkbox"/>

PREMATURE PITTING OF CHROME PLATING ON CABINET DOOR KNOB

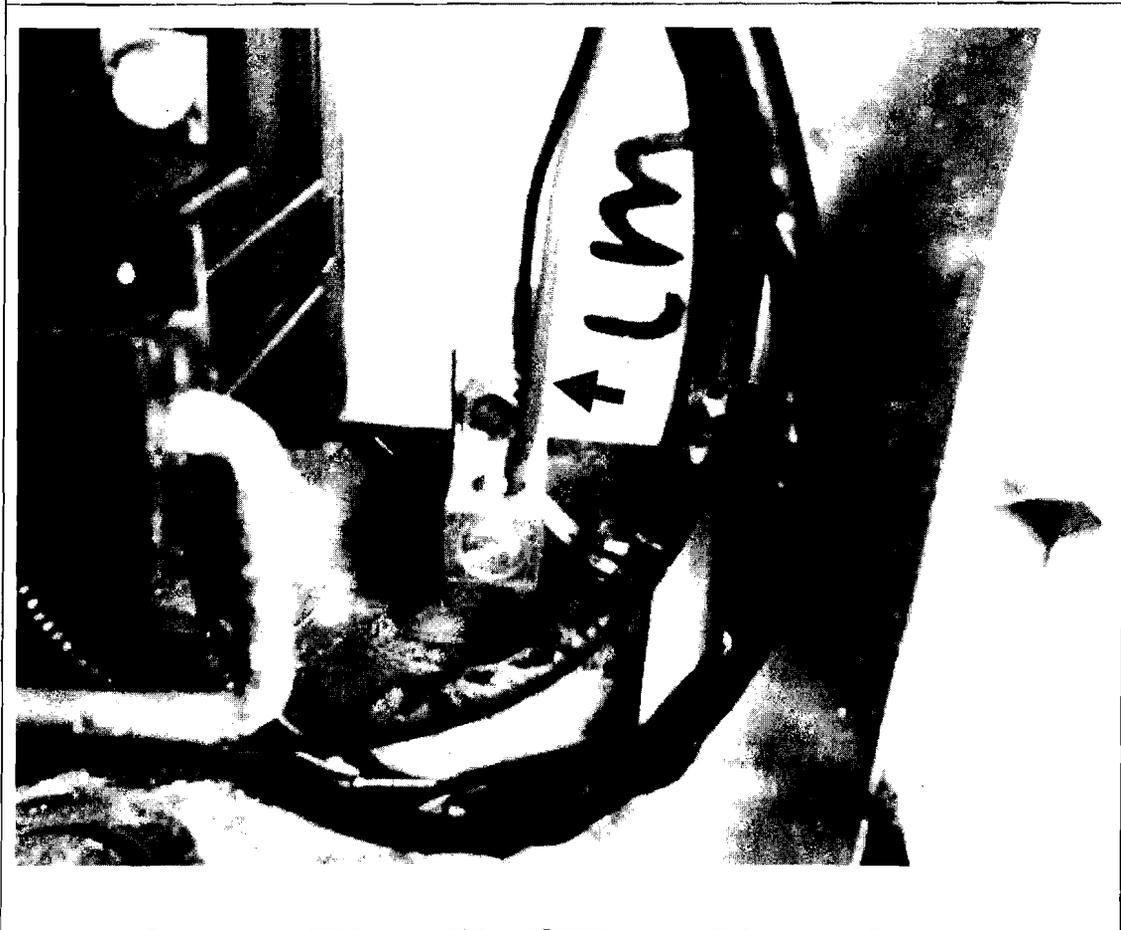
PHOTO ID:	037	LOCATION:				DESCRIPTION:	
		AHU - 2 ND LEVEL ATTIC				PREMATURE BLACKENING OF COPPER WIRE	
LOCATION OR ITEM SAMPLED		VCDD	<input checked="" type="checkbox"/>	VCDN			OCDO

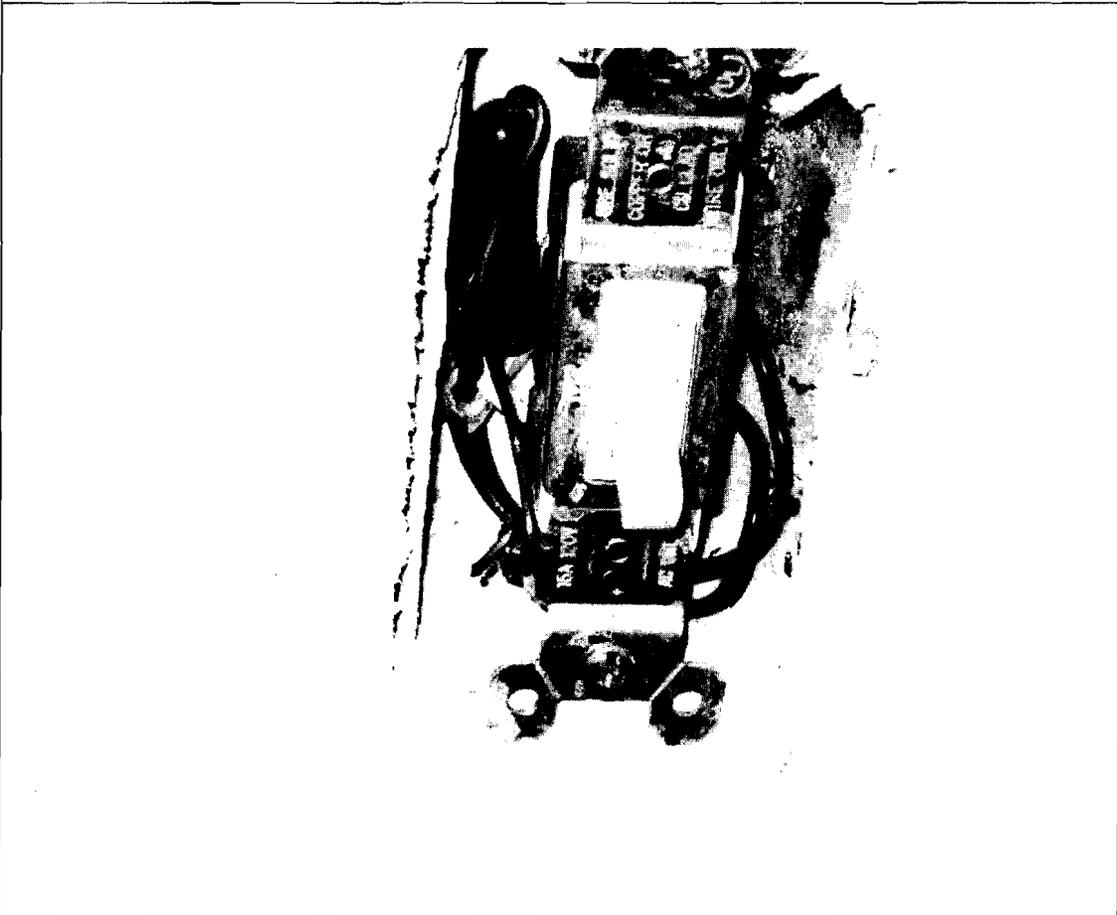
PHOTO ID:	LOCATION:	DESCRIPTION:
SAMPLE IMAGE FOR ILLUSTRATIVE PURPOSES AS VIEWED AT FLORIDA DEPT. OF HEALTH WEBSITE (http://www.doh.state.fl.us/environment/community/indoor-air/casedefinition.html)		Electrical switch panel with the cover removed showing no corrosion on the bare copper ground wire.

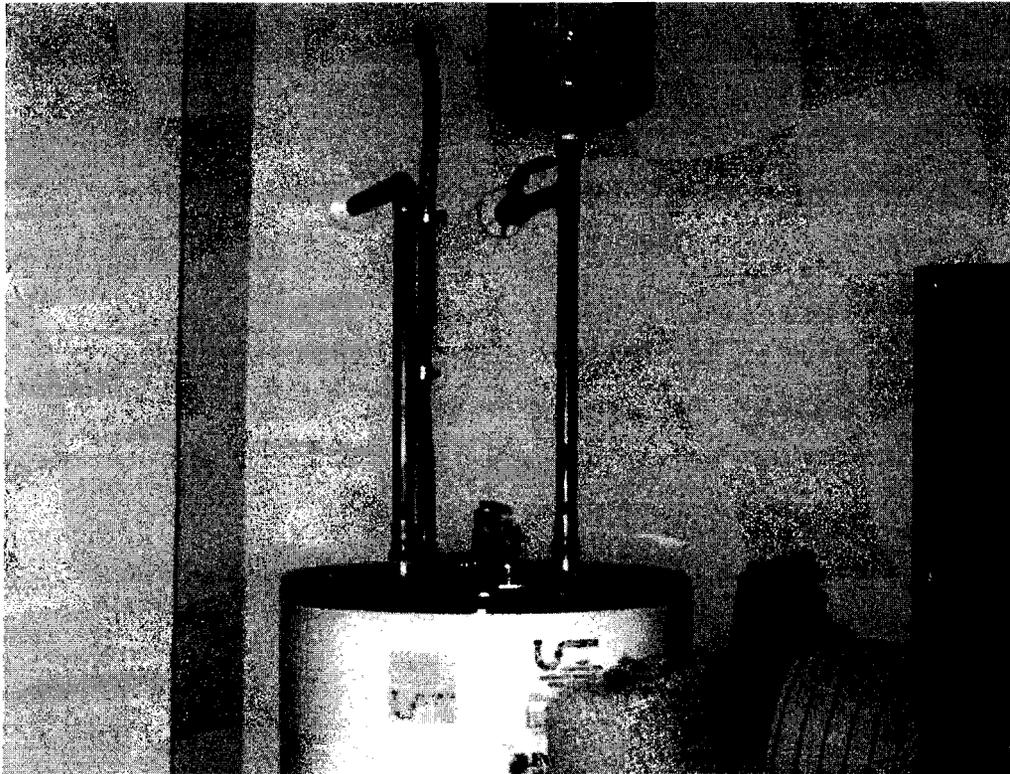
PHOTO ID:	LOCATION:	DESCRIPTION:
SAMPLE IMAGE FOR ILLUSTRATIVE PURPOSES AS VIEWED AT FLORIDA DEPT. OF HEALTH WEBSITE (http://www.doh.state.fl.us/environment/community/indoor-air/casedefinition.html)		Water heater in garage with no corrosion on copper water lines.

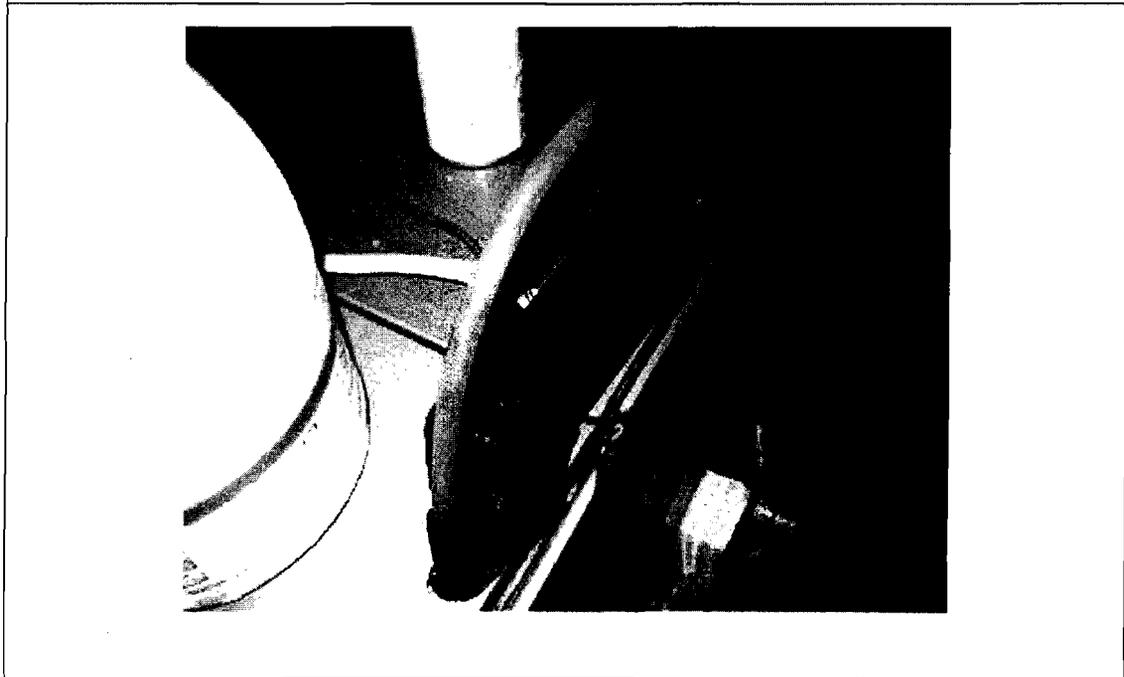
PHOTO ID:	LOCATION:	DESCRIPTION:
SAMPLE IMAGE FOR ILLUSTRATIVE PURPOSES AS VIEWED AT FLORIDA DEPT. OF HEATH WEBITE (http://www.doh.state.fl.us/environment/community/indoor-air/casedefinition.html)		Un-insulated copper pipe leading to the air handling unit with no signs of blackening corrosion.
