| 1. Task Number 090529CBB1741 | | 2. Investigator's ID 9102 | | EPIDEMIOLOGIC INVESTIGATION REPORT |
| 6. Synopsis of Accident or Complaint UPC 0-81999-10522-8 The family moved into their home in October 2006 and had to move out in April 2009 due to the ill health affects from the tainted drywall. The owner of the home cut holes in his walls to discover that the drywall was imported from Canada by an American Company and was a medium gray color. The homes two air conditioners coils had both been replaced twice. Chrome fixtures were pitted and electrical wiring was turning black. <div style="text-align: right;"> <p><u>MFR/PRV/LBR NOTIFIED</u> 10/13/09</p> <p>COMMENTS: <u>YES</u> <u>NO</u></p> <p><input checked="" type="checkbox"/> <u>OVERRULED</u>; <u>ATTACHED</u></p> <p><input checked="" type="checkbox"/> <u>EXCISIONS/FOIA Hqs.</u> <i>oche mpr.</i></p> <p><u>DO NOT RE-NOTIFY</u> <input checked="" type="checkbox"/> <u>RE-NOTIFY</u></p> </div> | | | | |

This incident involves health issues and copper and metal corrosion at the non seasonal home of the victims over an extended period of time as will be detailed later in this report which the owners believe were caused by contaminate

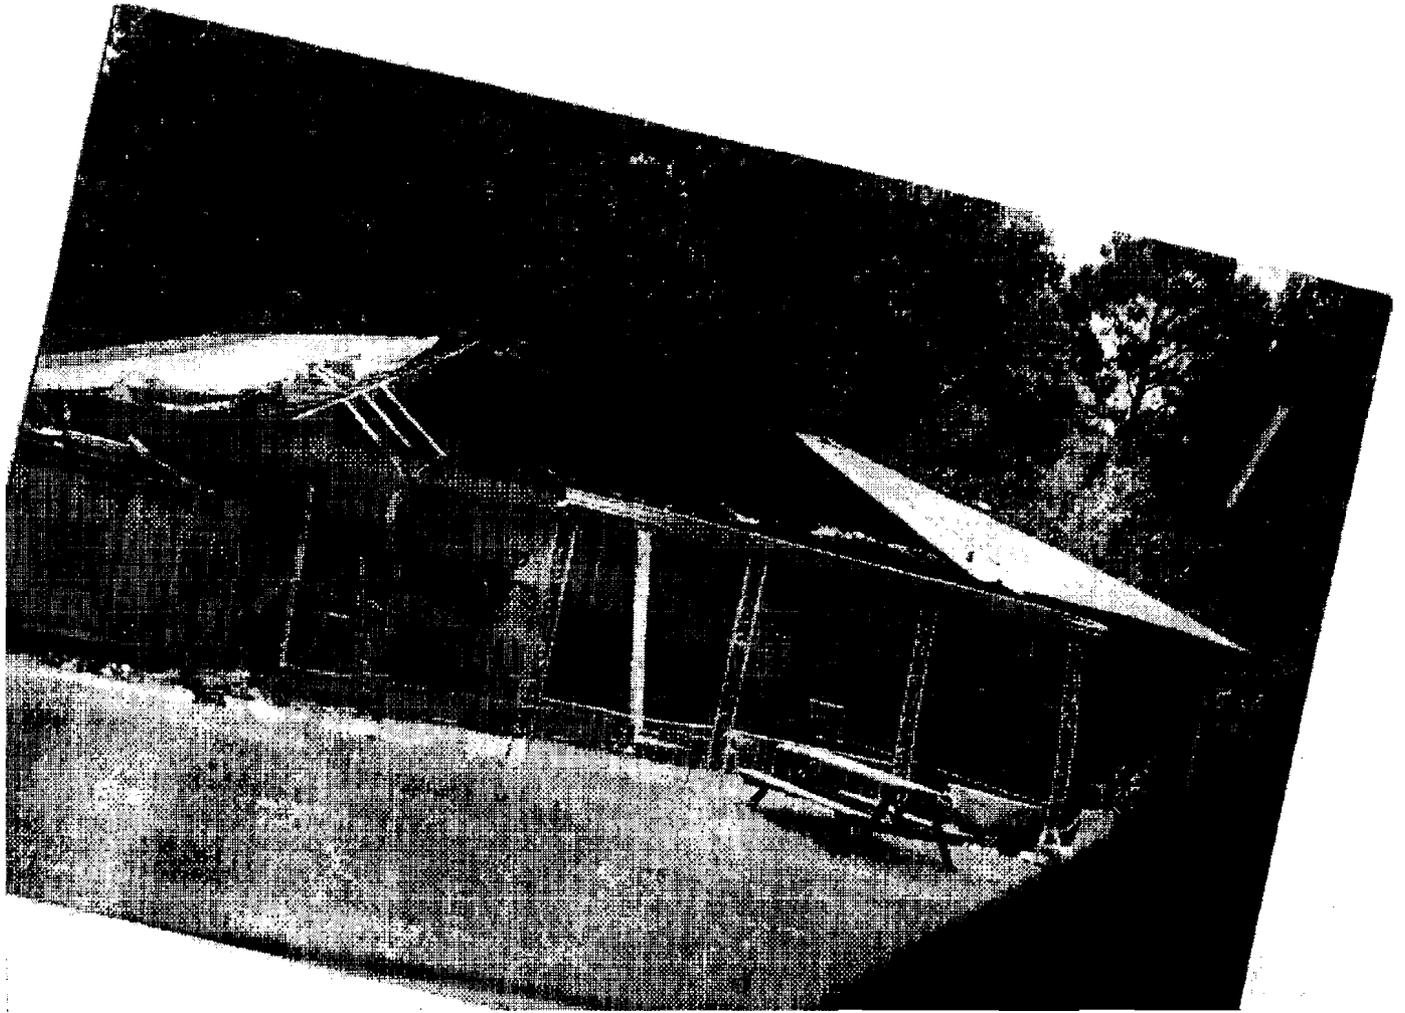
Photo 12: View of the 2004 fire damage (scanned photo provided by the complainant). The photo depicts the side of the house and shows the carport/utility room area.

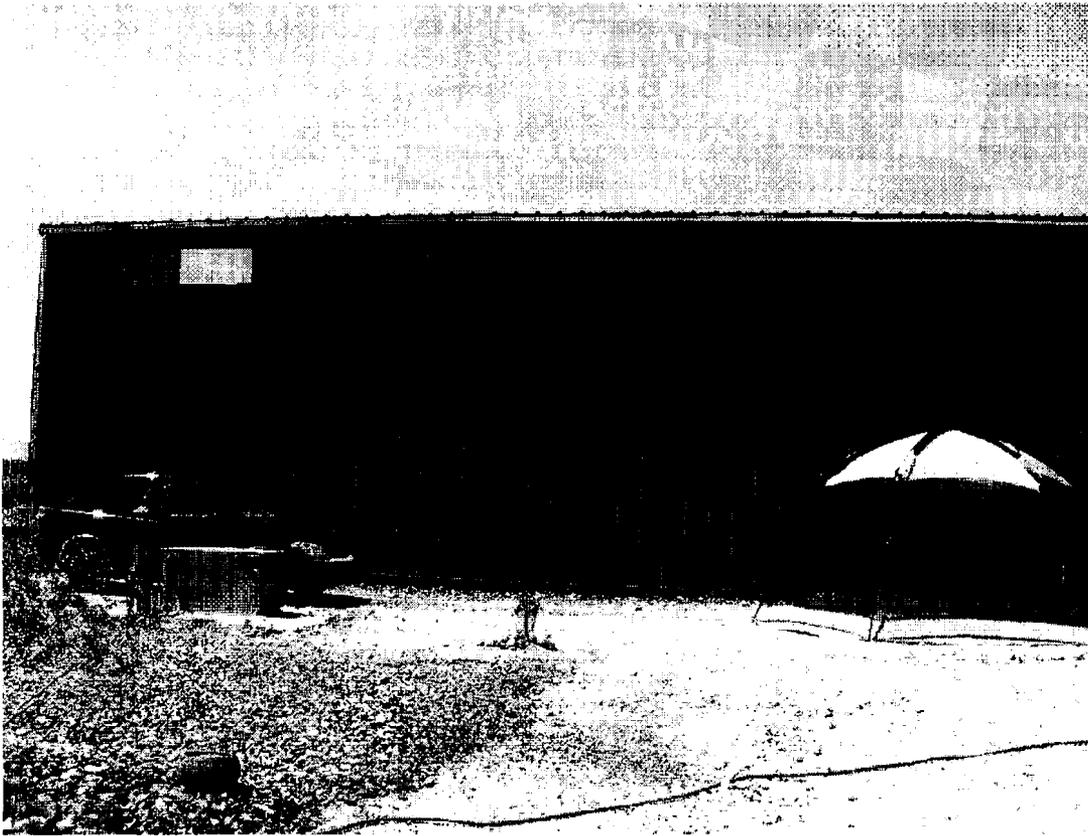
Photo 3 of 7-
Exterior view of metal building built by complainant and her partner. Building is used as an art studio and residence. Rooms shown above are located behind the wall behind the automobile.

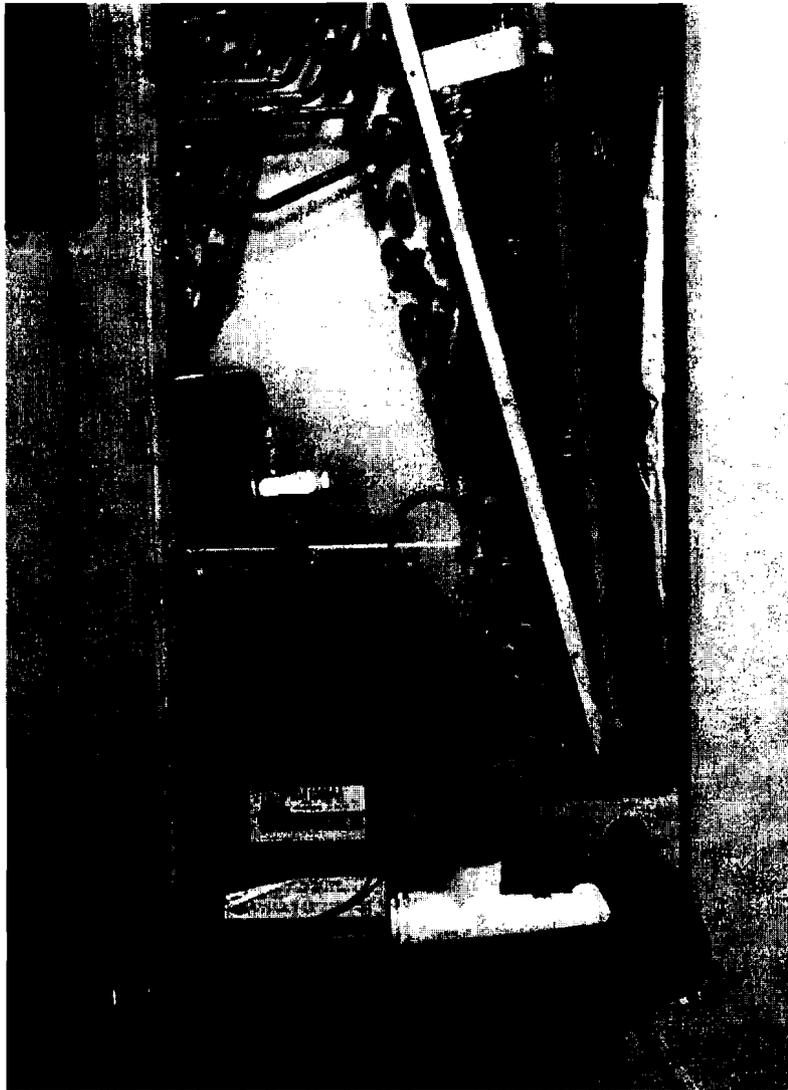
Exhibit 2 - Photograph of the evaporator coils of the central air conditioner in the consumer's home.

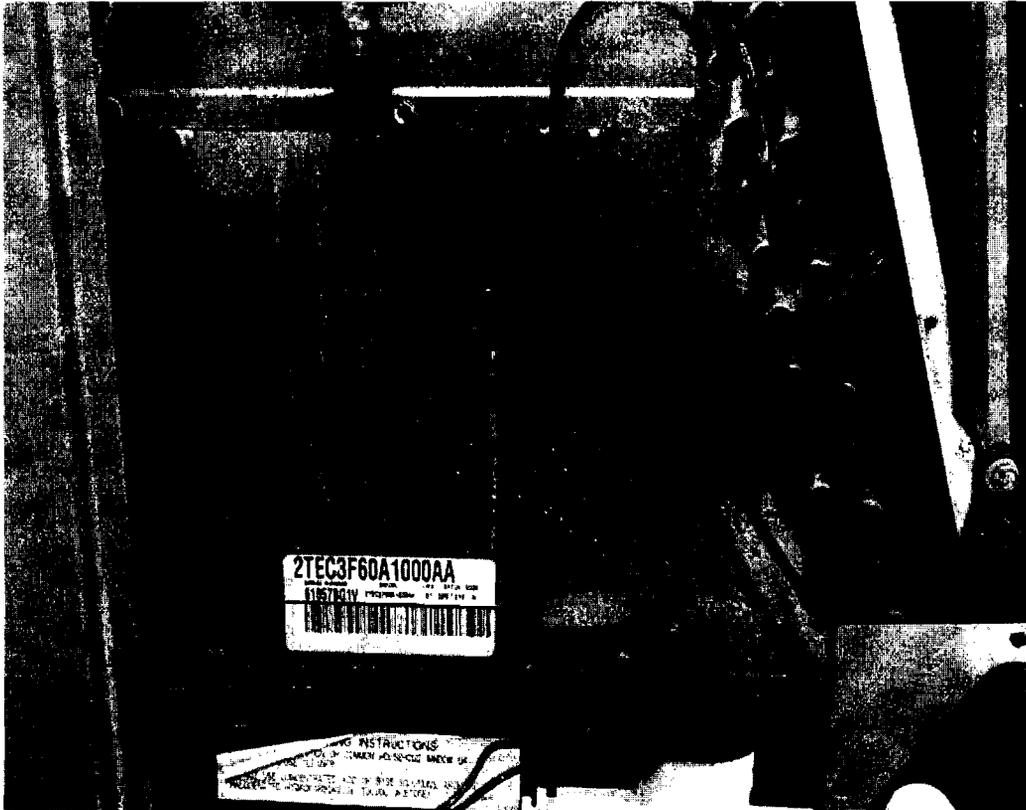
Exhibit 3 - Close up of the evaporator coils at the bottom of the air conditioner unit.

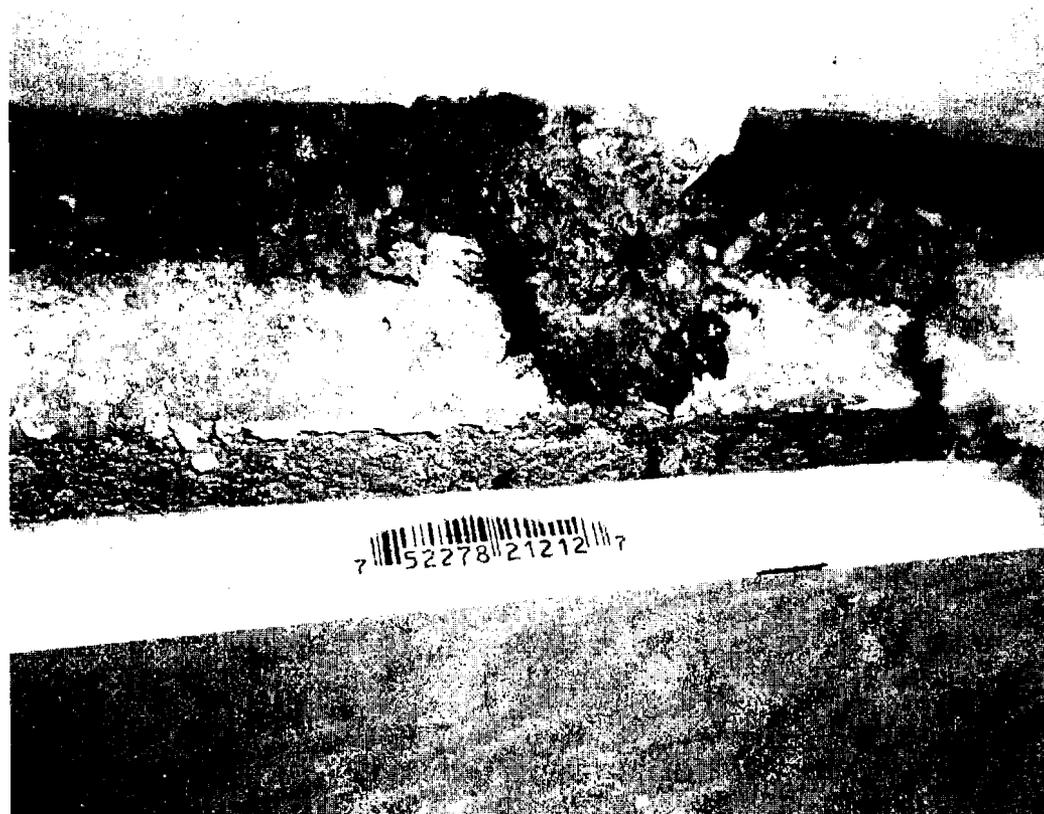
Exhibit 7 - The drywall is bar coded: "7 52278 21212 7"

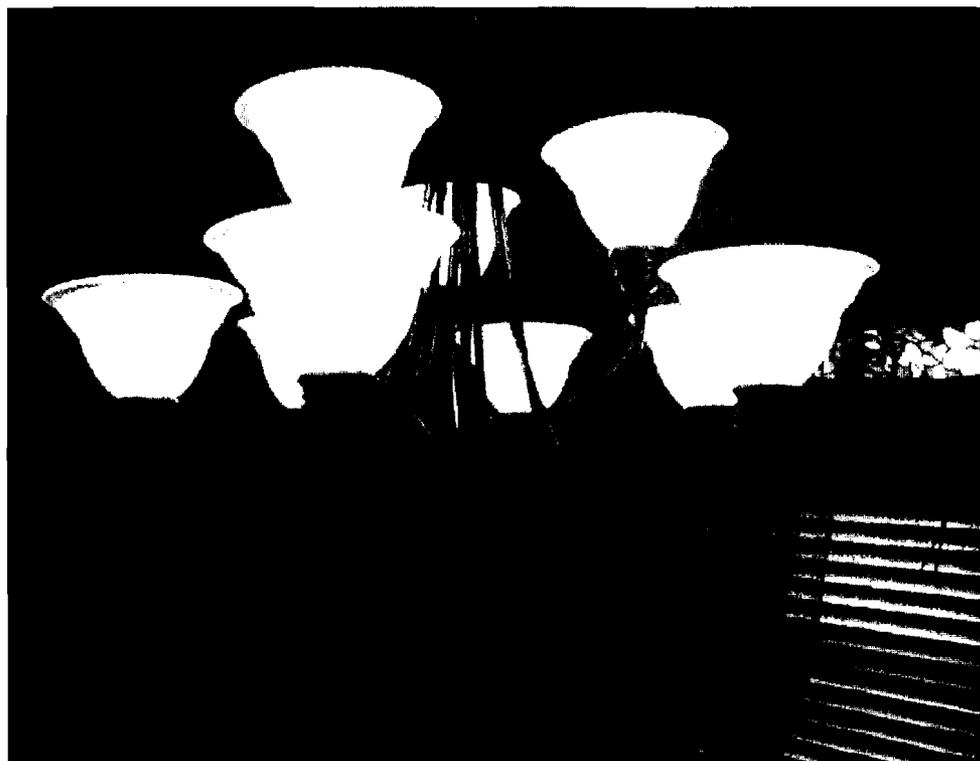
Exhibit 3 - Photograph of chandelier in the dining room.

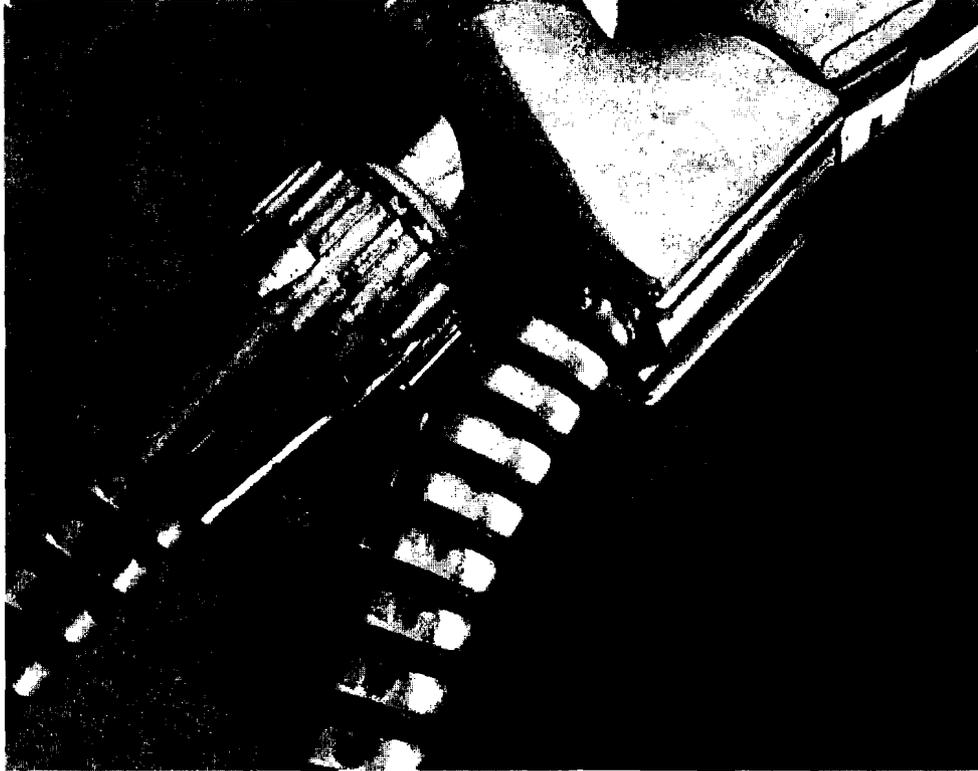
Exhibit 6 - Photograph of pitting on the shower head in the master bedroom.

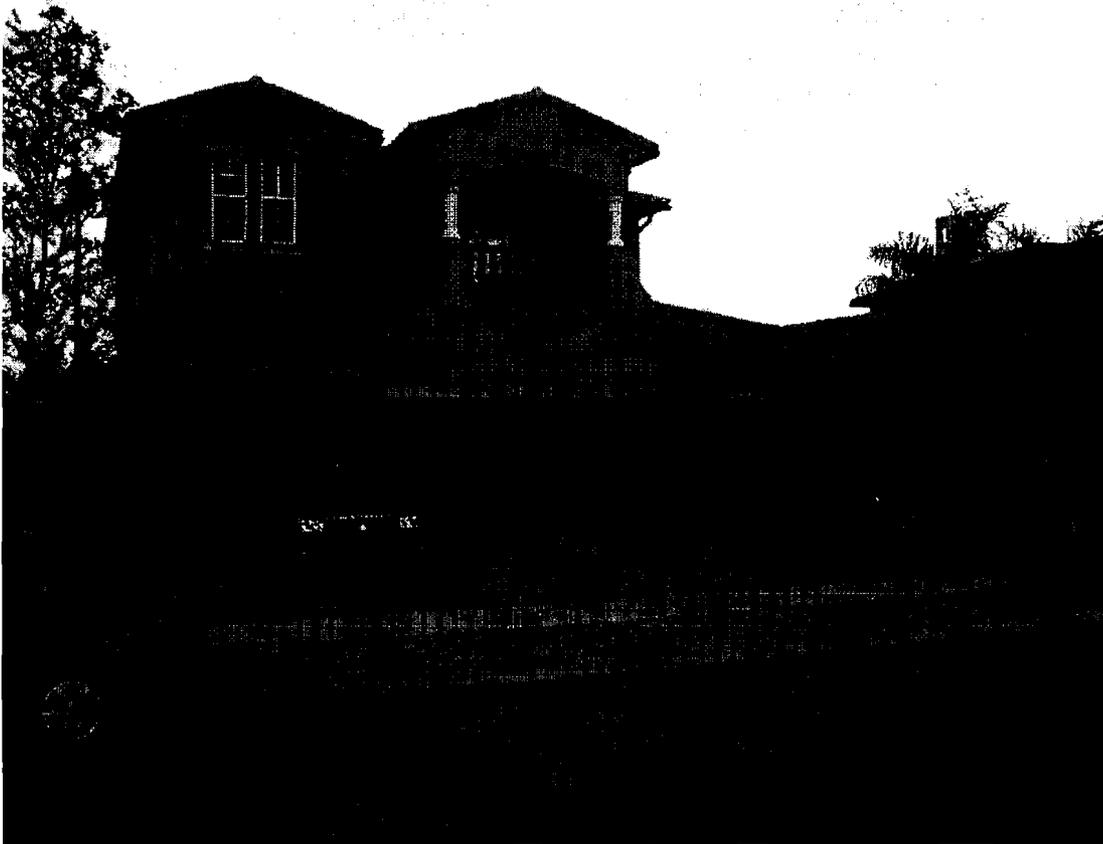
Exhibit A-1 is a view of the incident residence. The home is the Emerson-Expanded Spanish model.

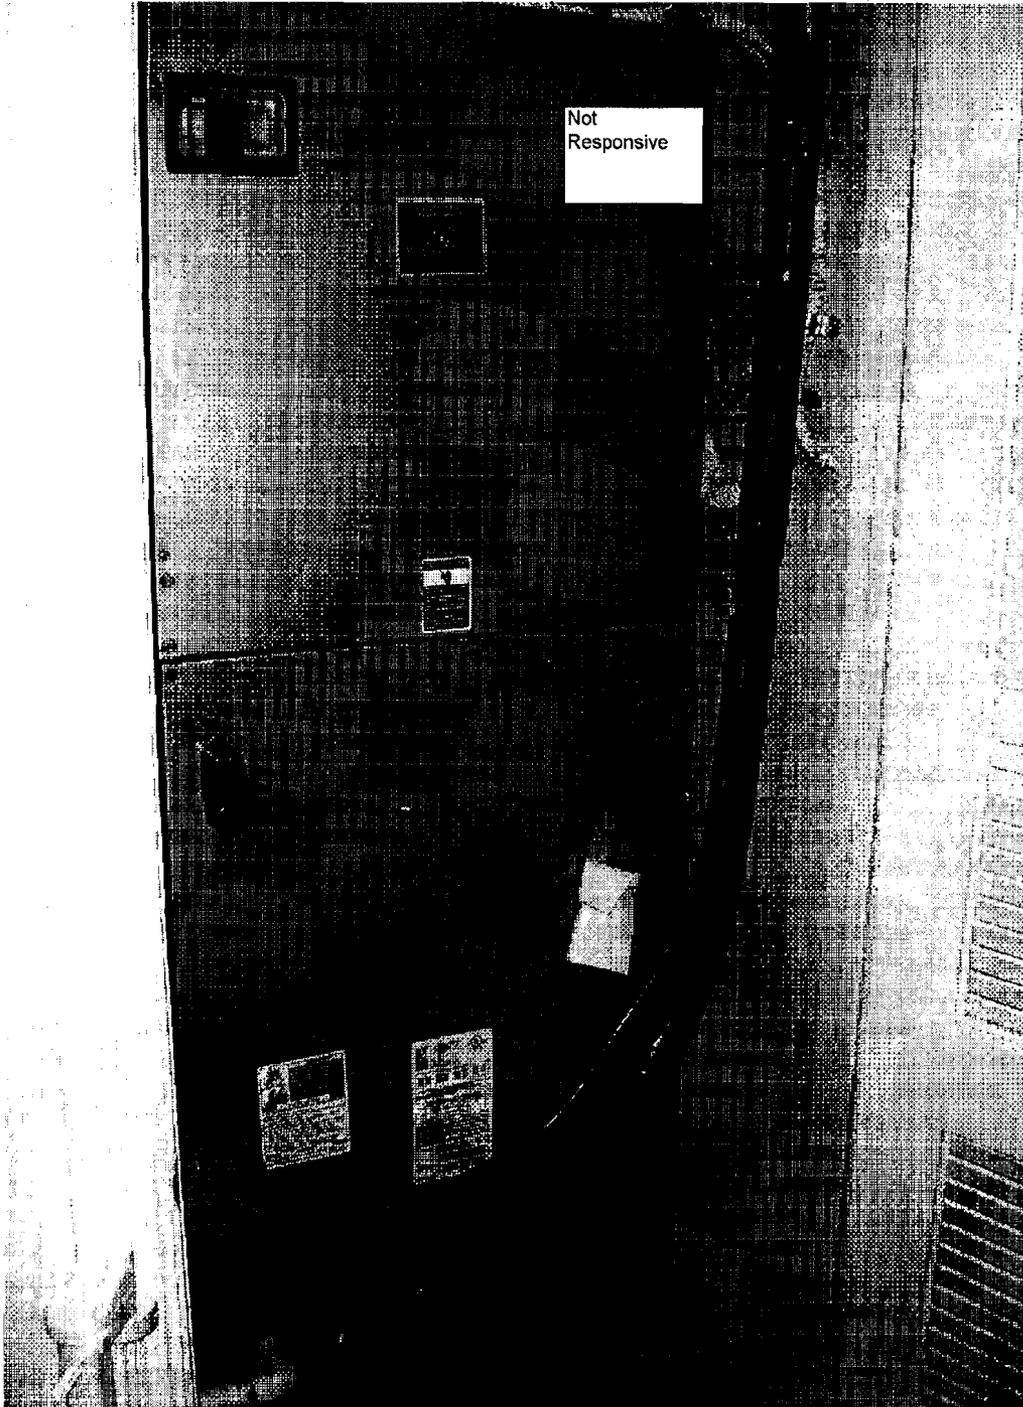
Exhibit A-1 is a view of the air handler on the main floor of the residence near the laundry room by the garage.

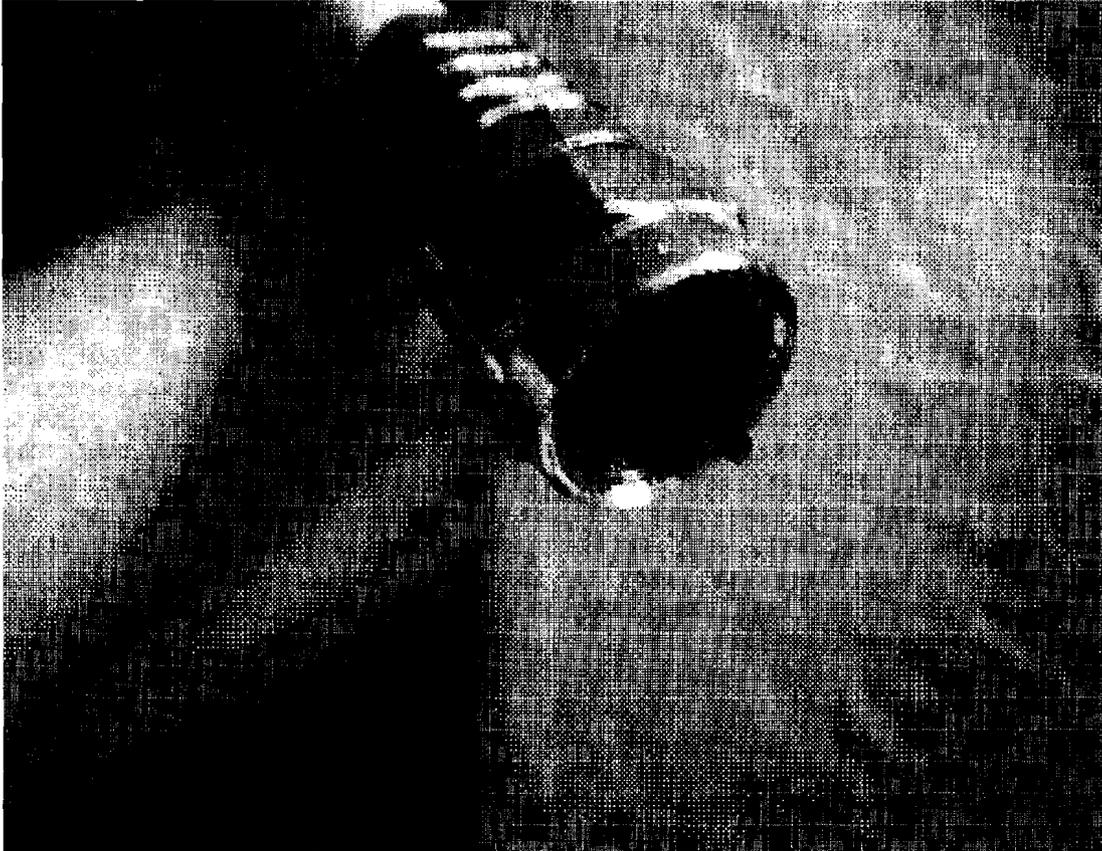
Exhibit A-6 is a view of exposed coaxial copper wiring in the laundry room.

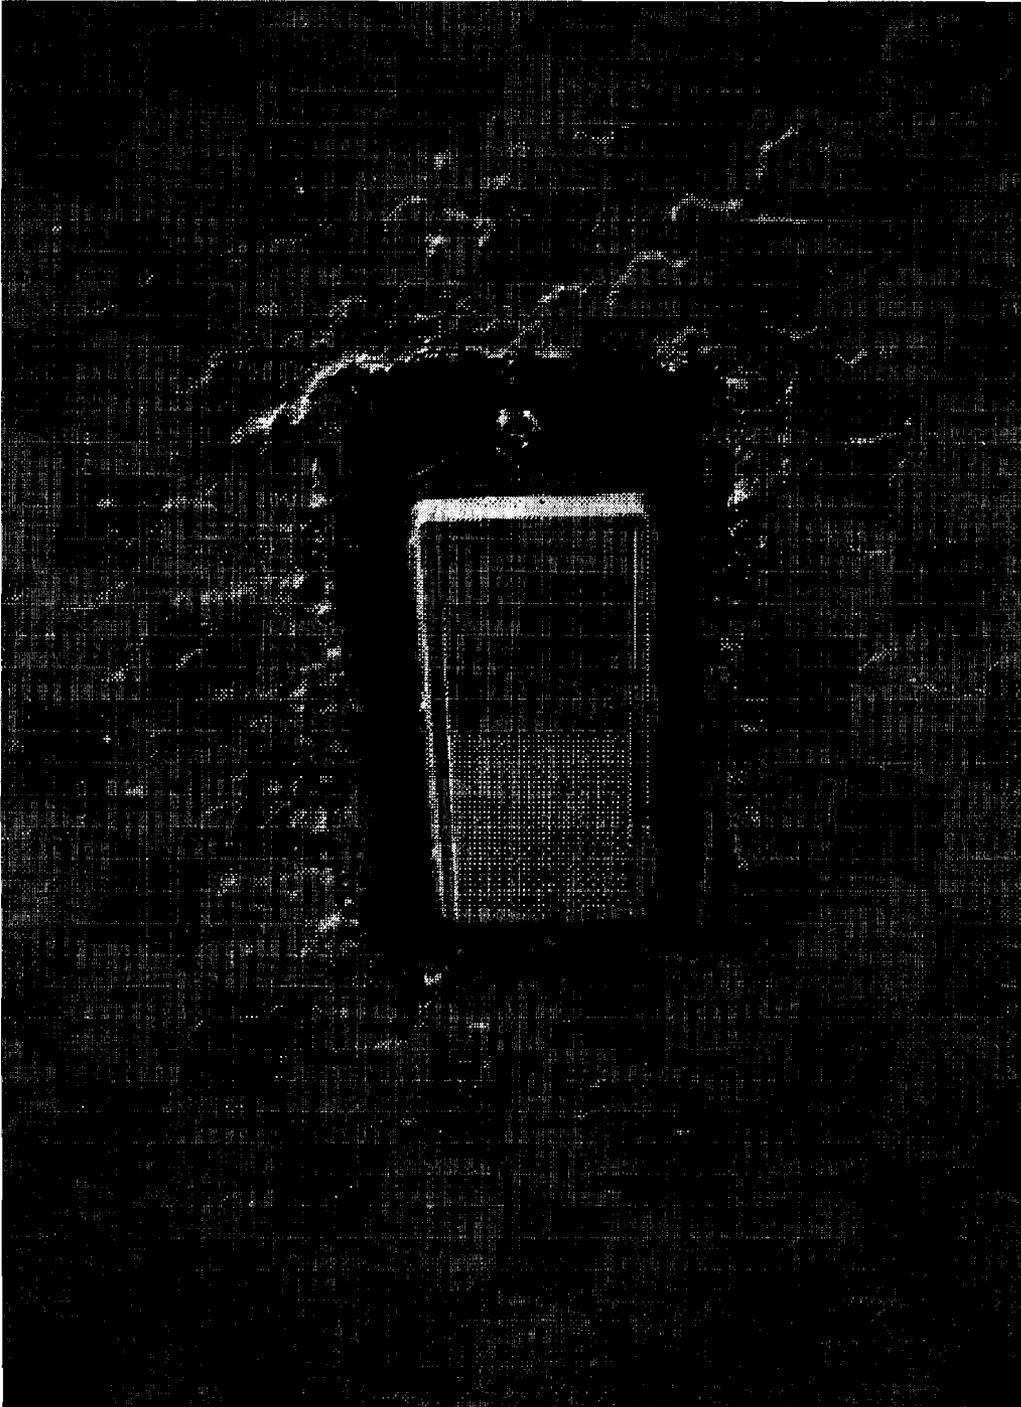
Exhibit A-9 is a view a light switch on the main floor of the residence with the face plate removed.

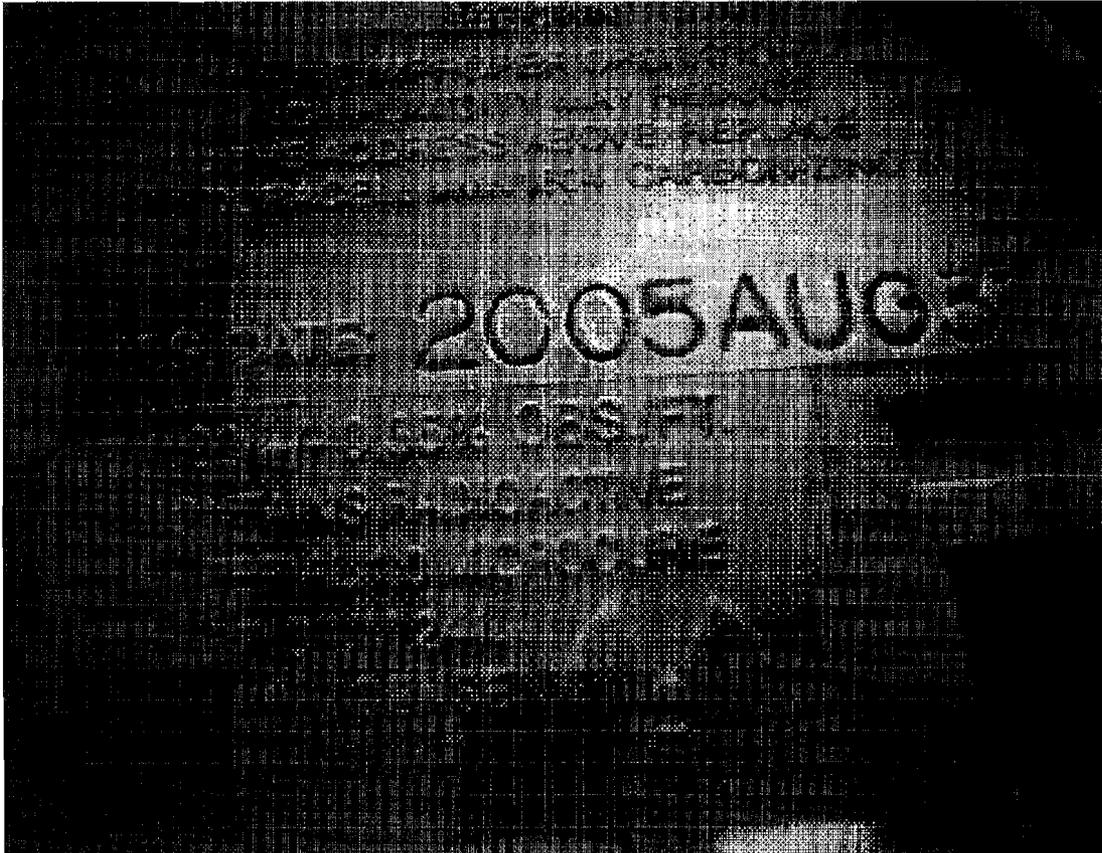
Exhibit A-17 is a view of the smoke alarm that malfunctioned.

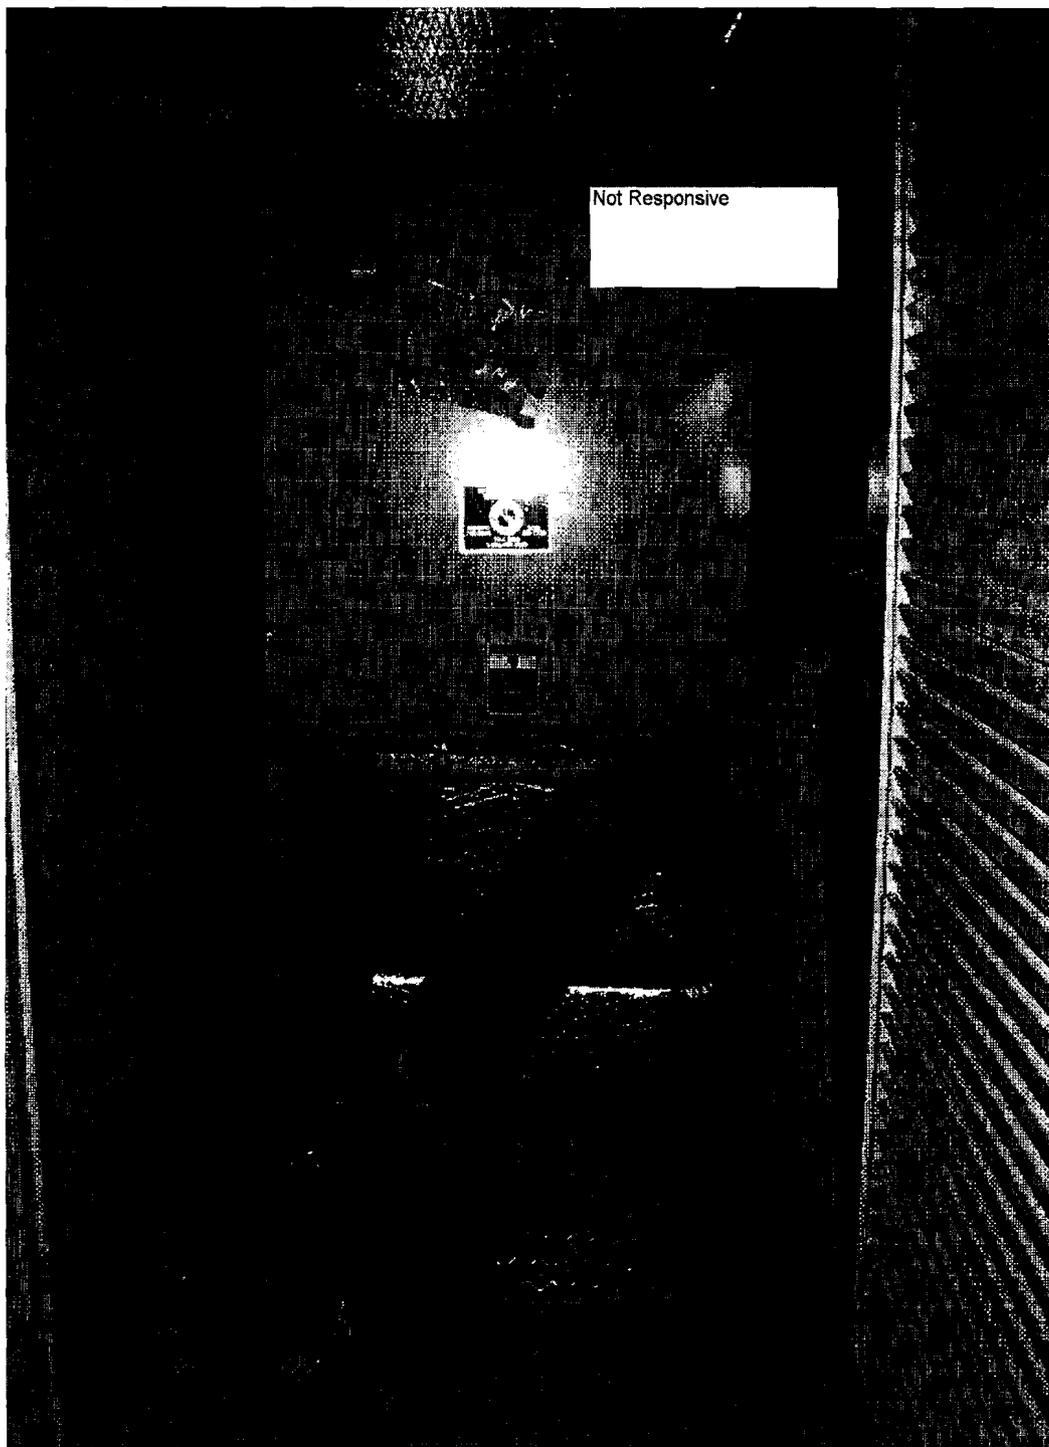
Exhibit A-28 is a view of the air handler on the second floor of the residence.
